EMERGENCY PERMIT APPLICATION FORM

**EM_2024-0003
This application for
SFR Foundation Repair/Stabilization
ONLY**

GEOTECHNICAL INVESTIGATION
BALDERSTON FOUNDATION IMPROVEMENTS
12700 NORTH HIGHWAY 1
MENDOCINO, CALIFORNIA

January 10, 2024

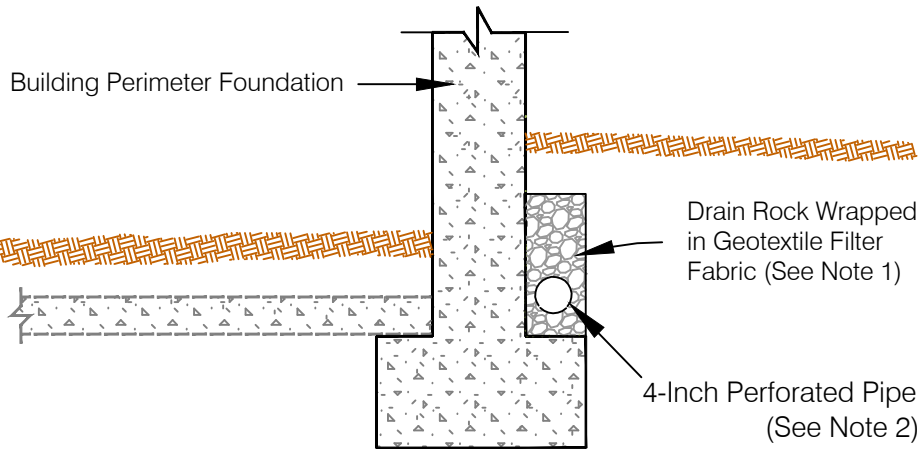
PERIMETER FOUNDATION DRAINAGE DETAIL
(Not to Scale)

Because surface and/or subsurface water is often the cause of foundation or interior moisture problems, care should be taken to intercept and divert concentrated surface flows and subsurface seepage away from the building foundations. Drainage across the lot should be by sheet-flow. Surface grades should maintain a recommended five percent gradient away from building foundations. To minimize the chance for moisture inundation of the near surface soils, we recommend that a perimeter foundation drain be installed around the perimeter foundation elements, as shown on Plate 11

1. Drain rock should be clean, free-draining 3/4 inch crushed rock. Perimeter foundation drain rock should be wrapped in a non-woven geotextile filter fabric (Mirafi 140N or equivalent) or Class 2 permeable material, without filter fabric, per Caltrans standard specifications, latest edition.
2. Pipe should be SDR 35 or equivalent, placed with perforations down, sloped at least 1 percent to gravity outlet or sump with automatic pump.
3. A clean-out pipe with cap should be installed at the up-slope end of the pipe, pipe elbows should be 45 degrees or less (for "snake" access).
