RE: Main St. Mendo LLC Appeal # 2024-0009 of Mendocino Historical Review Board  
Decision  
Address: 45040 Main St., Mendocino, CA APN 119-238-10  
Hearing Date: Potentially April 8, 2025

# Duncan Engineering Inc.

May 18, 2023

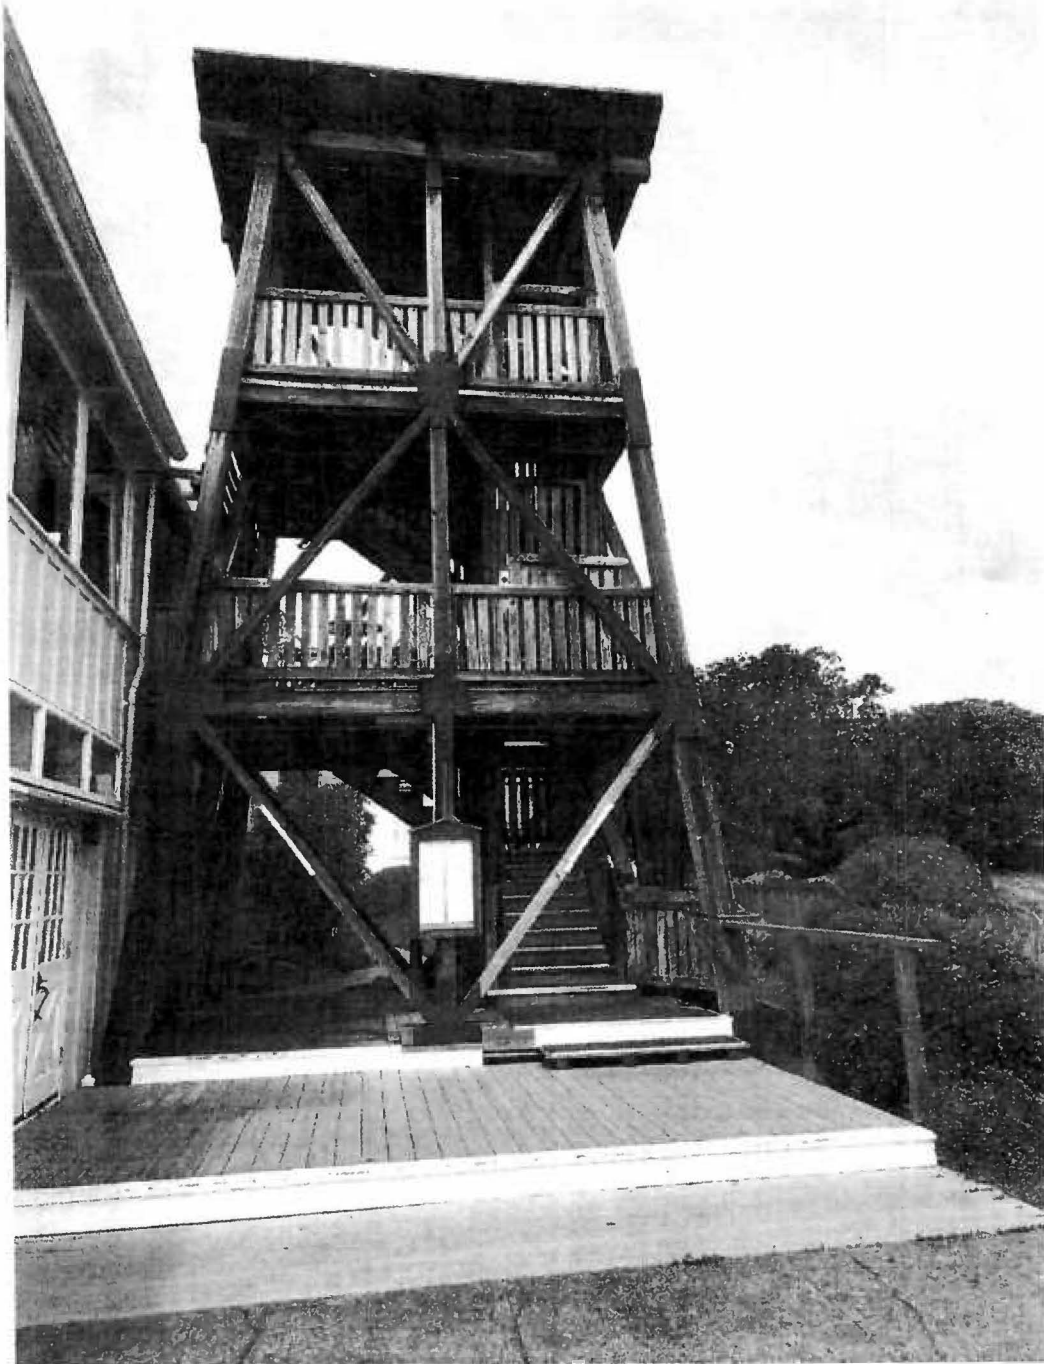
PLATE 1- SOUTH ELEVATION OF WATER TOWER BUILDING  
Showing ground floor= Level 1, Level 2, Level 3 and roof=Level 4

This assessment will document an existing wood structure at the above noted location. I made two site visits to assess the structural condition of the existing 'water tower' building and performed analysis in the office. The building has three elevated levels (two floors and a roof above the ground floor). The structure does not currently support a water tank but does provide second floor access to adjacent restaurant (PLATE 1).

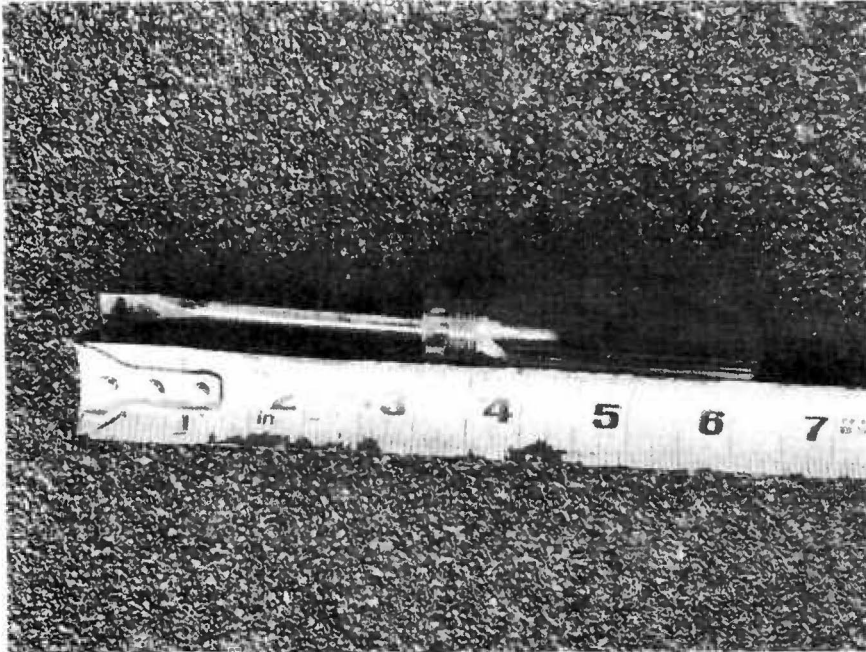
PLATE 2- 3" SCREW DRIVER-used to probe wood

posts. Three of the four corner posts had enough decay to allow the penetration of a 3" screw driver (PLATE 2) into the wood (see Plate 3). The northwest, southwest and southeast corner posts have severe decay. The intermediate posts (or middle posts) on the east and west side rest on corbels. The east corbel rests on decayed wood and is almost floating in air there is so little wood left.

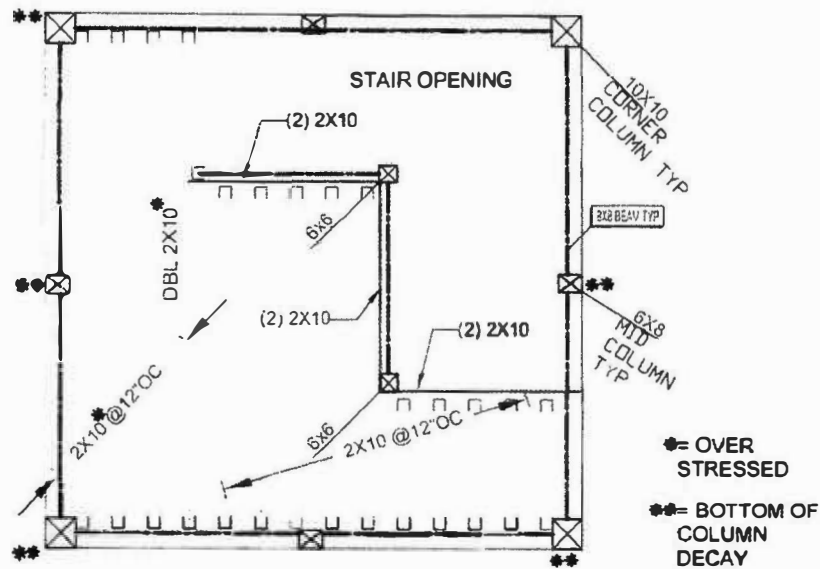
## SECOND FLOOR FRAME PLAN

A preliminary assessment of the second-floor framing was done. Several members are above their allowable stress limits (See plate 4). Additional posts or bigger members could be installed structurally to enhance the capacity. Levels above two were not analyzed as these are not open to the public. Note there could be some code triggers if the second-floor framing was replaced-an architect could advise on this.

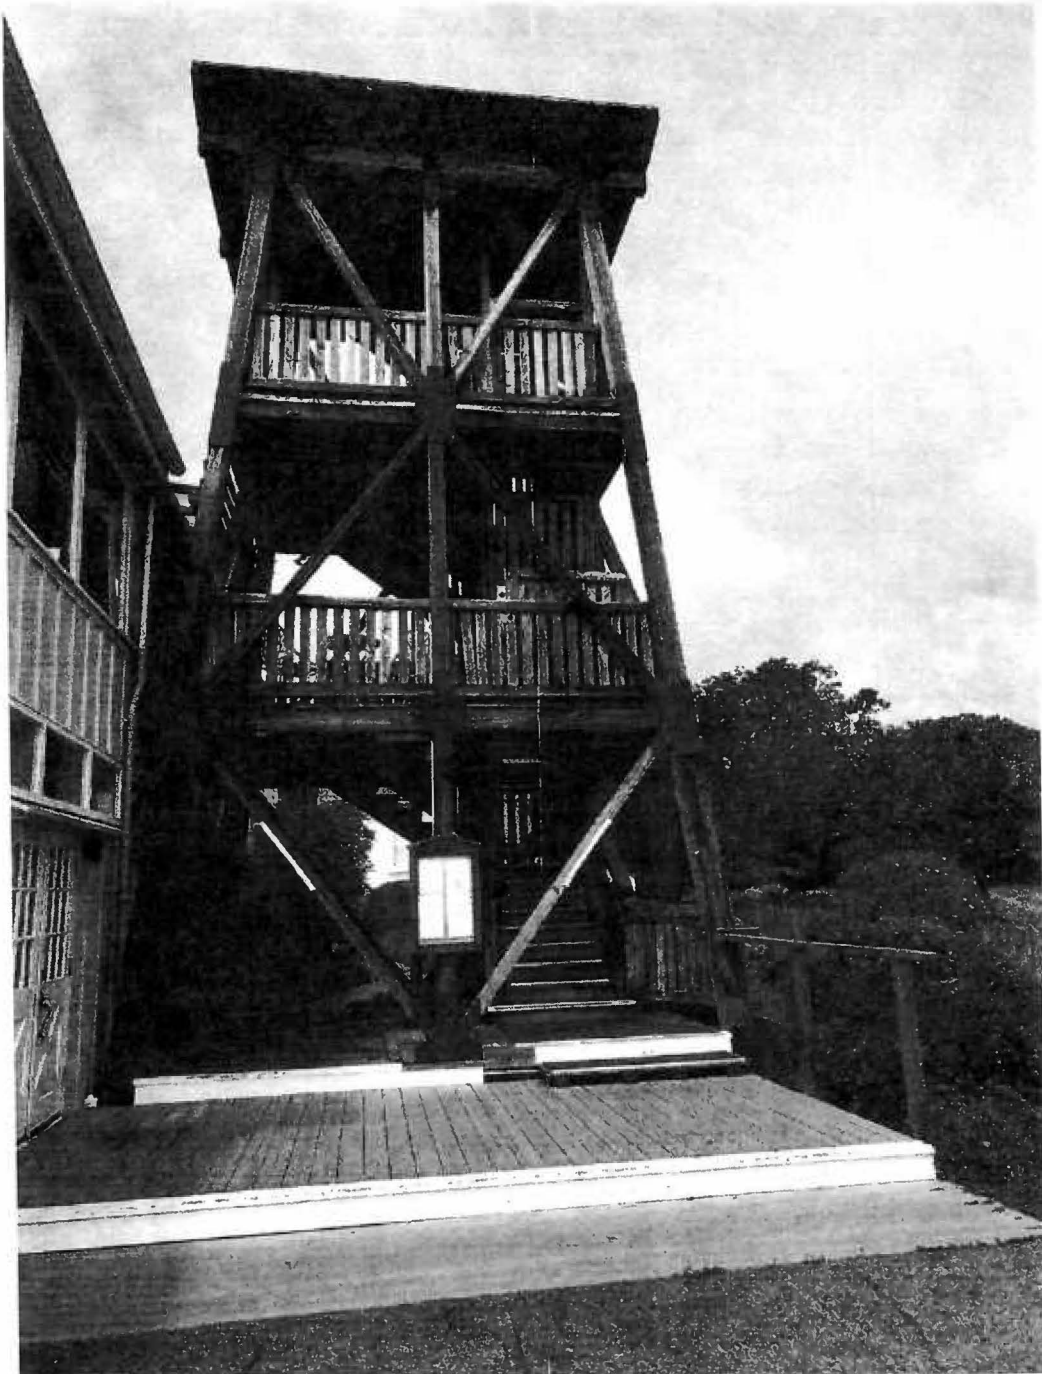
PLATE 1- SOUTH ELEVATION OF WATER TOWER BUILDING  
Showing ground floor= Level 1, Level 2, Level 3 and roof=Level 4

A structural assessment for the above noted structure was made in May of 2023. The items in that original assessment are still relevant and valid. A picture of the Water Tower is enclosed in Plate 1.
