Acceptance of Informational Report Regarding the Issuance of Emergency Coastal Development Permit EM\_2023-0003 (McLellan) to Relocate the Single-Family Residence, Located at 34301 Pacific Reefs Road, Albion, APN: 123-340-19

In early March 2023, approximately twenty-two (22) feet of the ocean bluff collapsed extending to the foundation of the existing single-family residence. On July 14, 2023, the current landowners submitted an emergency request application for the relocation of the existing single-family residence to Planning and Building Services. The application requests to relocate or re-construct the single-family residence to a new foundation within a stable building site on the subject parcel further away from the existing failed bluff edge, no less than sixty-six (66) feet east of the bluff top edge. Because of the structure's proximity to the blufftop, Planning Staff has determined the work is considered development and requires the issuance of a Coastal Development Permit

**NATURE OF EMERGENCY:** Approximately twenty-two (22) feet of the ocean bluff collapsed in early March 2023, extending to the foundation of the existing single-family residence.

**CAUSE OF EMERGENCY

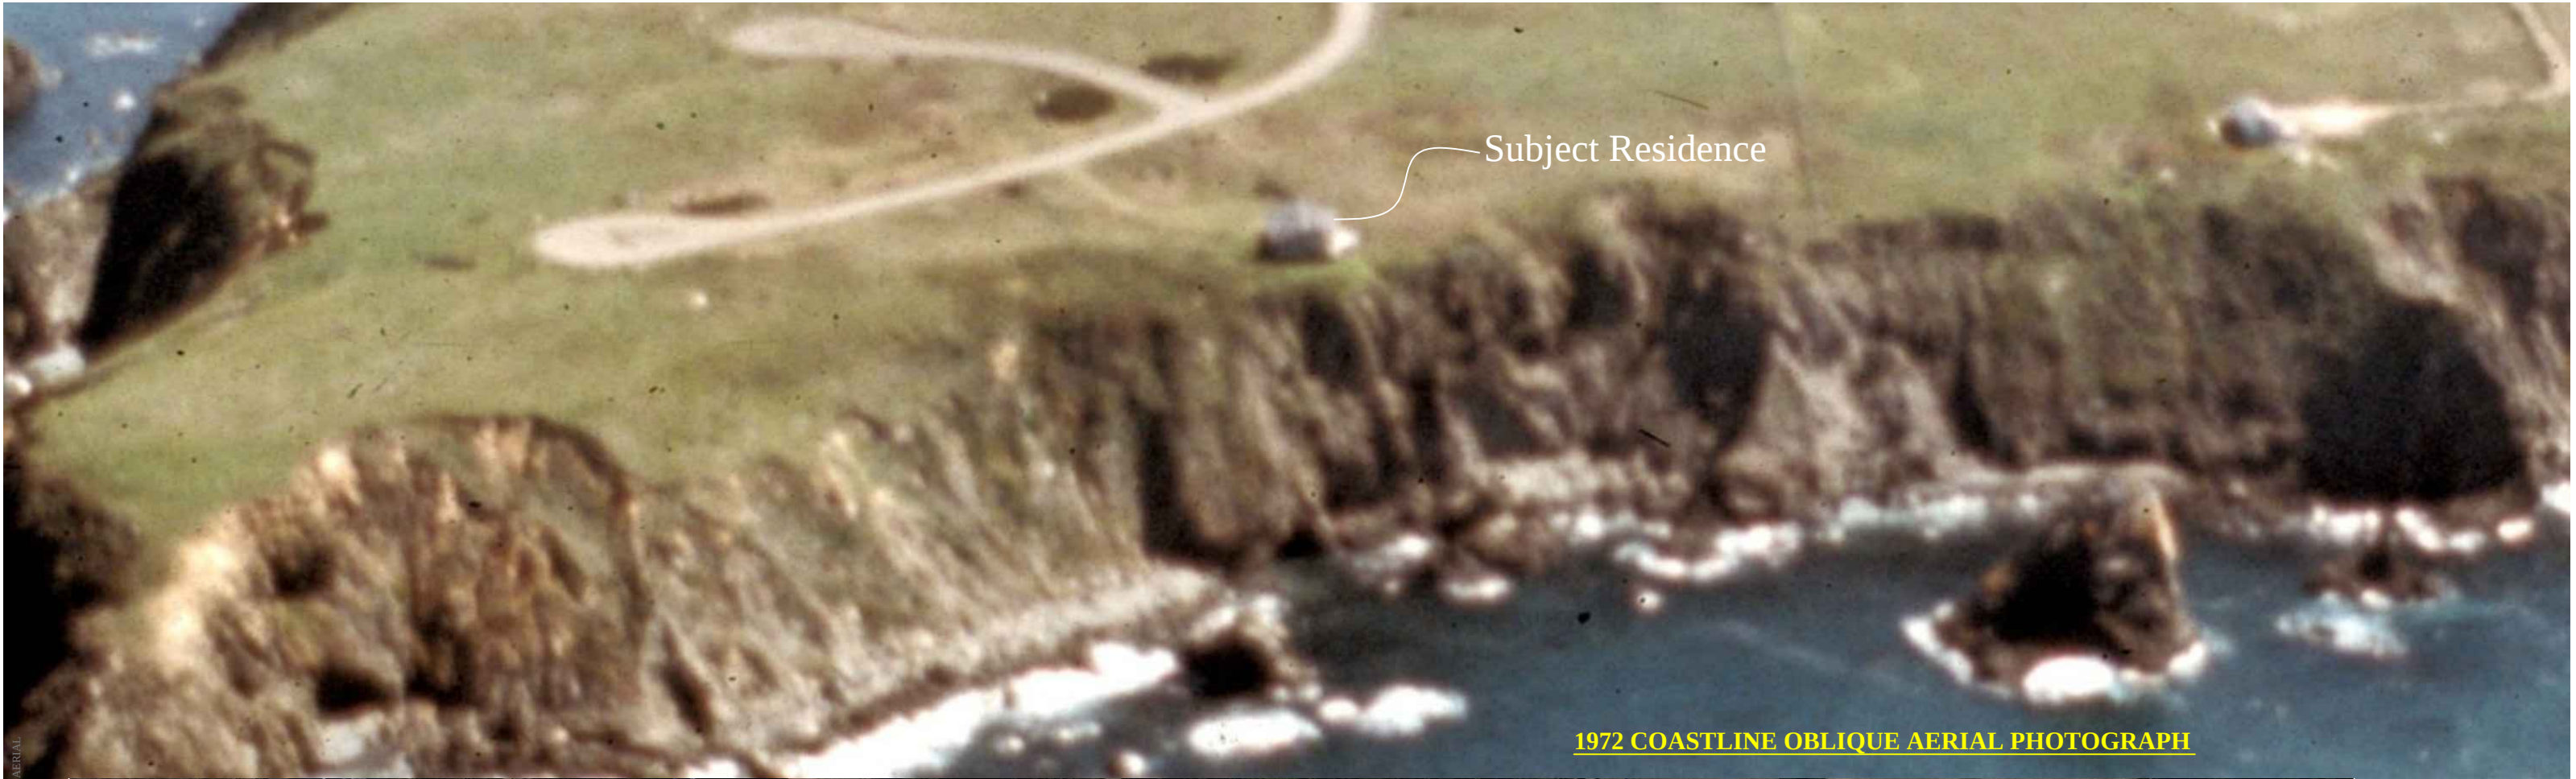
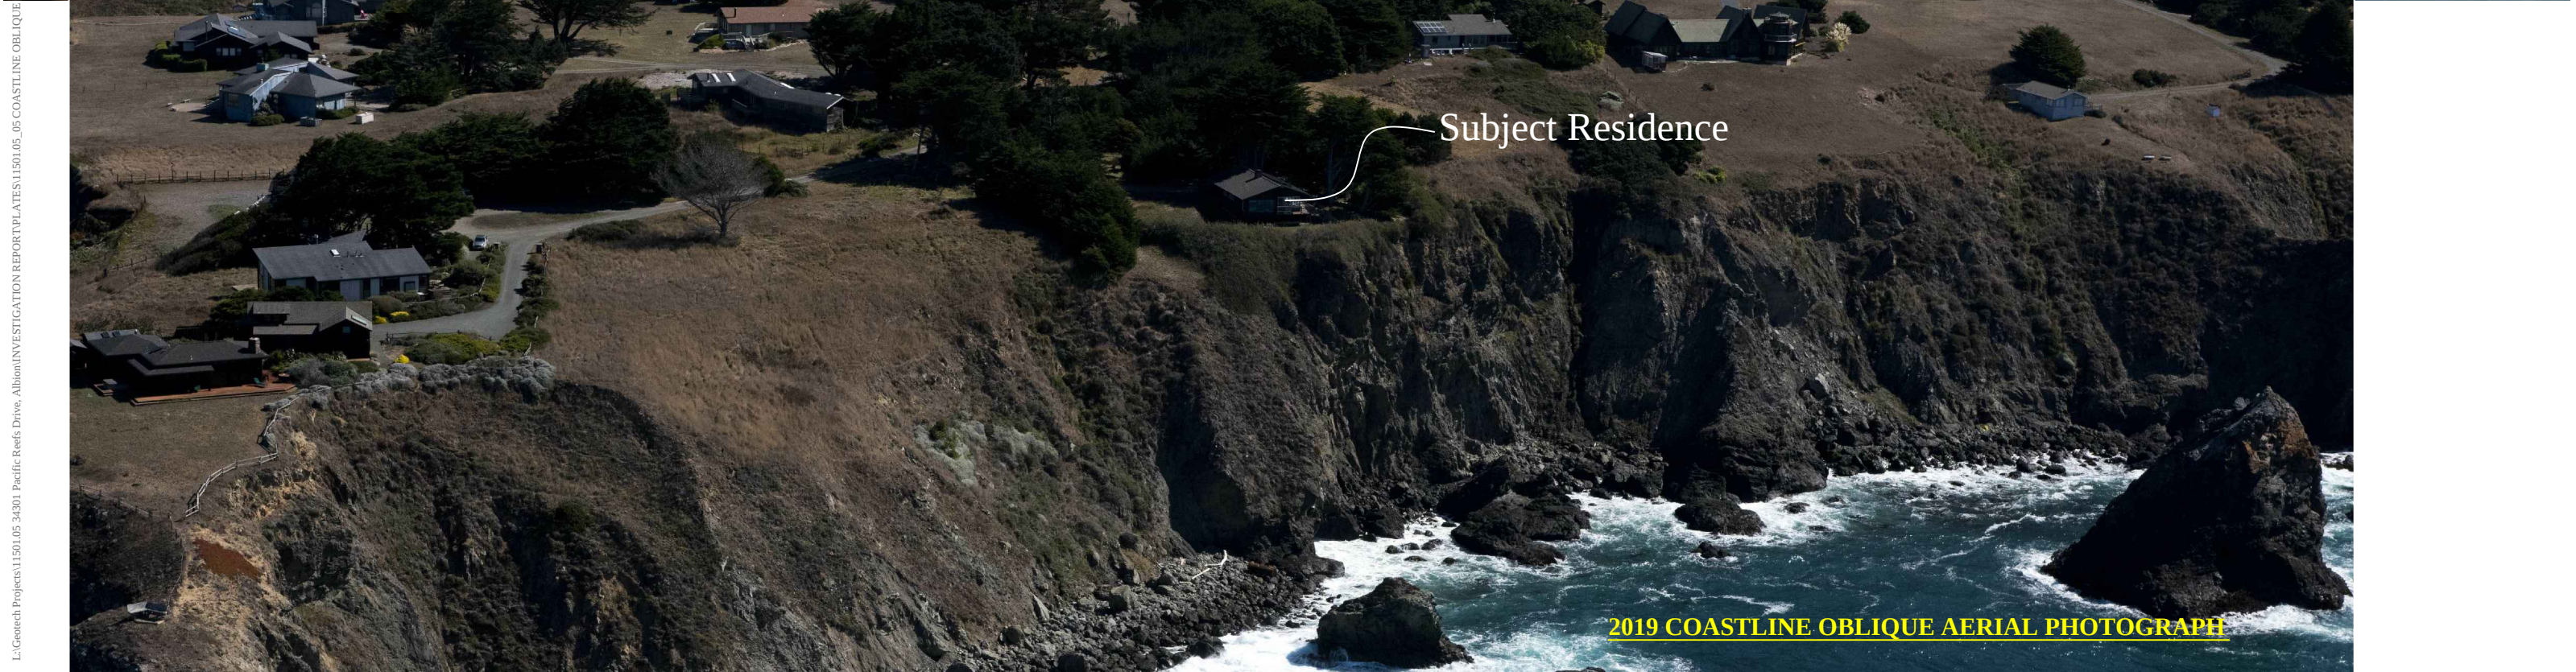
Our August 14, 2000 geotechnical investigation report determined that the bluff is eroding at an average rate of approximately two inches per year. This was accurate from the time of the house construction prior to 1972 (see Plate 5) up to early March 2023 (more than 51 years). Approximately 22 feet of the bluff, from the residence out to the bluff edge, failed in early March 2023. The landslide/bluff toe may have been weakened by the exceptionally strong storm waves in early January 2023. Those storm waves hit the Point Cabrillo Light House and at least two bluff houses in Little River. BAI observed evidence of January storm wave debris (rock fragments, ice plant, etc.) thrown up from the bluff faces onto terraces at project locations ranging from Westport to The Sea Ranch in Sonoma County. Factoring the 22 feet (rounding up to 25 feet) bluff loss over 50 years, the resulting bluff retreat rate is approximately 6 inches per year.

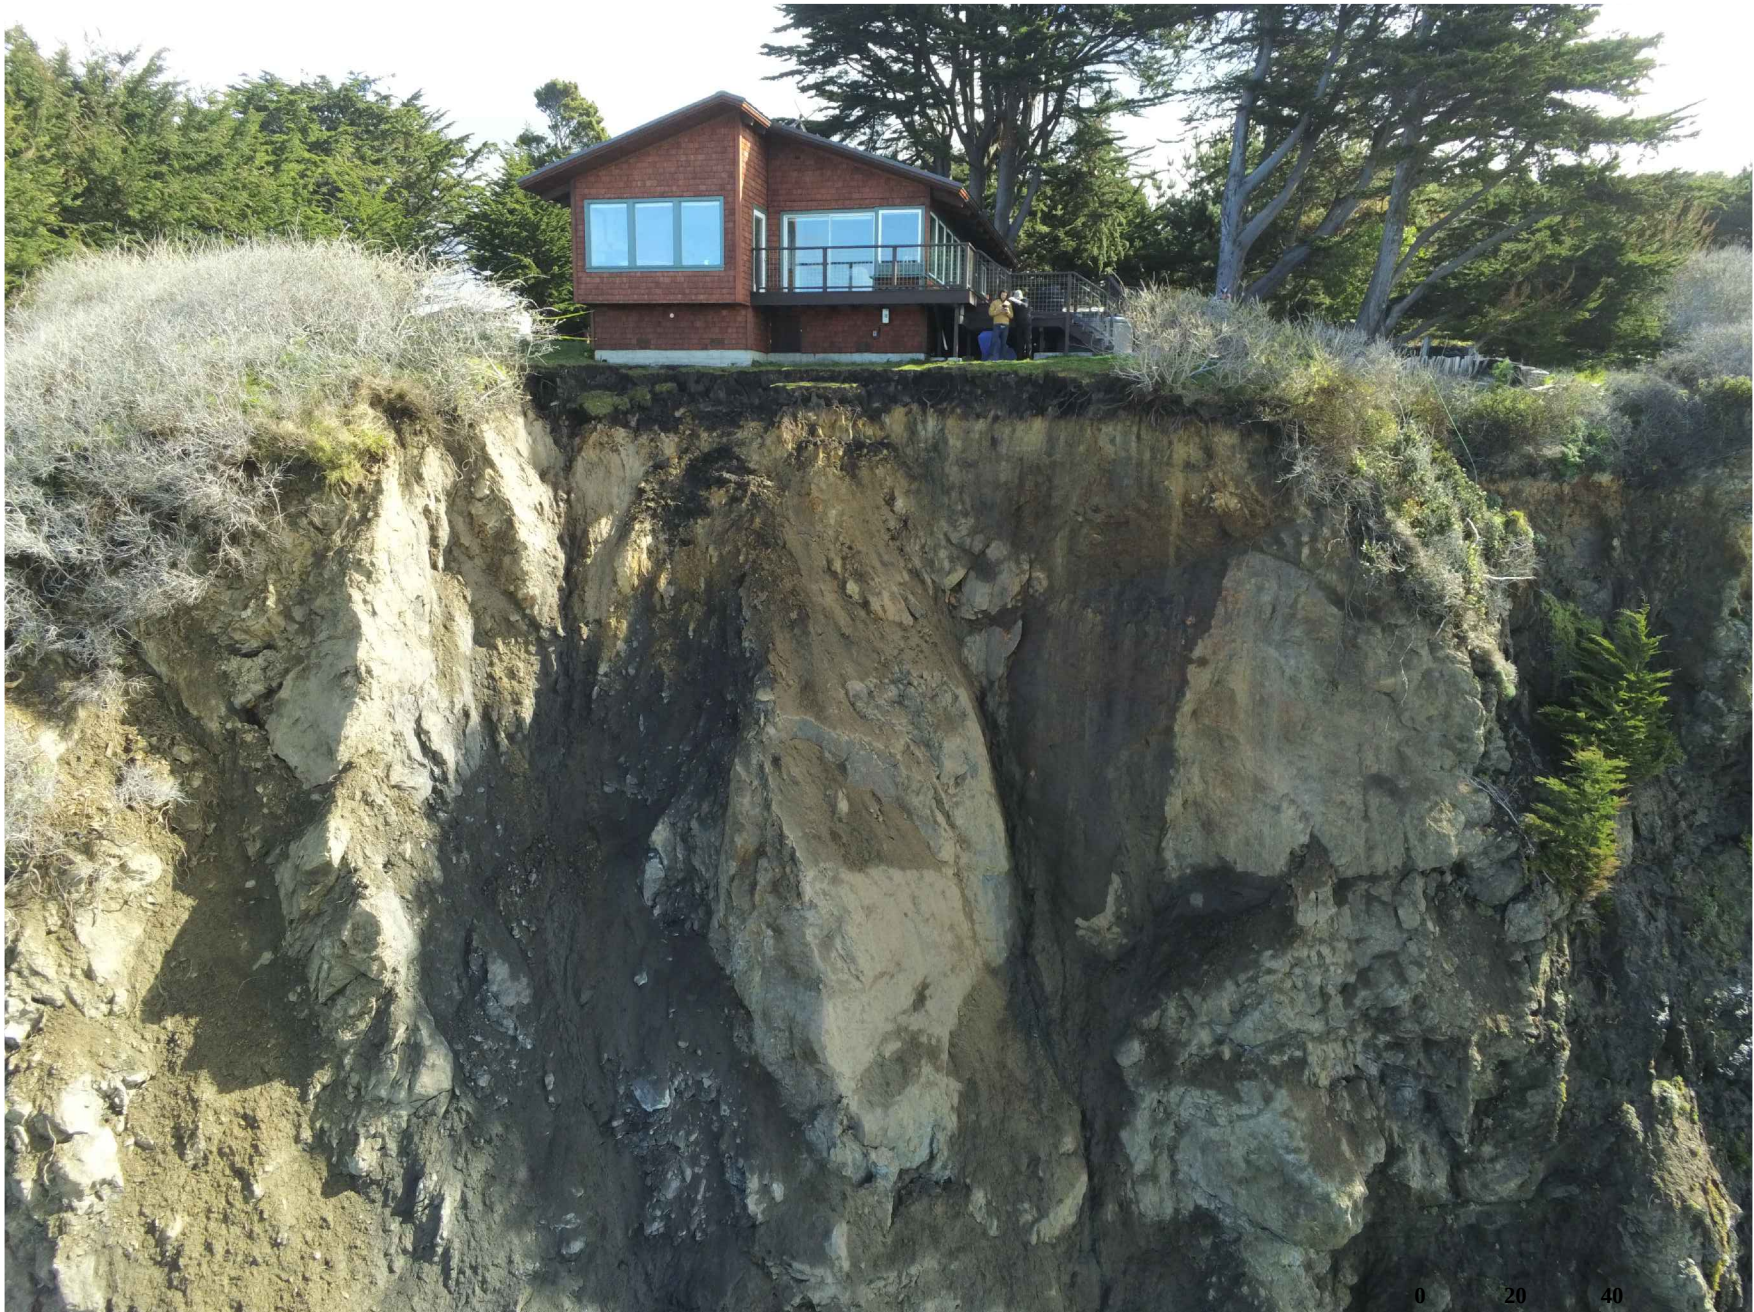
**6**

The property is situated near the southwest edge of a near-level, elevated, marine terrace that projects westward, forming Salmon Point. The terrace was created during the Pleistocene Epoch, when glaciation caused sea level fluctuations which created a series of steps or terraces cut into the coastal bedrock by wave erosion. The terrace is bordered by a steep ocean bluff that is approximately 100 feet high in the property vicinity, per Google Earth Pro. The bluff slope gradient varies from about one-half horizontal to one vertical (1/2H:1V) to near vertical. The existing upper bluff is shown in Drone Photograph A, Plate 6.

The bluff landslide extends from the southwest house foundation down to the bluff toe, as shown in Drone Photograph A, Plate 6. The landslide was a large rock fall that dropped catastrophically to the surf zone below. The landside was comprised of Franciscan bedrock and terrace soils from the upper bluff.

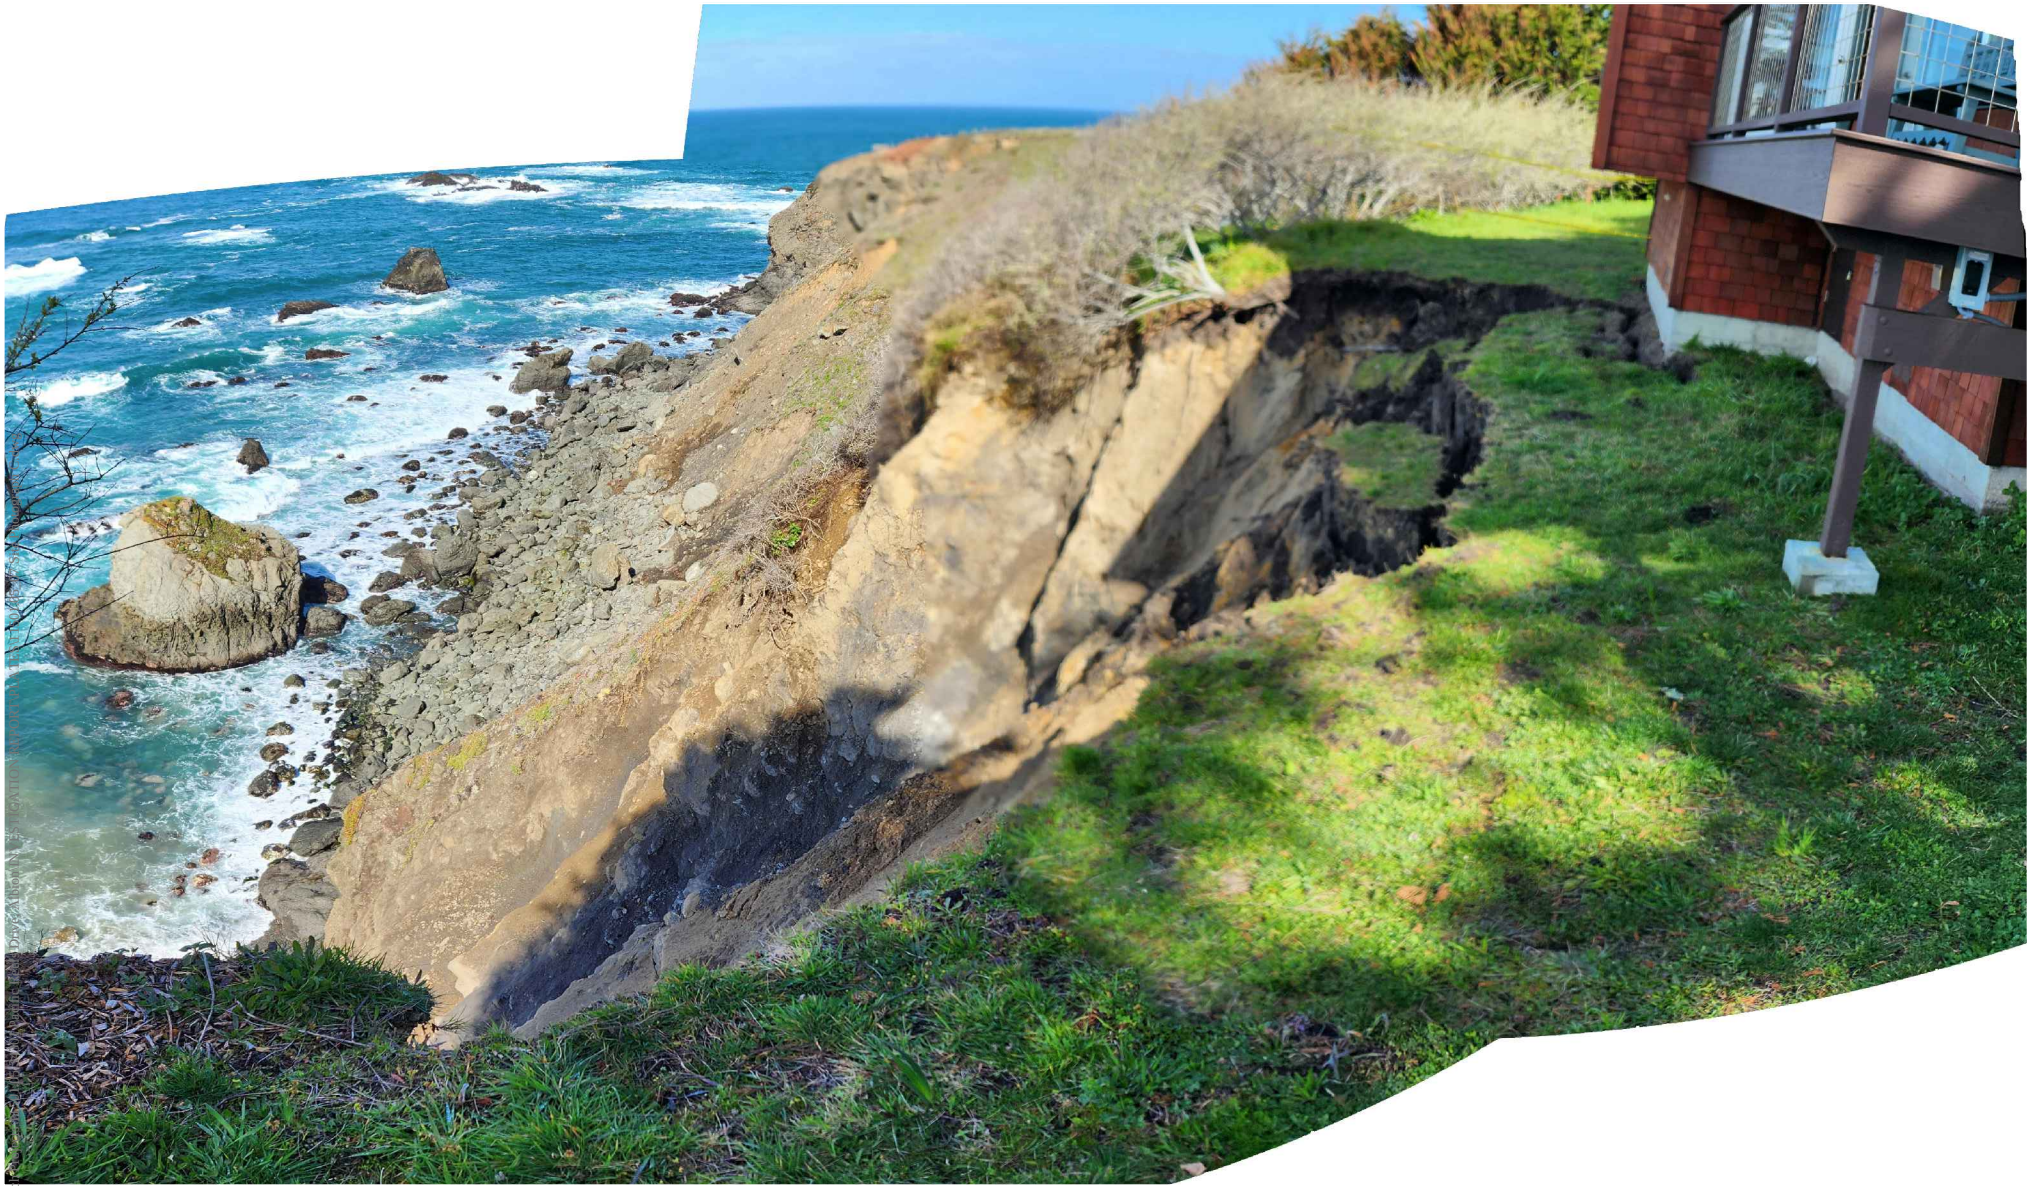
The existing residence is located at the bluff edge on the southwest end of the property. The southeast and southwest corners of the residence were approximately 22 and 20 feet from the bluff edge, respectively; as measured by Olsborg and Jim Reynolds with a 25-foot measuring tape on September 3, 2009. The bluff is currently at the landslide headscarp along the residence southwest foundation line (Site Photographs C and D, Plates 7 and 8, respectively).
