**CASE:** EM 2024-0002  
**OWNER:** KOPRIVA, Rebecca  
**APN:** 127-200-06  
**APLCT:** Erik E. Olsborg, VP  
**AGENT:**  
**ADDRESS:** 6170 S Hwy 1, Elk

KOPRIVA SLOPE STABILIZATION  
 6170 South Highway 1  
 Elk, California

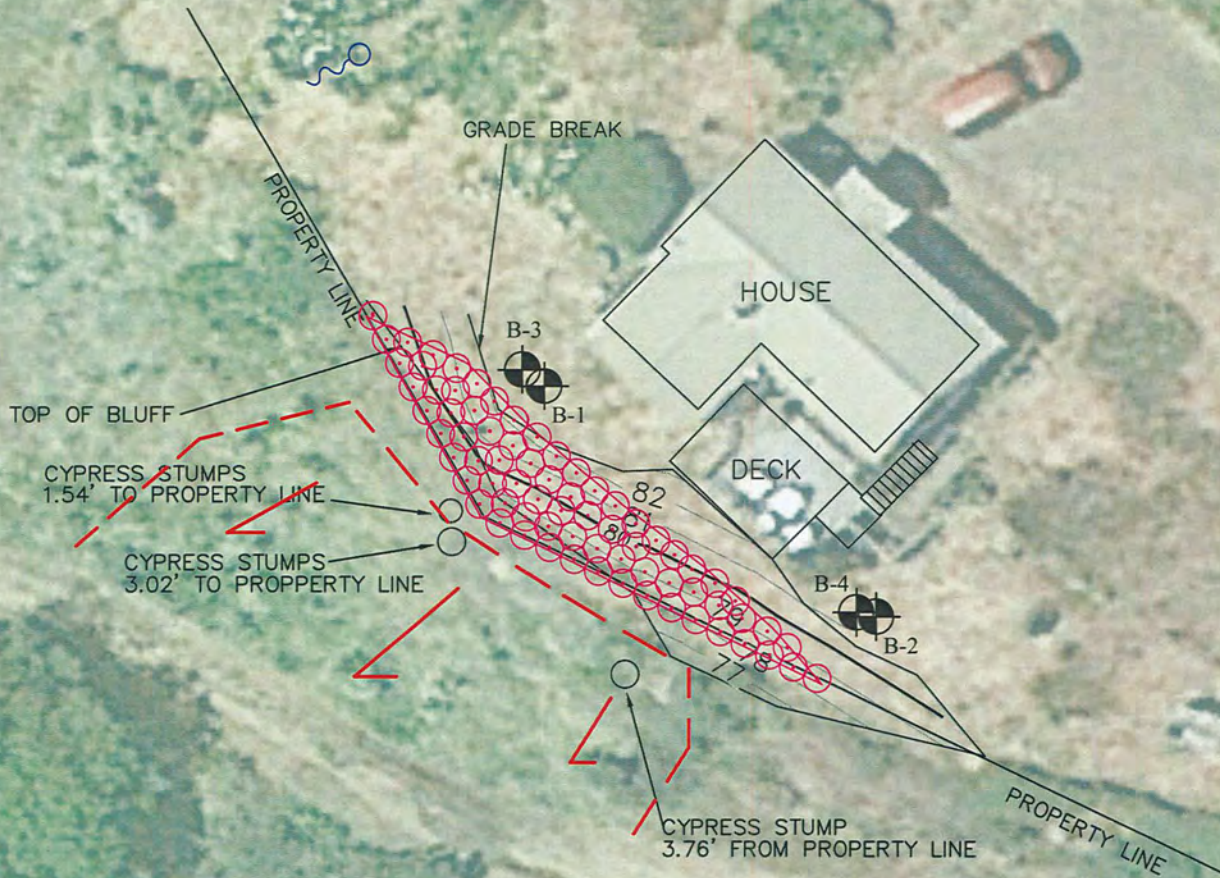
The slope soils can be “hardened” by the injection of ultra-fine cement, location shown on Plate 2b. The grouting objective is to permeate the fractured sandstone and overlying terrace deposits with ultra-fine cement grout, as shown on Plate 15. Due to the low permeability of the fine grained sand and silts, the rate of injection is anticipated to be particularly low when injecting close to the slope face and near surface due to the required allowable pressure of grout injection. Fine grained sands and silts typically exhibit a permeability ranging from  $5 \times 10^{-4}$  to  $1 \times 10^{-6}$  cm/sec.

In-fill grouting may be required in order to fully grout the area shown on Plate 2b and cross section on Plate 15. Drilling grout injection holes will require sufficient torque and thrust to penetrate several feet into fractured soft bedrock.

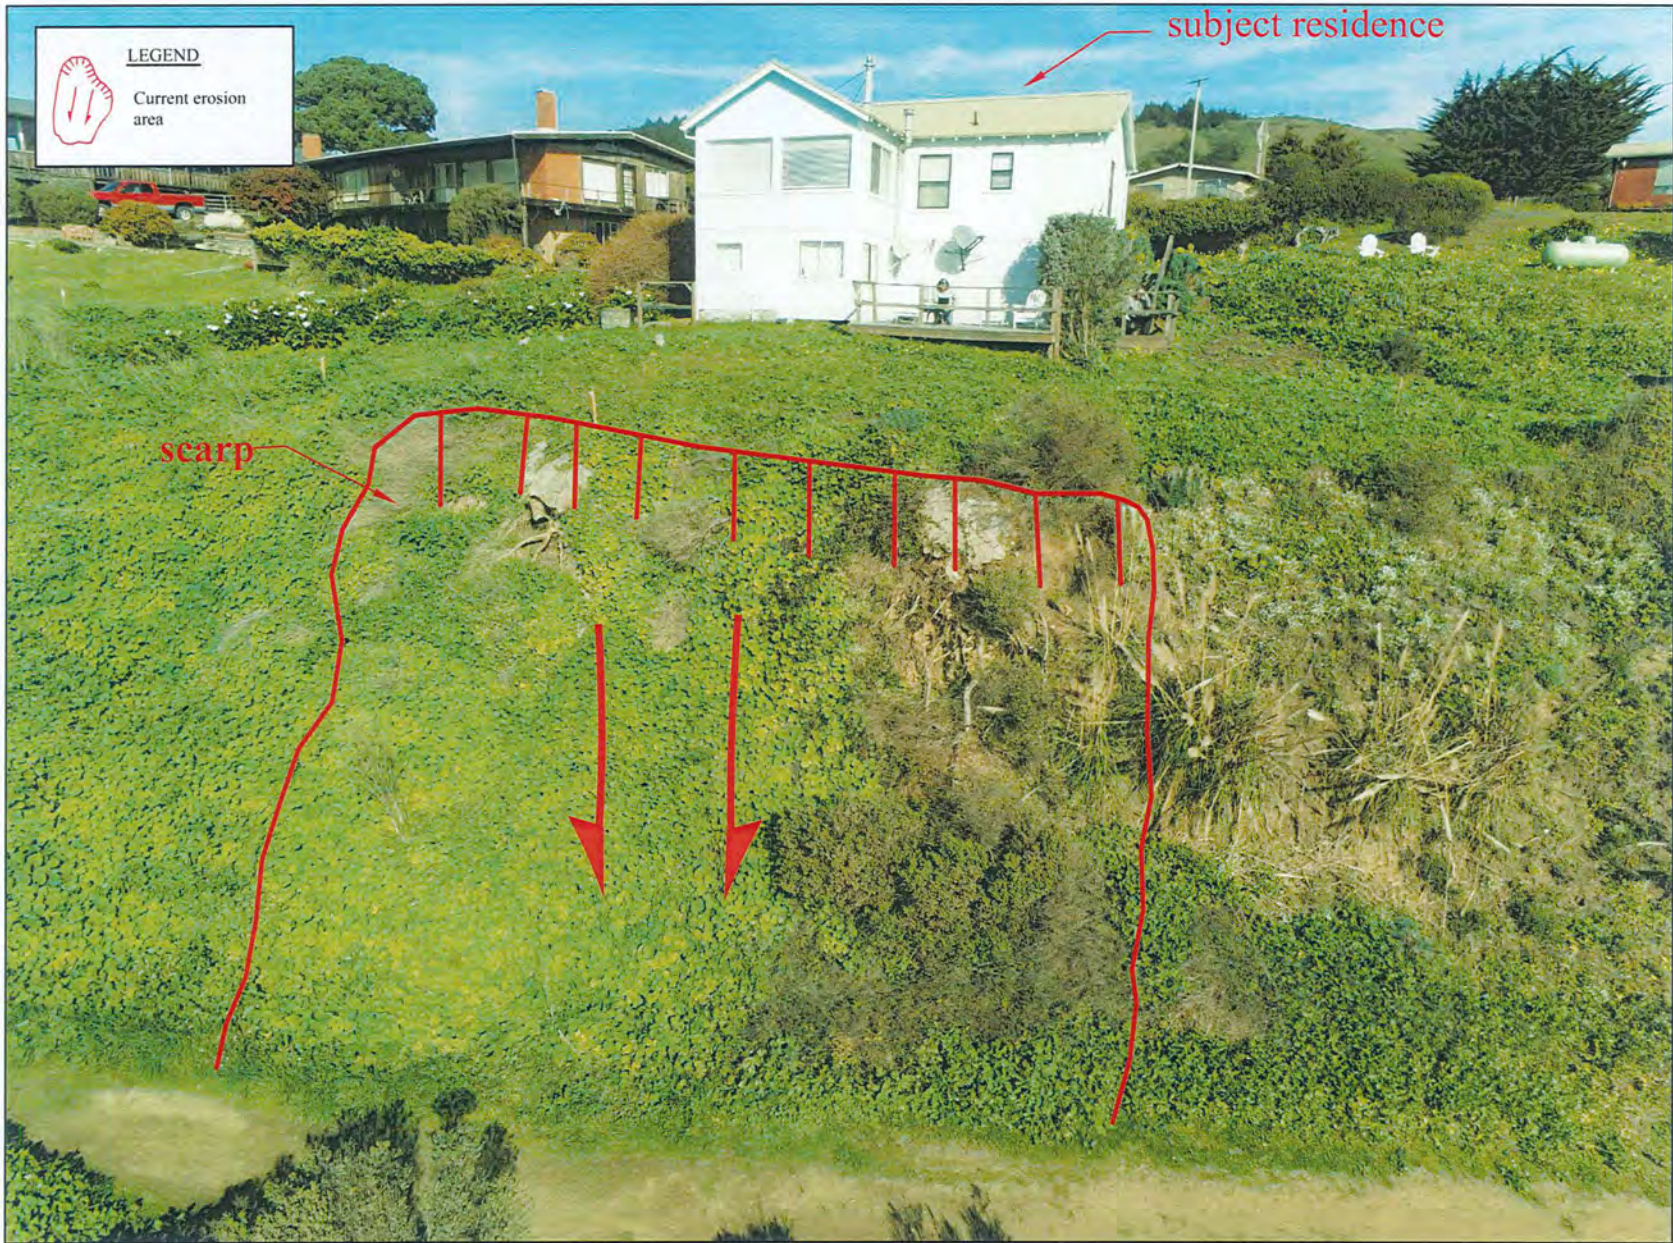
**PLATE**  
**12**

No deep-seated landslides were observed within or adjacent to the Kopriva property. Severe erosion is occurring on the beach access road cut slope below the Kopriva property as shown on Plate 12. The upper portion of the erosion area, just below the Kopriva property shows leaning tree stumps and small, bare scarps where the ground has dropped downslope. The stumps are from trees removed by the State of California prior to 2013. The hillside below the Kopriva property is mapped as a "debris slide slope" on California Division of Mines and Geology Open File Report 84-12 SF (OFR 84-12 SF). A debris slide slope" is defined as "a geomorphic feature characterized by steep..., usually well vegetated slopes that have been sculpted by numerous debris slide events; vegetated soils and colluvium above shallow soil/bedrock interface may be disrupted by active debris slides...".

The access road cut slope, downslope of the property, is in violation of current excavation and grading code, section 18.70.090 - Cuts. Cut slopes shall be no steeper than 2H:1V and not create a hazard to public or private property. Our client has requested that State Parks and Recreation Department construct a retaining wall at this location to support the steep cut slope. Short of legal action, State Parks is not inclined to construct a retaining wall. Instead, their apparent policy is to periodically clean up slough soils in order to just keep the road open. In order to avoid lengthy and costly litigation, our client is willing to stabilize the slope on her own property at her own expense.

The cut slope erosion should be mitigated as soon as possible before the unstable area further enlarges and causes more damage to the property. Eventually, erosion could enlarge further upslope and affect the residence. Therefore, a stabilization structure to protect the residence should be constructed along the property line just above the erosion area, as shown on Plates 2a and 2b. The stabilization structure would be intended to halt uphill migration of the downslope erosion. The stabilization structure, consisting of drilled piers connected by a concrete grade beam or injected grout, will be entirely below the ground surface when completed.

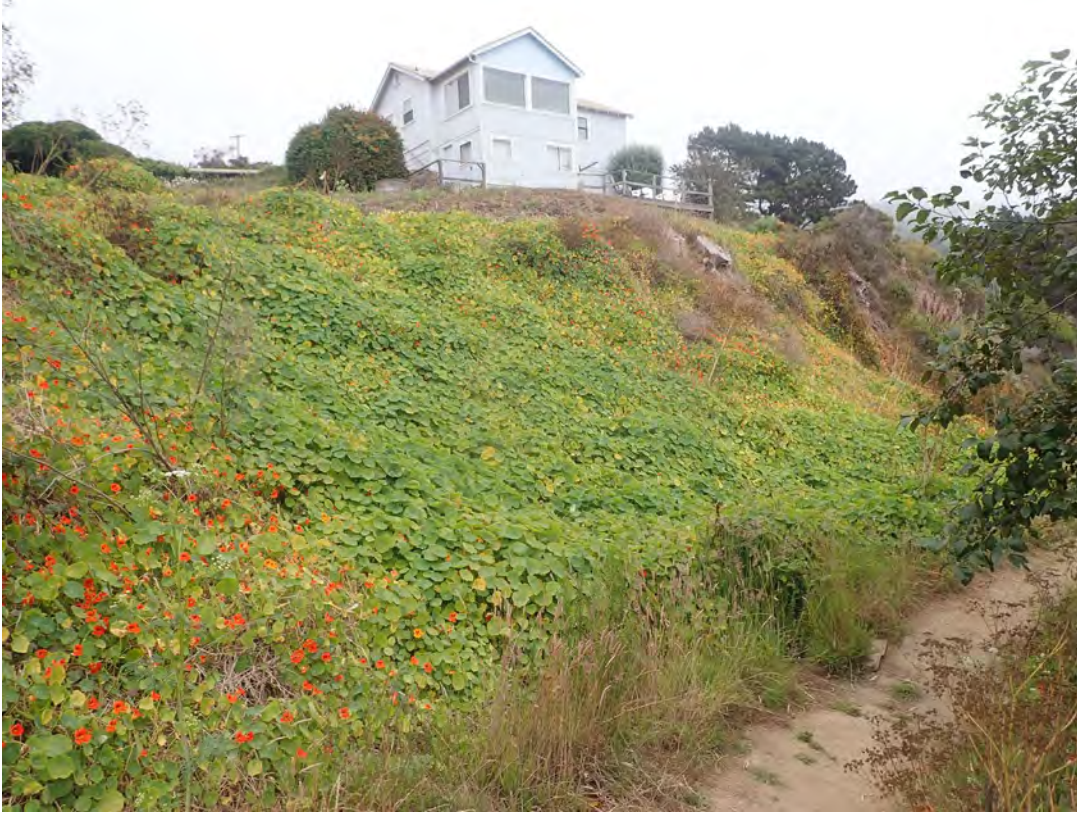
*Figure 5. Non-native plants dominating eroding hillslope beneath residence.*
