Date: 09/27/2018

Report: Mendocino County

501 Low Gap Road Ukiah, Ca 95482

Southern Magnolia Trees located in front of Mendocino County Courthouse

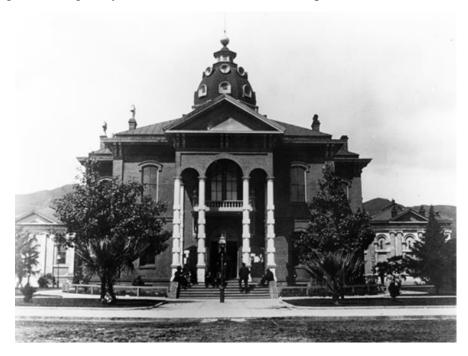
Figure 1. Mendocino County Courthouse in 1873 showing the young Southern Magnolia trees.

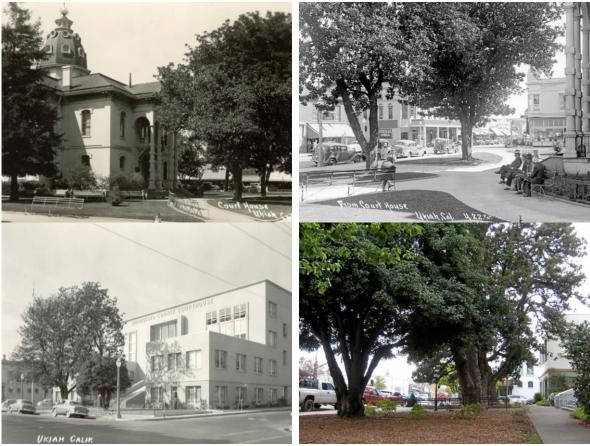
Figure 2a-d: counterclockwise starting in upper left corner: 2a) the Mendocino Courthouse dated between 1920 and 1930. 2b) Mendocino courthouse dated in 1930's. 2c) Mendocino Courthouse dated in 1950's. 2d) Mendocino Courthouse present day.
