DEPARTMENT OF TRANSPORTATION

DIVISION OF AERONAUTICS – M.S. #40

April 1, 2015

The California Department of Transportation (Caltrans), Division of Aeronautics, conducted a State permit compliance inspection and Federal Aviation Administration (FAA) Airport Master Record (Form 5010-1) update of the Little River Airport, FAA Site No. 01778.*A, on March 19, 2015. We appreciate the cooperation Mr. Bob Morgan, Mr. Dave Thorpe, and you provided to us during our inspection. The updated information will be entered into State and FAA Airport Master Records.

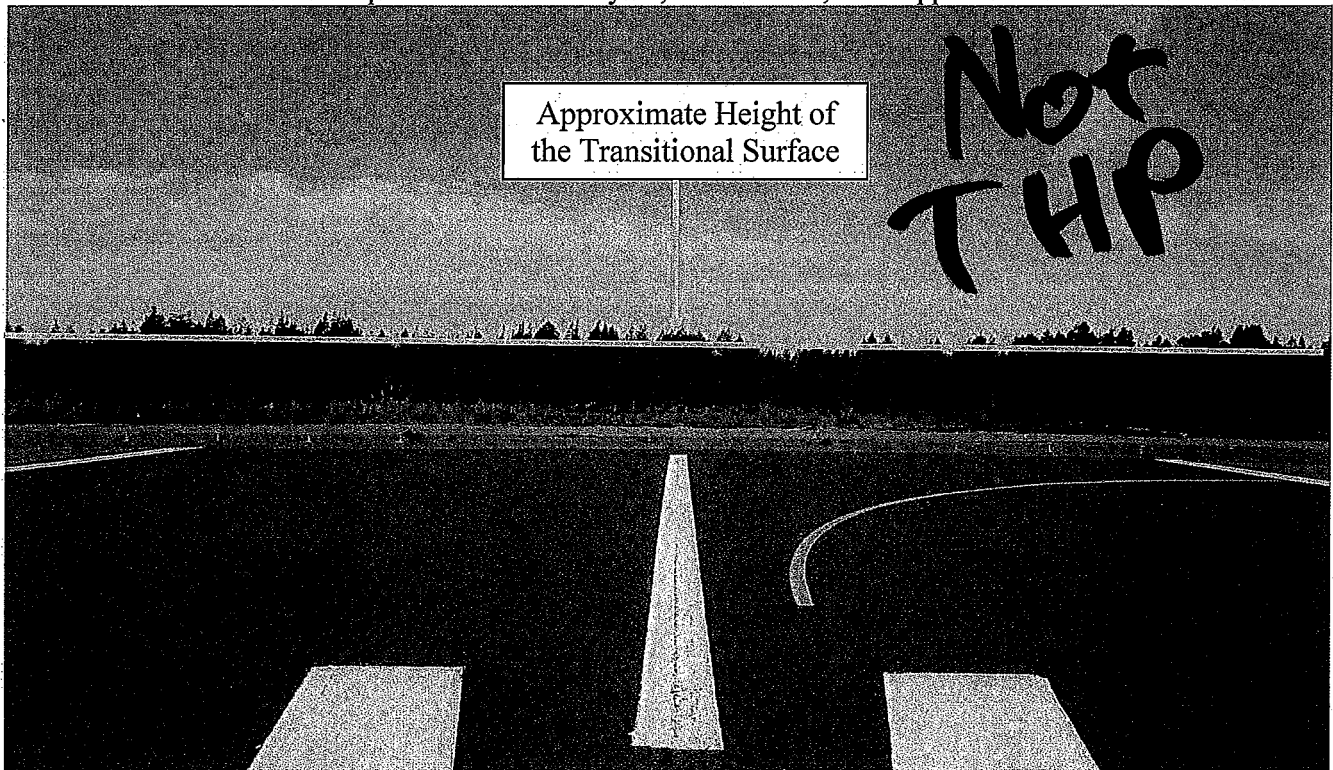
1. A line of trees 1,250 feet west of the Runway 11 displaced threshold penetrate the Federal Aviation Regulation (FAR) Part 77, 20:1 Approach Surface by approximately ten feet (please refer to Photo 1). Several other trees under the approach must be monitored and trimmed or removed, if they penetrate the Approach Surface.

Photo 1 - Trees penetrate the Runway 11, FAR Part 77, 20:1 Approach Surface.

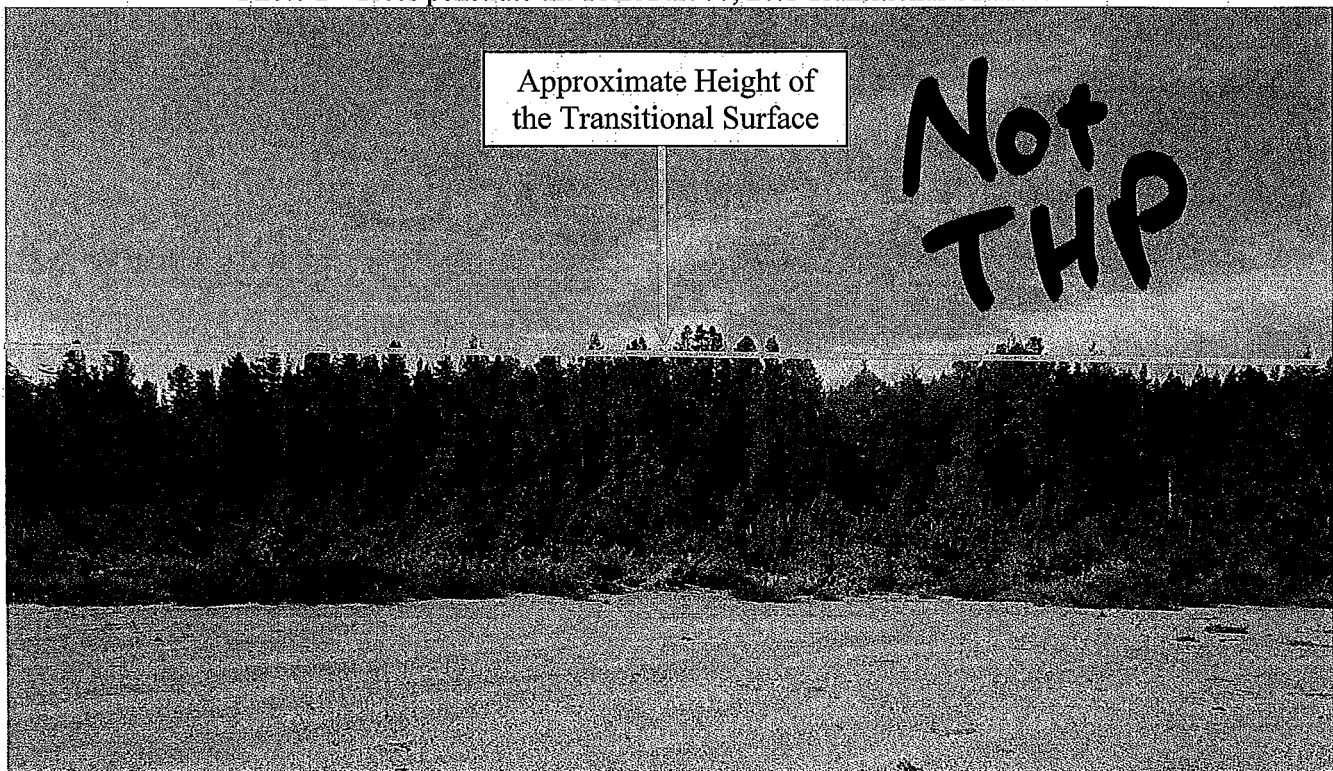
- a. Trees located approximately 250 feet southeast of the Runway 11 displaced threshold and 750 feet southwest of the runway centerline penetrate the FAR Part 77, 7:1 Transitional Surface by approximately five feet (please refer to Photo 2).

Photo 2 - Trees penetrate the FAR Part 77, 20:1 Transitional Surface.

2. Trees along Runway 11/29 penetrate the FAR Part 77, 7:1, Transitional Surface at five distinct locations on the airfield. These trees must be removed or trimmed as shown in the enclosed respective photograph(s), so that they do not penetrate the Transitional Surface. In addition, numerous other trees currently under the Transitional Surface must be monitored and trimmed or removed if they penetrate the Transitional Surface.

With the exception of items a and d, Caltrans recognizes that this condition has existed and increased over a period of time. Caltrans requests a definitive plan within 90 days of receipt of this letter to address and maintain obstruction-free FAR Part 77 imaginary surfaces to the airport to continue to allow operations at night. Failure to comply may lead to initiation of action to suspend night operations.

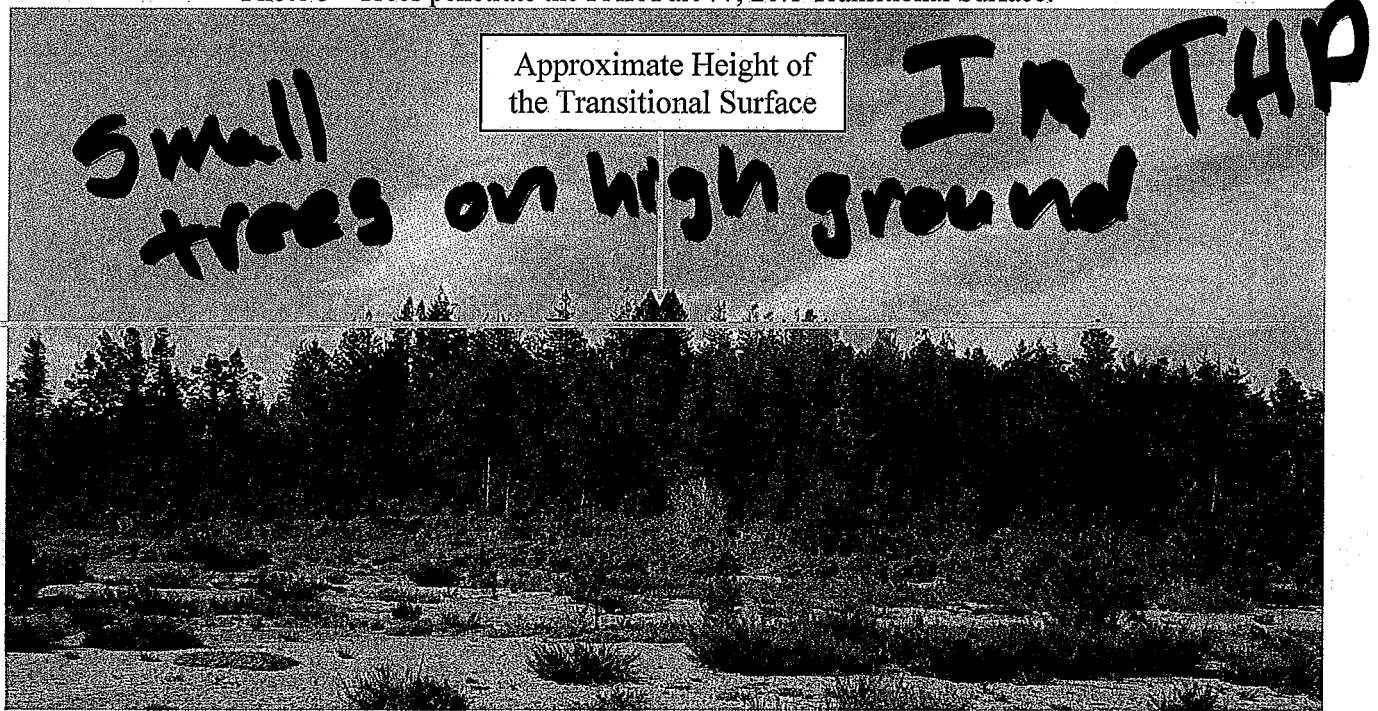
- b. Trees located approximately 1,000 feet southeast of the Runway 11 displaced threshold and 700 feet southwest of the runway centerline penetrate the FAR Part 77, 7:1 Transitional Surface by approximately ten feet (please refer to Photo 3). This is a repeat discrepancy.

Photo 3 - Trees penetrate the FAR Part 77, 20:1 Transitional Surface.

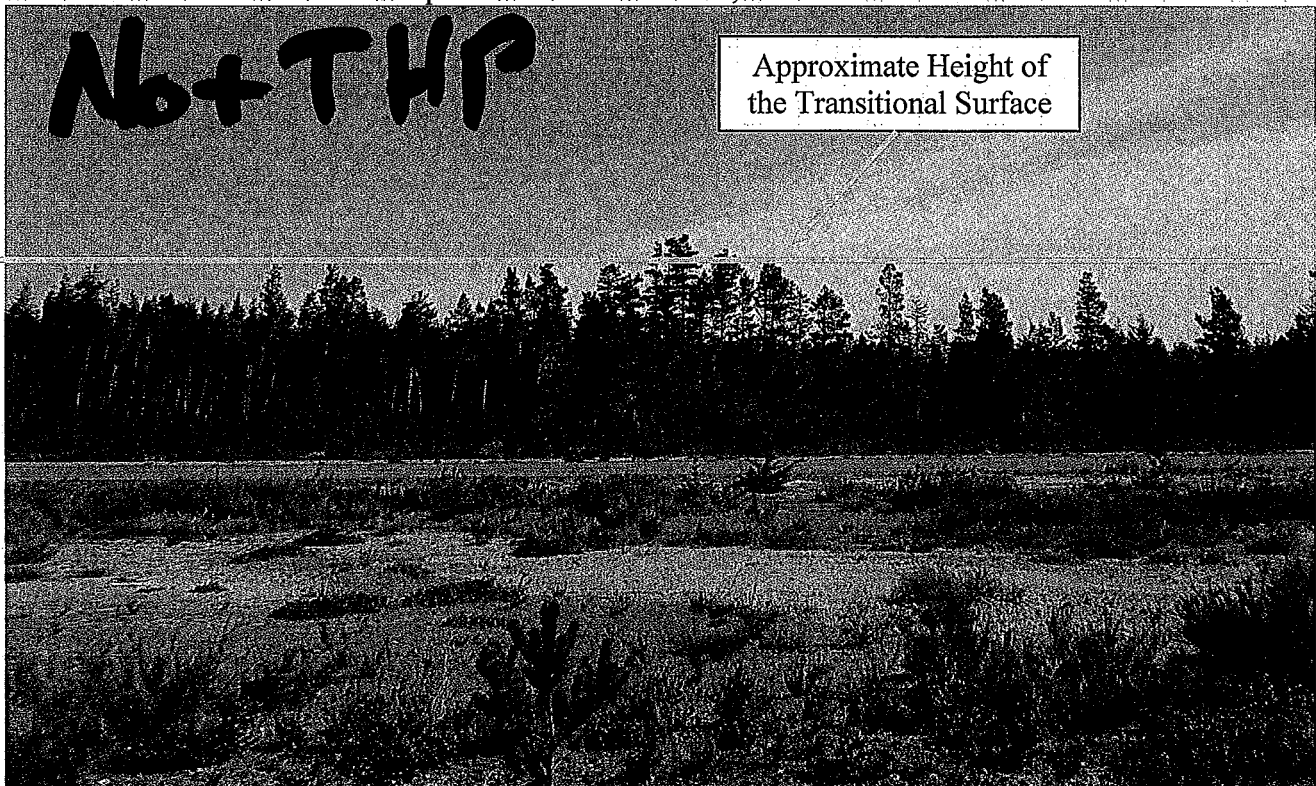
- c. Trees located approximately 750 feet southeast of the Runway 11 displaced threshold and 700 feet northeast of the runway centerline penetrate the FAR Part 77, 7:1 Transitional Surface by approximately five feet (please refer to Photo 4). This is a repeat discrepancy.

Photo 4 - Trees penetrate the FAR Part 77, 20:1 Transitional Surface.

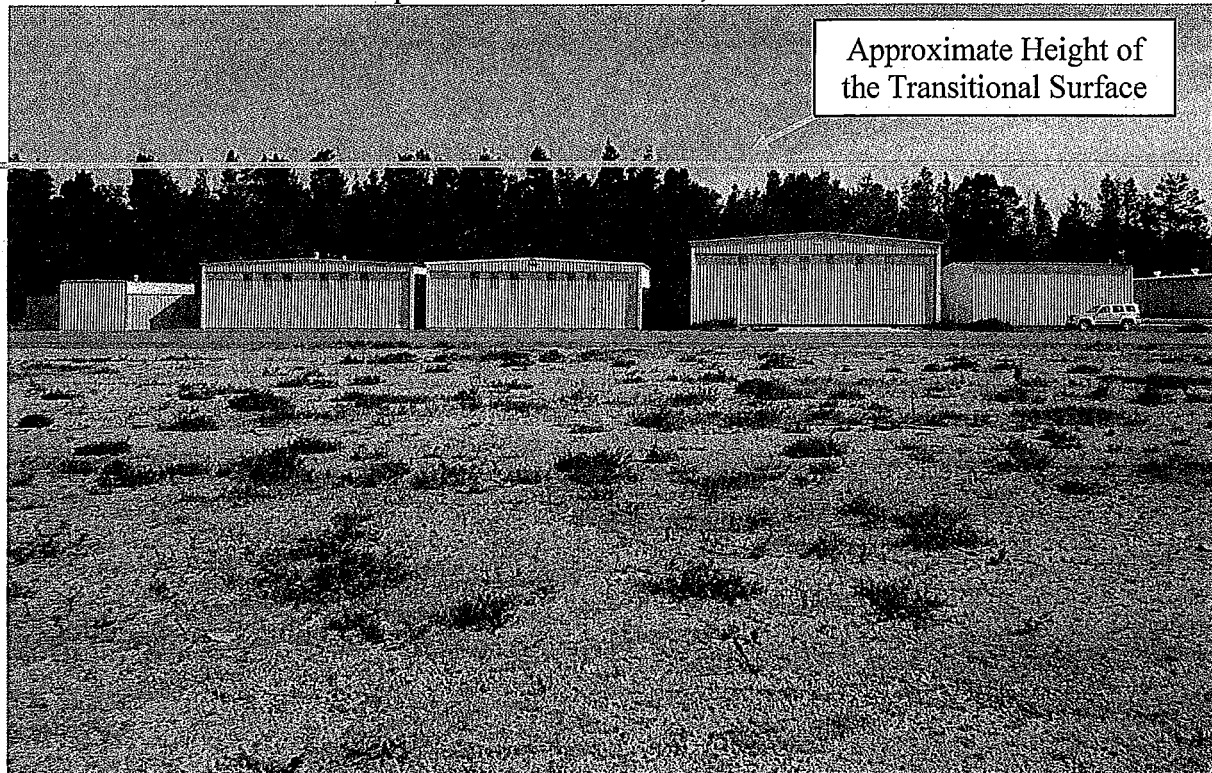
- d. Trees located just north of the hangars at midfield penetrate the FAR Part 77, 7:1 Transitional Surface by approximately three feet (please refer to Photo 5).

Photo 5 - Trees penetrate the FAR Part 77, 20:1 Transitional Surface.

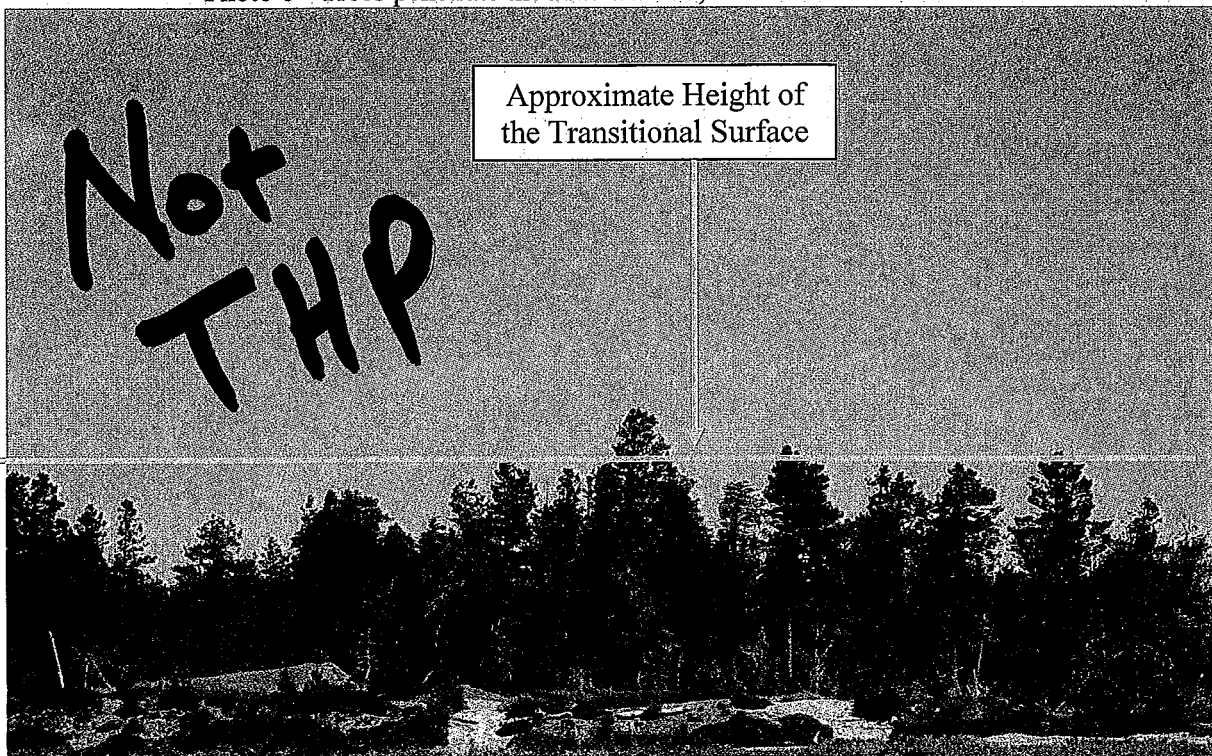
- e. Trees abeam of the Runway 29 threshold and 750 feet northeast of the runway centerline penetrate the FAR Part 77, 7:1 Transitional Surface by approximately five feet (please refer to Photo 6). This is a repeat discrepancy.

Photo 6 - Trees penetrate the FAR Part 77, 20:1 Transitional Surface.

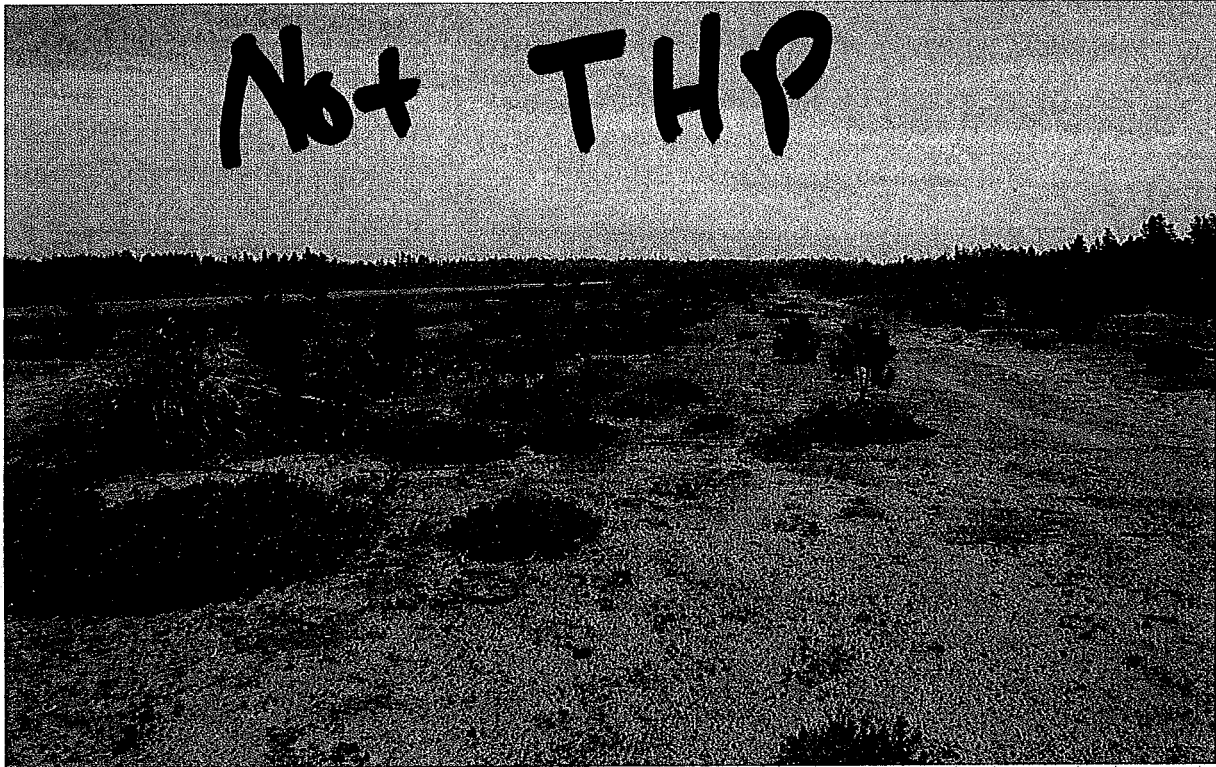
3. Small trees and shrubs intermittently penetrate the full length of the Primary Surface along the south side of Runway 11/29 and must be removed (please refer to Photo 7). We understand that this clearing will take place as part of your annual agreement with the California Department of Forestry and Fire Protection (CalFire).
4. The windsock at the segmented circle was missing at the time of the inspection and should be replaced as soon as possible. In addition, windsocks at both the west and east ends of the field are faded and in need of replacement.

Photo 7 - Small trees and shrubs in the Primary Surface on the south side of Runway 11/29
