EMERGENCY PERMIT APPLICATION FORM

February 14, 2024

10945.05

GEOTECHNICAL INVESTIGATION

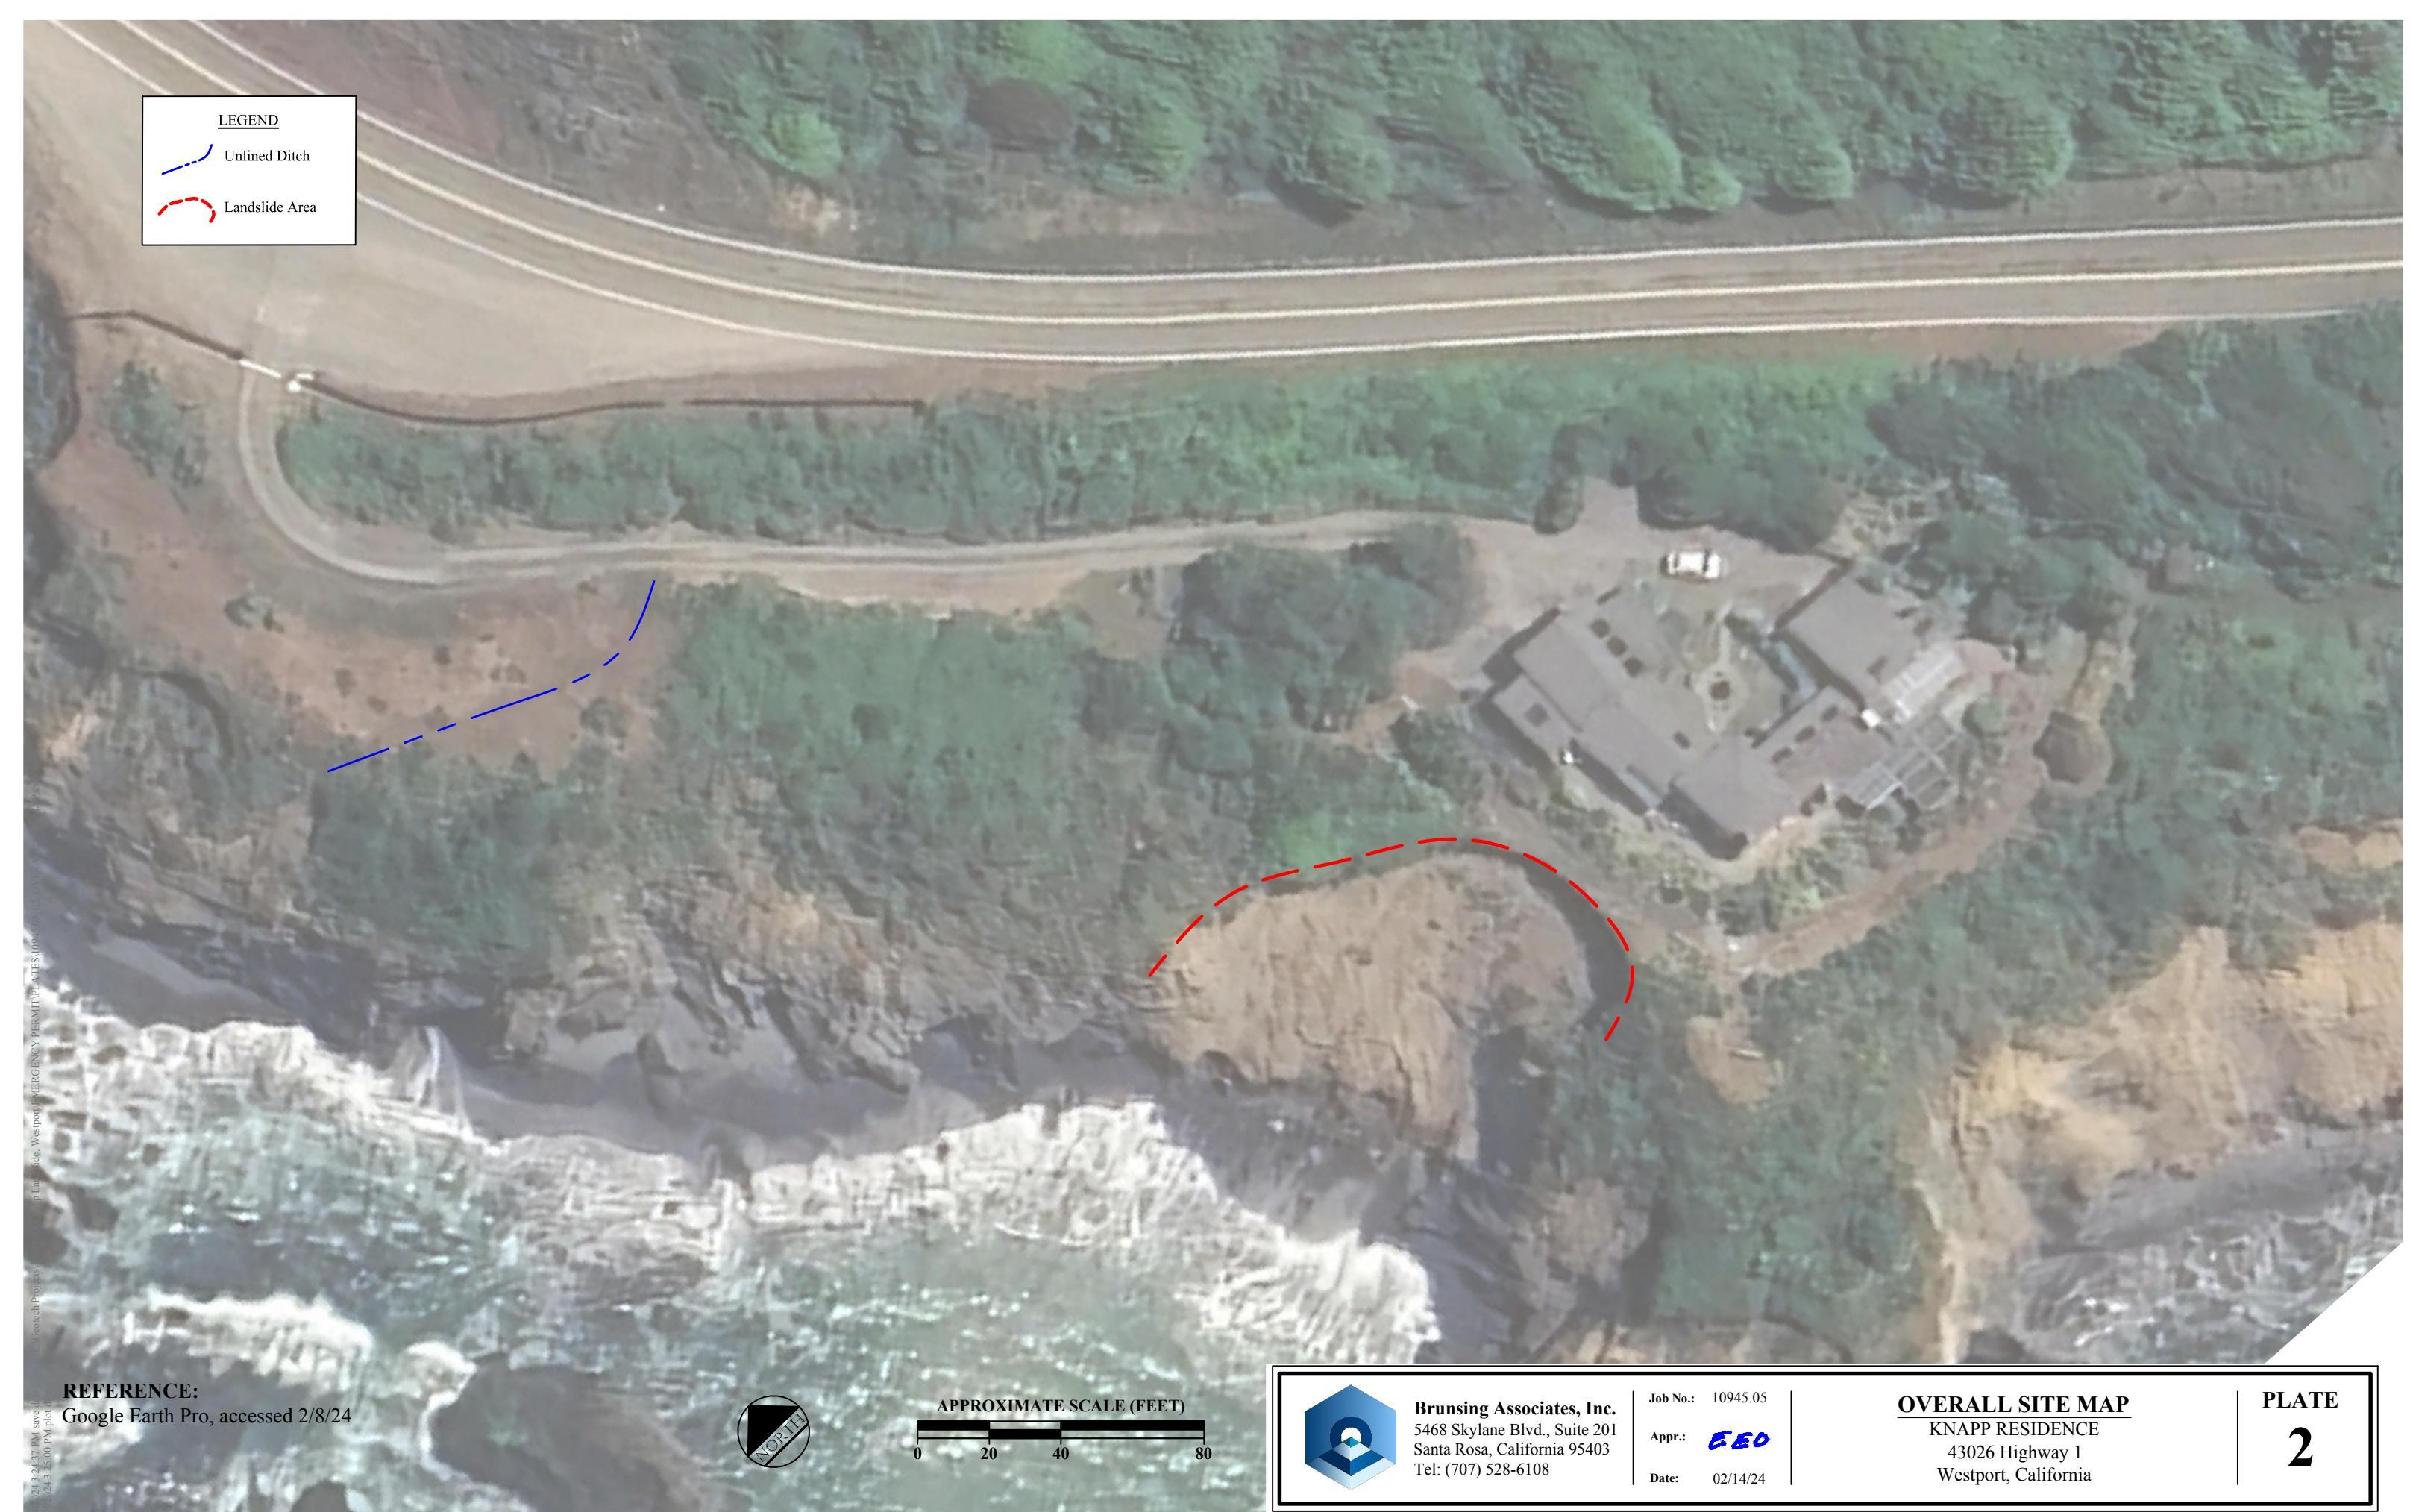
Groundwater migrating beneath Highway 1 flows southwest beneath the residence and daylights, seeping out of the bluff face adjacent to the residence. This discharge has been observed at several locations. Runoff water from Highway 1 and ground water seepage collect at the toe of the slope on the uphill side of the Knapp driveway. This water seeps into the ground and saturates the underlying fill and terrace deposits in the Knapp residence vicinity. To mitigate the water runoff/seepage concerns, a drainage system was designed by a structural/civil engineer and permitted by the County of Mendocino. The drainage system consists of an uphill ditch that empties into a culvert under the driveway about 250 feet northwest of the residence. The culvert water is carried by an unlined ditch over to an outfall over the bluff edge, Plate 2.

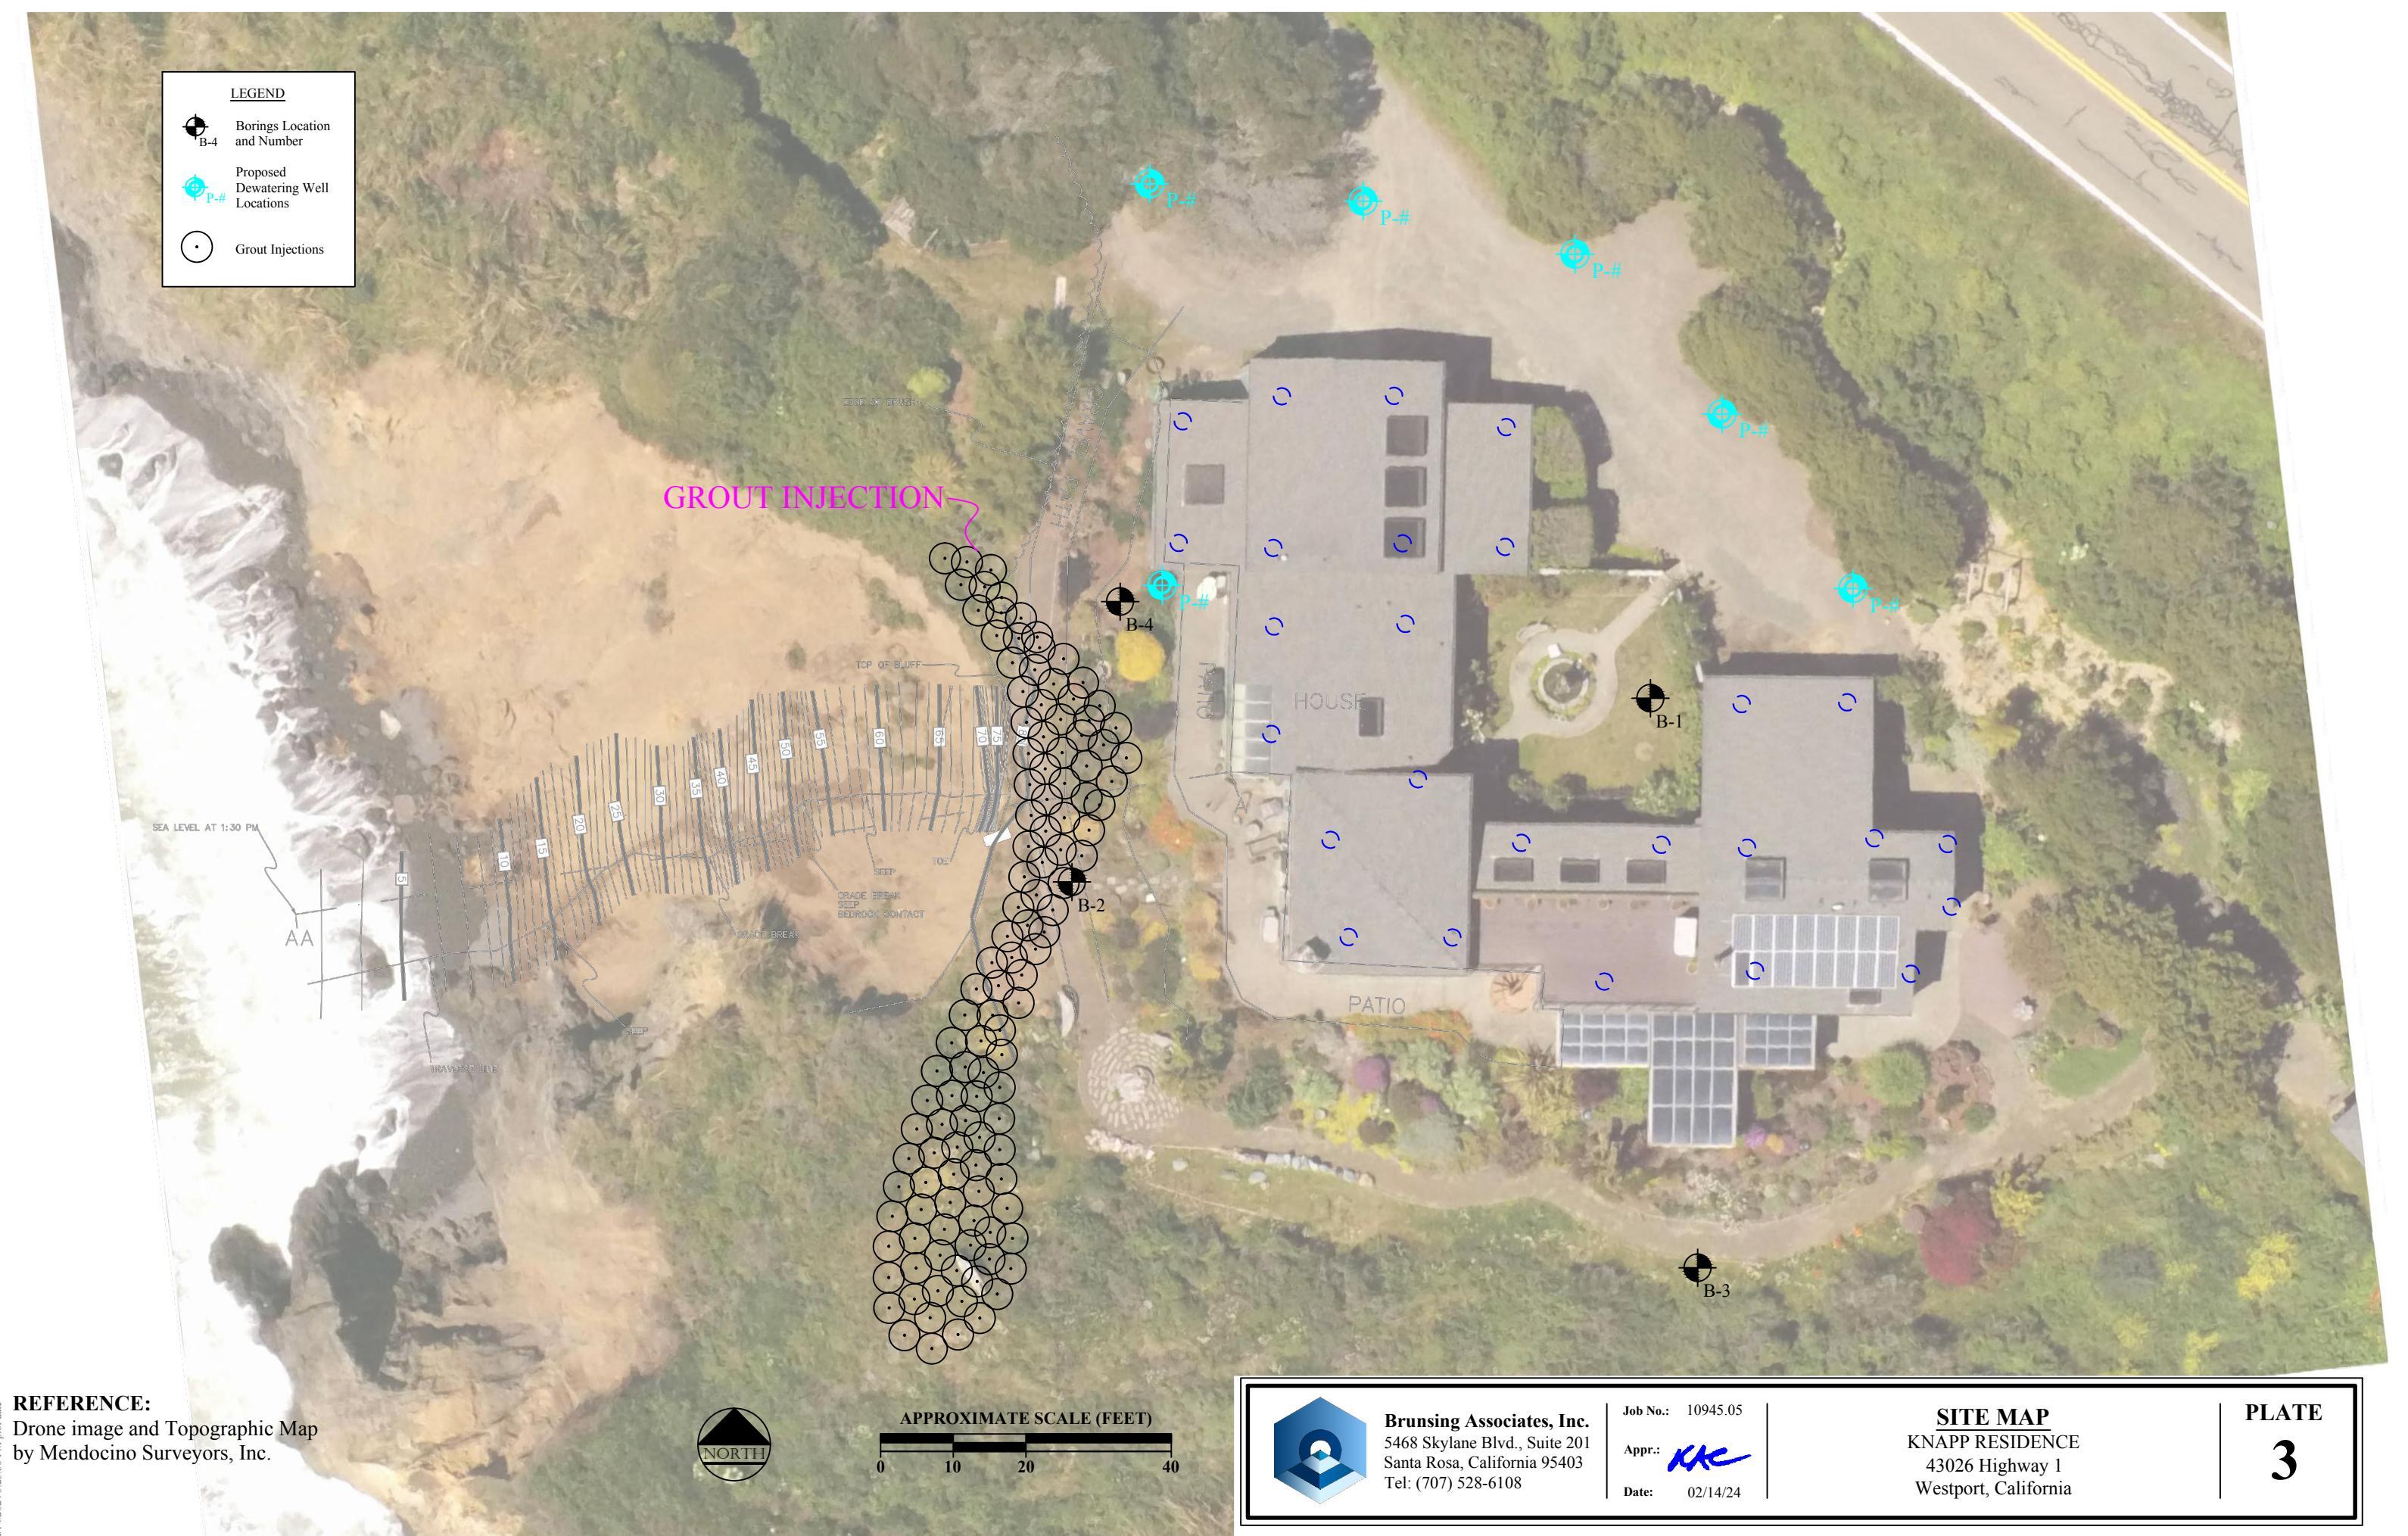
The proposed mitigation measures include four 4-inch diameter extraction wells extending to a depth of 35 feet below ground surface as shown on Plate 3. The area to be grouted is approximately 1000 square feet. The permeation grout should extend from near surface to bedrock within the recommended grouted area shown on Plate 3.

Grouting will ensure that both the non-conforming fill and underlying terrace deposit are more resistant to failure caused by seepage. The shape of the grout area is designed to deflect any groundwater that is not intercepted by the wells parallel to the bluff face so that it will seep out of the bluff face away from the residence. Due to the gradation of soils to be grouted, BAI

The high void ratio reported in the non-conforming fill would be significantly reduced by a properly designed grouting program. The seepage at the bluff causing excessive bluff failure within the non-conforming fill can be intercepted by a series of extraction wells which pump the collected groundwater to the existing stormwater sump.

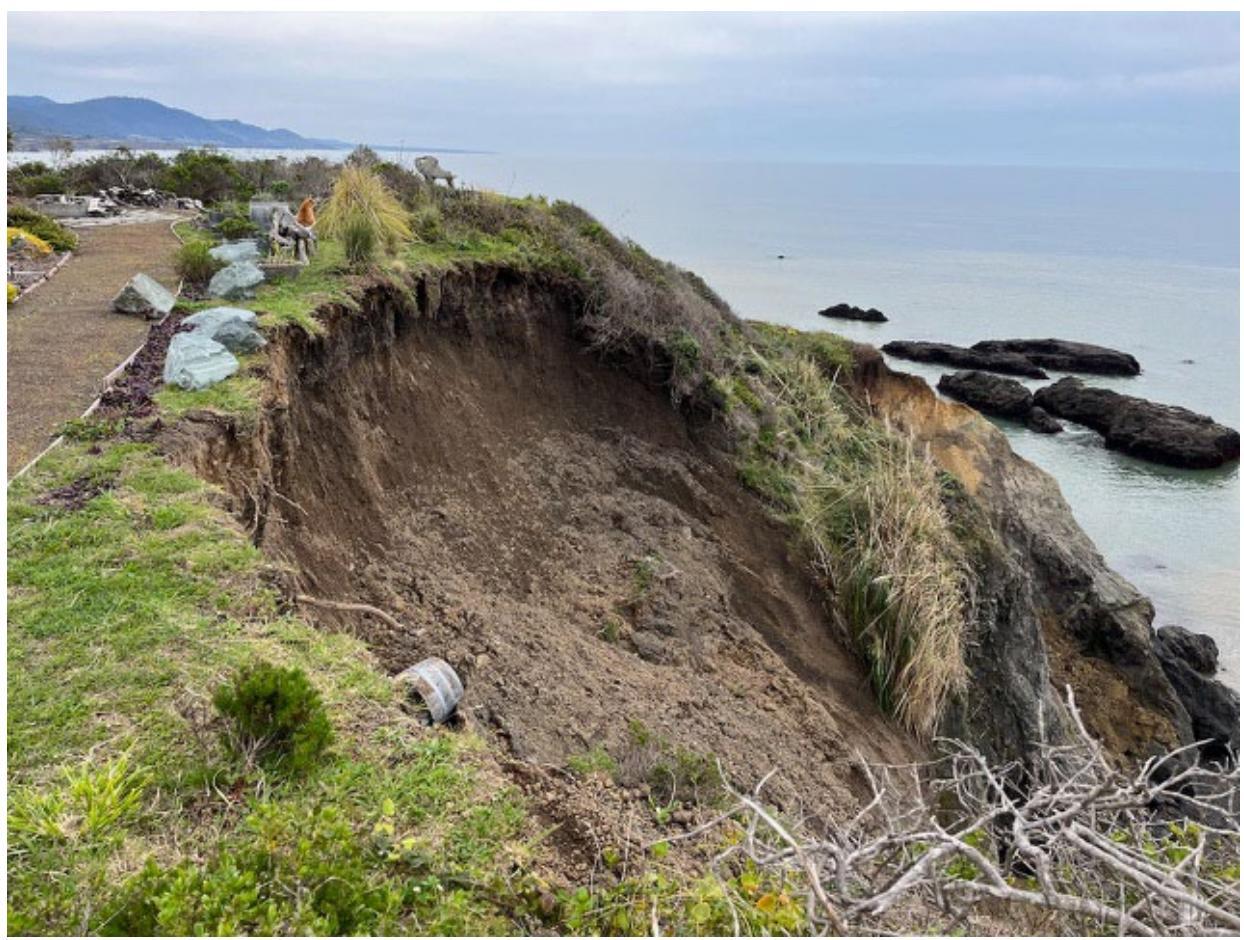
Here are some add'l photos the property owner provided. These were taken in March 2023 when the retreat began.

March 18, 2023 looking South

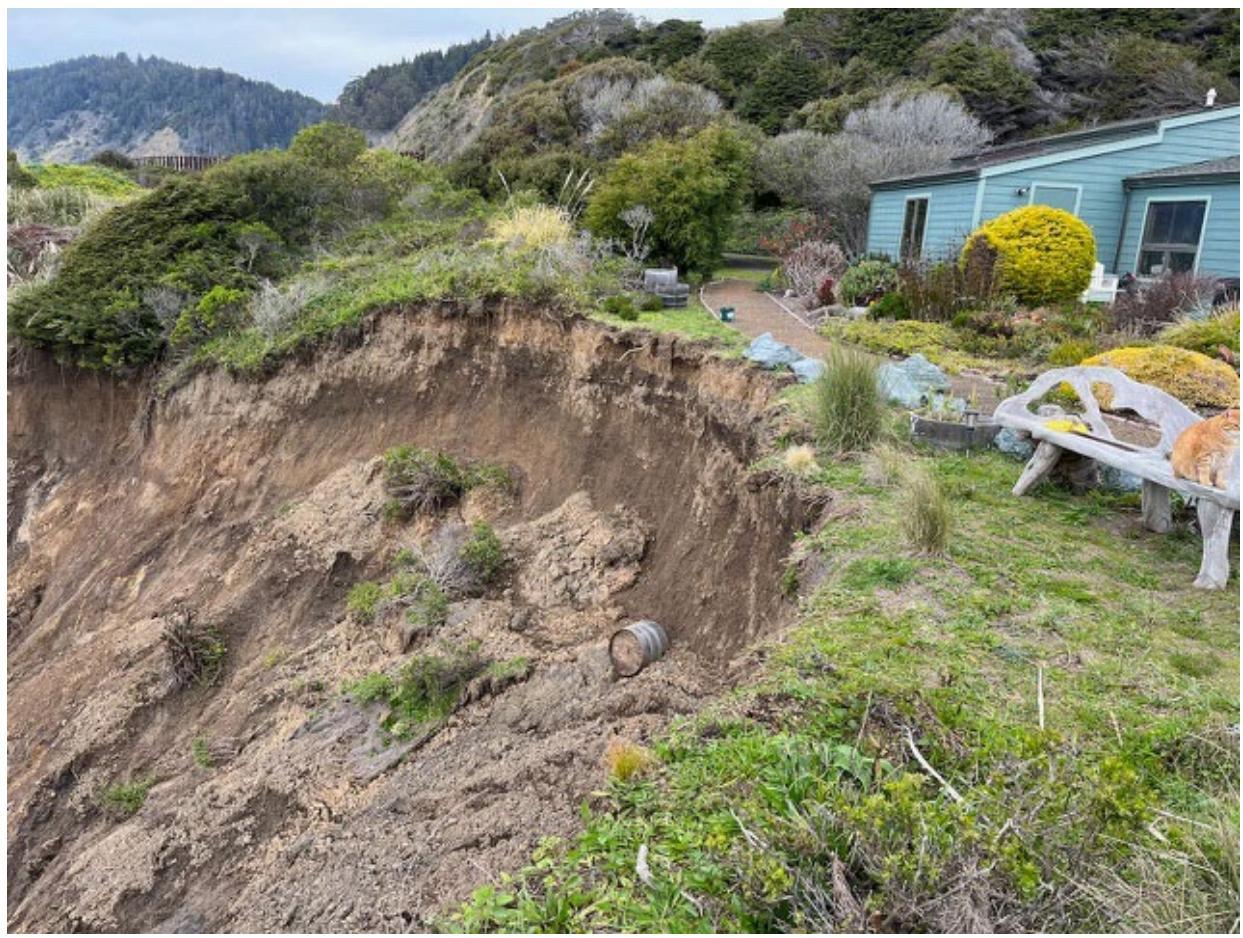
March 18, 2023 looking NW same area

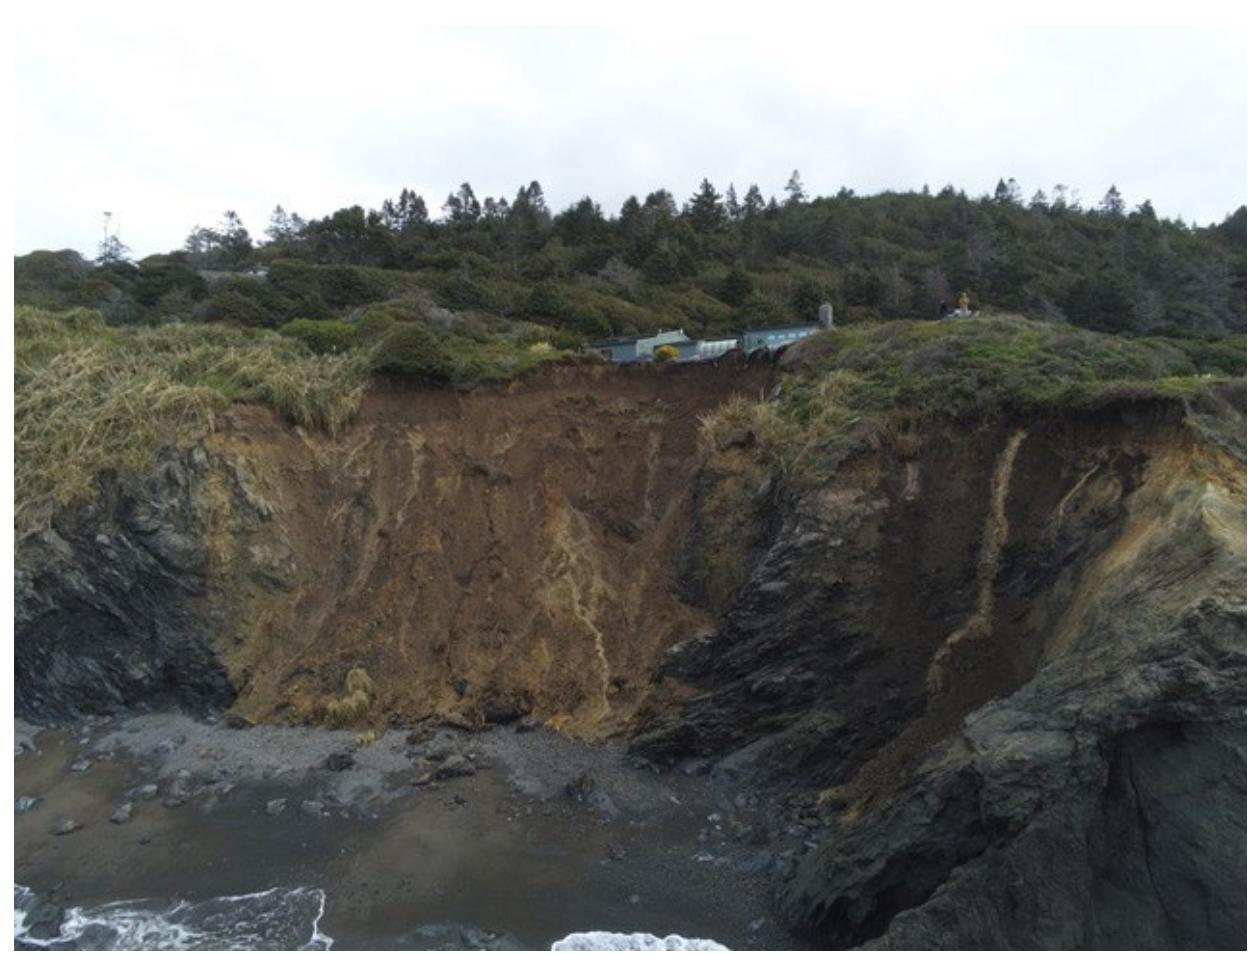
March 30, 2023 Drone photo from West showing where water seeps exited on the face
