## PUBLIC NOTICE OF PENDING ACTION COASTAL DEVELOPMENT ADMINISTRATIVE PERMIT

**CASE#**: CDP\_2022-0027 **DATE FILED**: 7/27/2022

**REQUEST:** Administrative Coastal Development Permit application to construct a single-family

## A NEW SINGLE FAMILY RESIDENCE FOR:

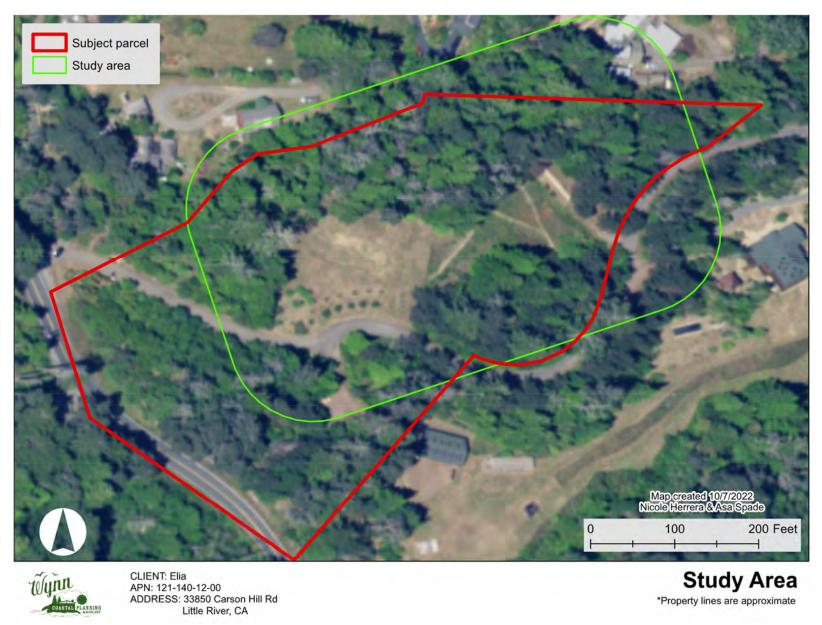
Figure 2. Aerial photograph of the study area.

The subject parcel is located at 33850 Carson Hill Rd, Little River, CA (**Figure 1**). The parcel is east of the highway within the California Coastal Zone. The designated building envelope for residential structures is in a Coastal Development Permit Exclusion Zone. The parcel (**Figure 2**) can be accessed from CA-1 by turning east onto Carson Hill Rd and proceeding ~400ft; the parcel is to the north. The subject parcel is surrounded primarily by parcels of similar size, developed with single-family residences, and with forested land with some clearings. Highway CA-1 borders the subject parcel along its west side. The study area is sloped toward the southwest with an elevation of approximately 320 feet above sea level at the eastern end of the clearing and 250 feet at its western end. A number of native trees have been planted along the outside edge of the clearing and a few fruit trees are present along the south side of the clearing. Existing development includes some irrigation piping, and a retaining wall near the top of the clearing. A building envelope (**Figure 3**) for a single-family residence was designated during the subdivision creating the subject parcel in 1989.

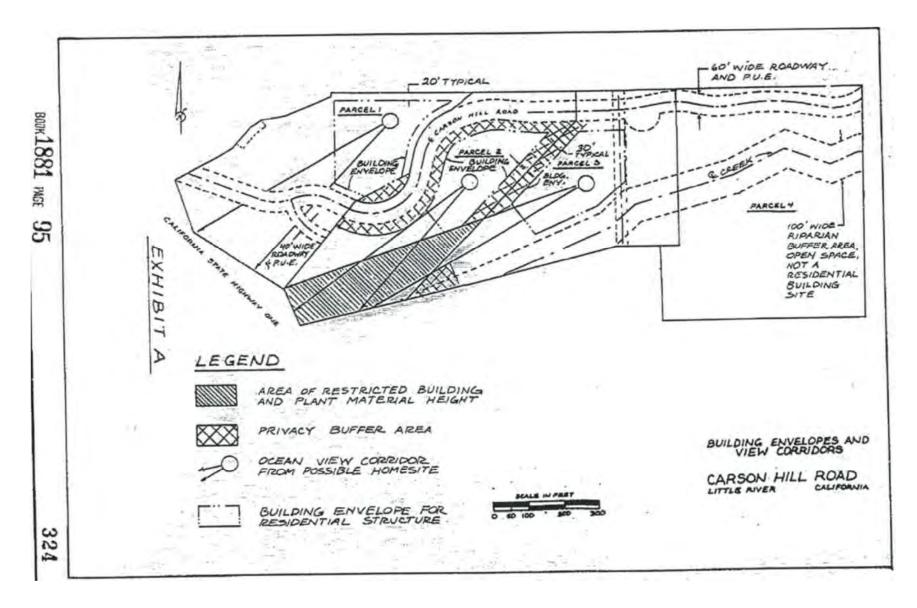
Figure 3. Designation of building envelope for residential structure for the 1989 subdivision.

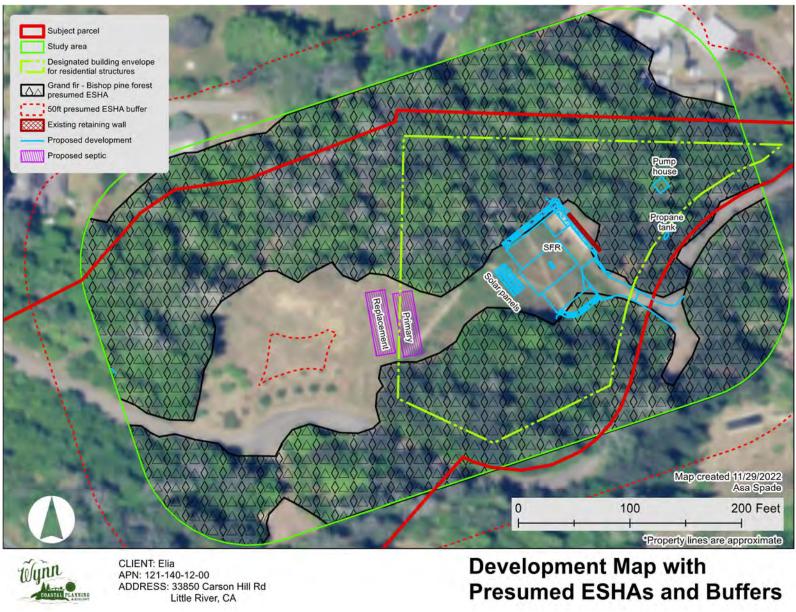
Figure 4. Proposed development relative to presumed ESHA observed at the site. The proposed development avoids ESHA to the greatest extent practicable.

The proposed development (**Figure 4**) is a single-family residence located at the upper (eastern) end of the existing clearing, within the area designated for residential structures by the 1989 subdivision. The existing driveway will be improved. A primary septic leach field and the designation of a replacement field are proposed near the middle of the clearing. Three standing dead trees at the northwestern edge of the building envelope and a few small trees at the northeastern edge of the building envelope are proposed for removal. A 10ftx10ft pump shed and propane tank are also proposed.

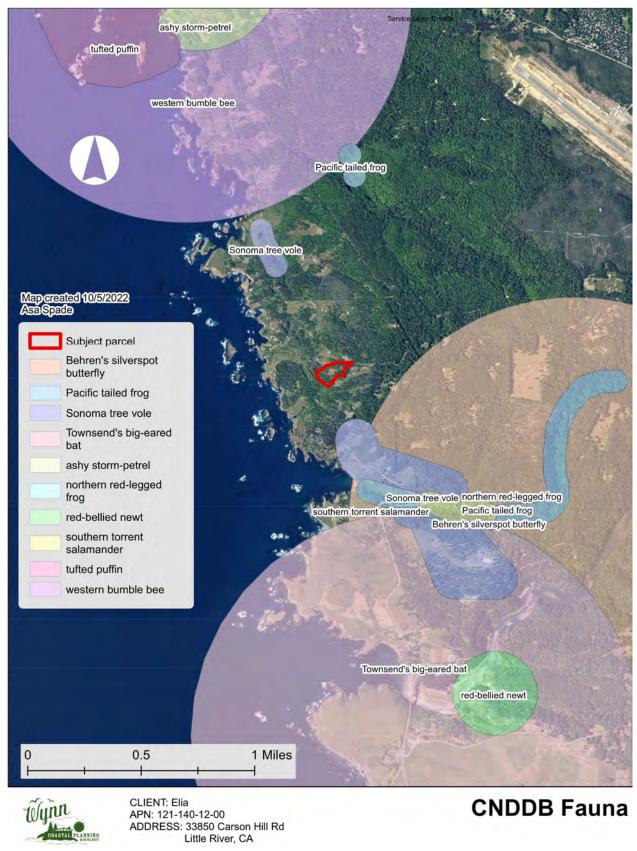
Figure 6. Special status fauna reported to CDFW in the proximity of the study area and recorded in the CNDDB database.

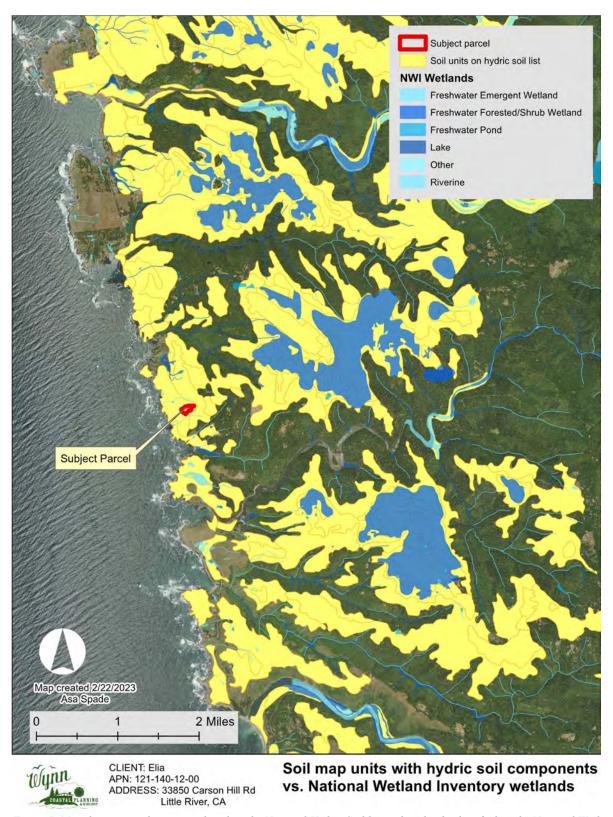
Figure 7. Map depicting soil map units listed on the National Hydric Soil list and wetlands identified on the National Wetland Inventory. It should be noted that being listed on the National Hydric Soil list is not the same thing as meeting the hydric soil parameter for the purpose of a wetland delineation survey.

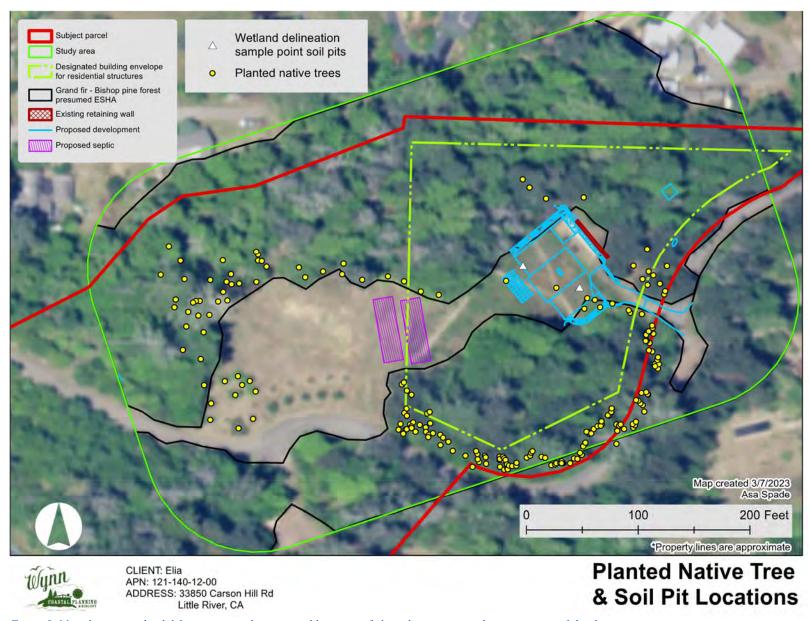
Figure 8. Map showing wetland delineation sample points and locations of planted native trees relative to proposed development.

No observable indicators of wetland occurred in this area, but a sample point was conducted in the vicinity of the proposed residence at the recommendation of a Mendocino County Planner because the soil map unit, Bruhel-Shinglemill complex, 2-15% slopes is on the National Hydric Soil list. The area was mowed after the end of the growing season the year before, so grass identification was difficult. Dominant plant species at this sample point were Bishop pine (*Pinus muricata* UPL), redwood manzanita (*Arctostaphylos columbiana* UPL), purple-awned wallaby grass (*Rytidosperma penicillatum* UPL), slender wild oat (*Avena barbata* UPL), and rattlesnake grass (*Briza maxima* UPL). The hydrophytic vegetation parameter was not met. No wetland hydrology indicators and no hydric soil indicators were observed within the pit dug to 18-

As per SP01, no observable indicators of wetland occurred in this area, but a sample point was conducted in the vicinity of the proposed residence at the recommendation of a Mendocino County Planner because the soil map unit, Bruhel-Shinglemill complex, 2-15% slopes is on the National Hydric Soil list. The area was mowed after the end of the growing season the year before, so grass identification was difficult. Dominant plant species at this sample point were Bishop pine (*Pinus muricata* UPL), coast redwood (*Sequoia sempervirens* UPL), coyote brush (*Baccharis pilularis* UPL), common velvet grass (*Holcus lanatus* FAC), and purple-awned wallaby grass (*Rytidosperma penicillatum* UPL). The hydrophytic vegetation parameter was not met. No wetland hydrology indicators and no hydric soil indicators were observed within the pit dug to 18-inches deep. As no wetland parameters were met, Sample Point SP01 was determined to be in an upland area.

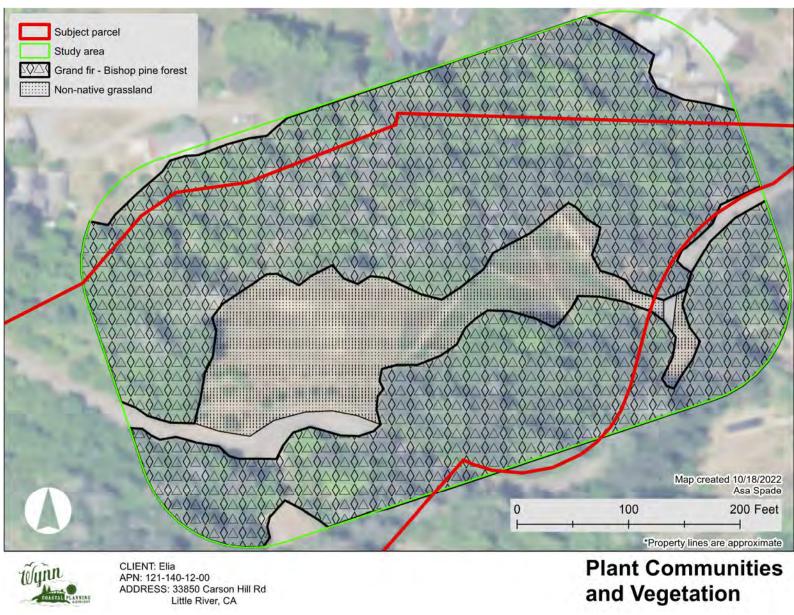
Figure 9. Plant communities and vegetation map. Grand fir – Bishop pine forest is a sensitive natural community.

Plant communities and vegetation (**Figure 9**) observed within the study area consisted primarily of non-native grassland within the clearing, and grand fir – Bishop pine forest surrounding the clearing. A number of native trees have been planted on the subject parcel along the edges of the grassland and along the road.

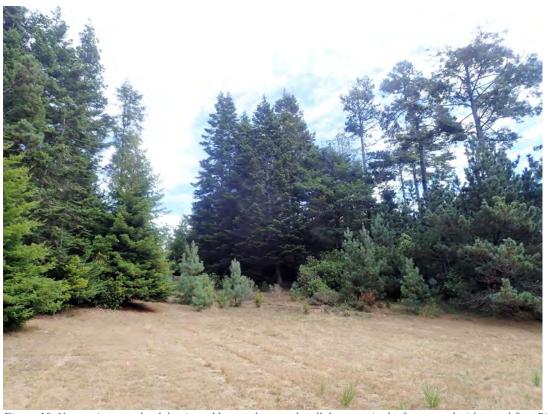
Figure 10. Non-native grassland dominated by purple-awned wallaby grass in the foreground with grand fir – Bishop pine forest in the background.

The non-native grassland (**Figure 10**) present was dominated by purple-awned wallaby grass (*Rytidosperma penicillatum*). Also present were common velvet grass (*Holcus lanatus*), bird's foot trefoil (*Lotus corniculatus*), hairy cat's ear (*Hypochaeris radicata*), English plantain (*Plantago lanceolata*), California blackberry (*Rubus ursinus*), bull thistle (*Cirsium vulgare*), sweet vernal grass (*Anthoxanthum odoratum*), wonder woman sedge (*Carex gynodynama*), sow thistle (*Sonchus oleracea*), creeping bentgrass (*Agrostis stolonifera*), rattlesnake grass (*Briza maxima*), and cottonbatting plant (*Pseudognaphalium stramineum*). Along the edges of the clearing were a number of planted trees including coast redwood (*Sequoia sempervirens*), western red cedar (*Thuja plicata*), Sitka spruce (*Picea sitchensis*), and some species that require more sunlight than is found within the forest understory including pampas grass (*Cortaderia jubata*), coyote brush (*Baccharis pilularis*), and hairy manzanita (*Arctostaphylos columbiana*). A number of seedling and sapling Bishop pine (*Pinus muricata*) and Douglas fir (*Pseudotsuga menziesii*) trees were also present within the area mapped as non-native grassland.

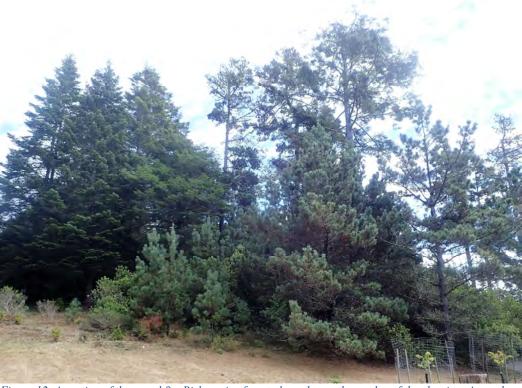
Figure 11. A portion of the Grand fir – Bishop pine forest along the northern edge of the clearing.

The forested portion of the study area had an overstory dominated by grand fir (Abies grandis) and Bishop pine (Figure 10 - Figure 12). Also present in the overstory to a lesser degree was Douglas fir and small amount of tanoak (Notholithocarpus densiflorus). The understory of the forest contained poison oak (Toxicodendron diversilobum), western bracken fern (Pteridium aquilinum), California blackberry, hairy manzanita, spreading rush (Juncus patens), western sword fern (Polystichum munitum), California wax myrtle (Morella californica), evergreen huckleberry (Vaccinium ovatum), Douglas iris (Iris douglasiana), hairy honeysuckle (Lonicera hispidula), sapling tanoak, salal (Gaultheria shallon), coastal burnweed (Senecio minima), Chinook brome (Bromus laevipes), bluegrass (Poa pratensis), dwarf mistletoe (Arceuthobium campylopodum), oxe-eye daisy (Leucanthemum vulgare), thimbleberry (Rubus parviflora), vanilla grass (Anthoxanthum occidentale), woodland strawberry (Fragaria vesca), coyote brush, cotoneaster (Cotoneaster spp.), English holly (Ilex aquifolium), Latin American fleabane (Erigeron karvinskianus), pearly everlasting (Anaphalis margaritacea), blueblossum (Ceanothus thyrsiflorus), redwood violet (Viola sempervirens), woodland madia (Madia madioides), rattlesnake plantain (Goodyera oblongifolia), and everlasting pea (Lathyrus latifolius).

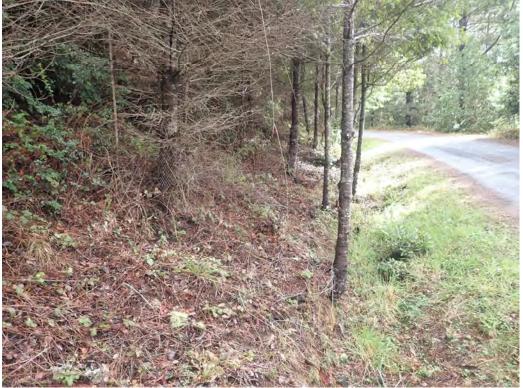
Figure 12. A portion of the grand fir -Bishop pine forest along the southern edge of the clearing. A couple caged planted fruit trees are present at the lower right of the photo.

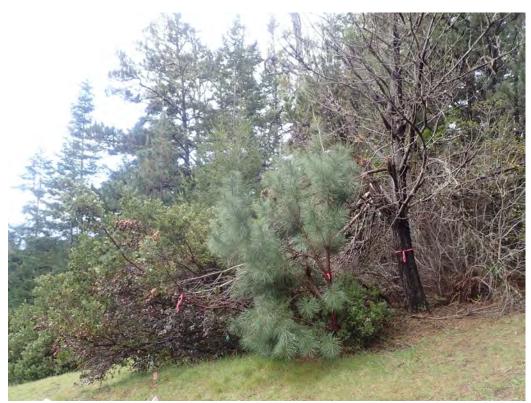
Figure 14. Manzanita brush, a young Bishop pine, and a standing dead Bishop pine that are proposed for removal to accommodate the northern edge of the proposed residence. The removal of this vegetation will not be a significant impact to the forest present.

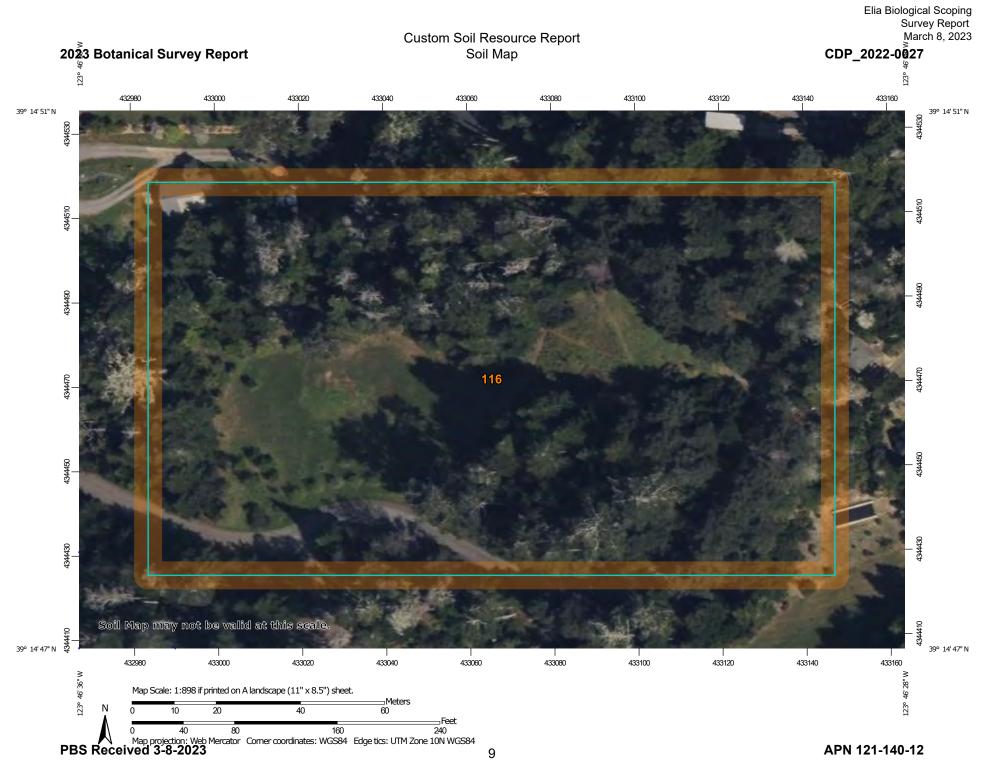
# Soil Map

The soil map section includes the soil map for the defined area of interest, a list of soil map units on the map and extent of each map unit, and cartographic symbols displayed on the map. Also presented are various metadata about data used to produce the map, and a description of each soil map unit.
