BIOLOGICAL SCOPING & BOTANICAL SURVEY REPORT

for
5200 North Highway 1
Little River, CA 95456
APN 121-130-10, -13, -14, -33, -34 &
123-010-18, -31, -32, -33
Mendocino County

July 23, 2021

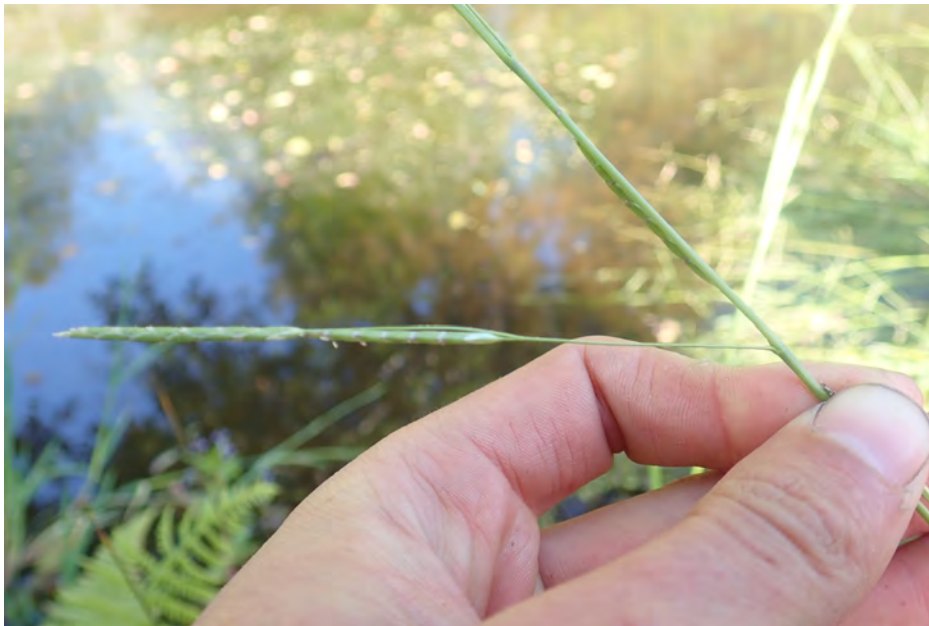
Figure 9. Nodding semaphore grass observed near pond.

Nodding semaphore grass is a perennial grass that is found in wet meadows and shady banks. It does not have a protected special status classification; however, it is a watch list species with a California Rare Plant Rank of 4.2 indicating that it is a plant of limited distribution and is fairly threatened in California. It was observed along the banks of the manmade freshwater pond.

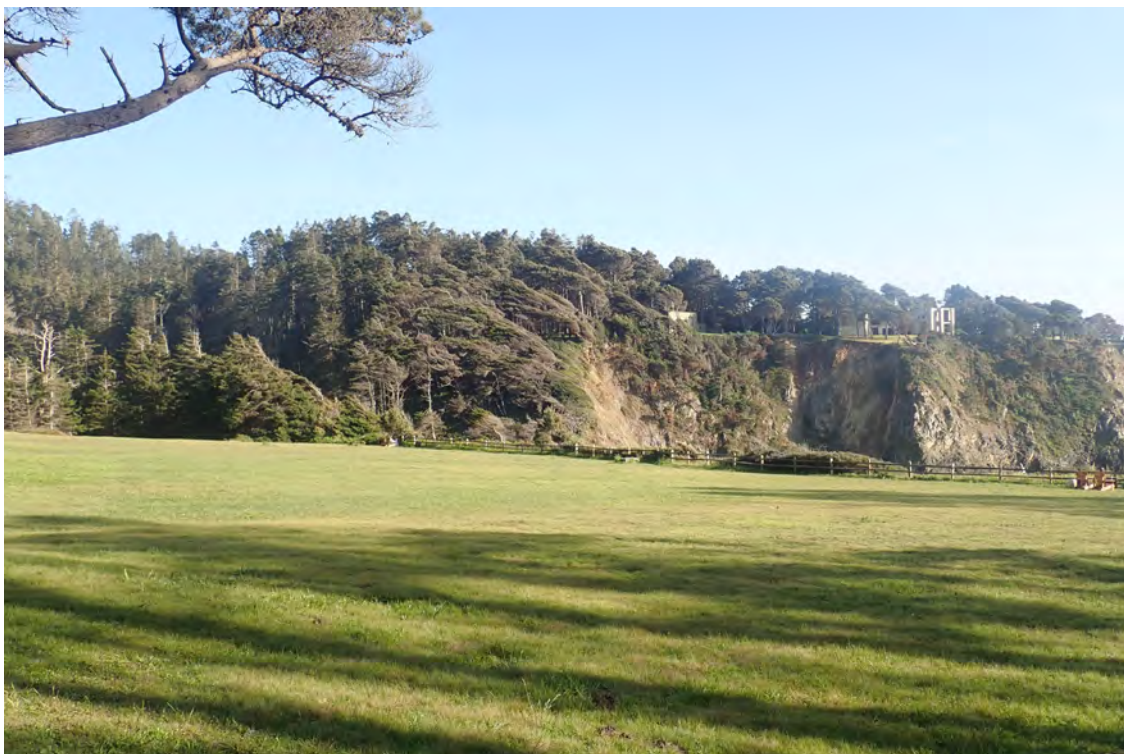
Figure 10. Mowed, non-native grassland dominated by sweet vernal grass and common velvet grass on southwestern portion of parcel.

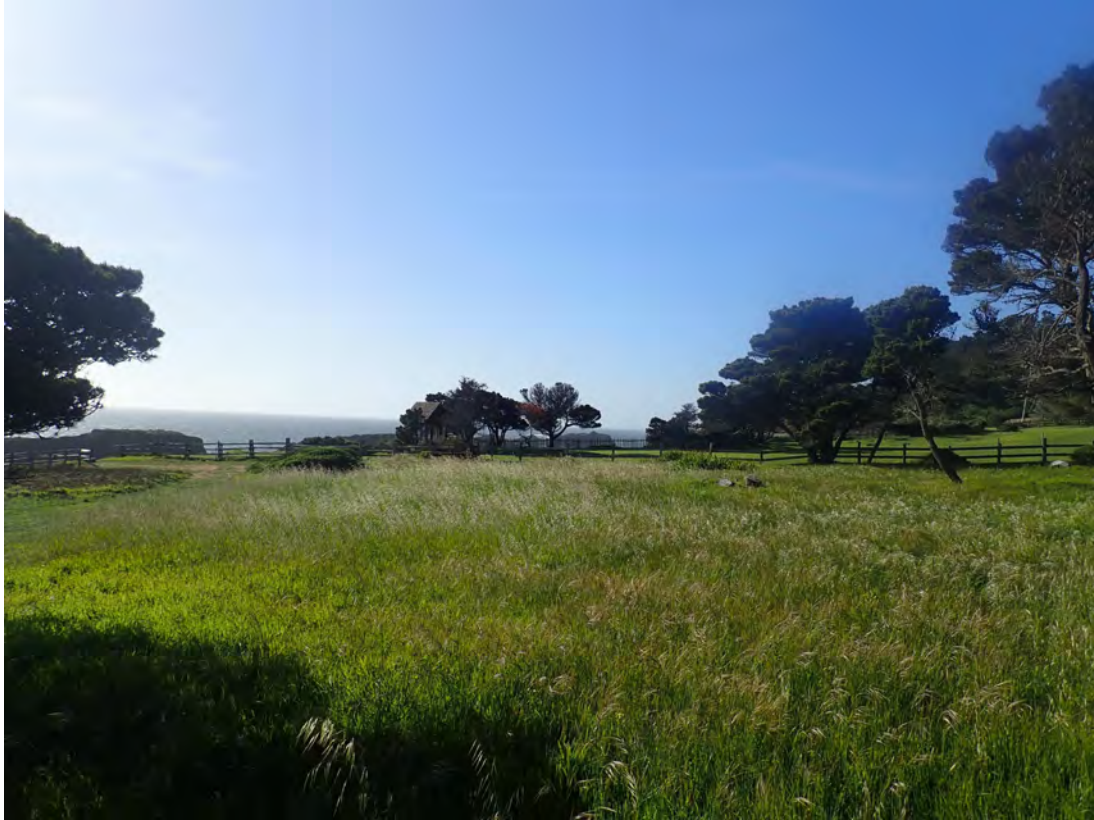
Figure 11. Non-native grassland with a higher density of ripgut brome on northwestern portion of property

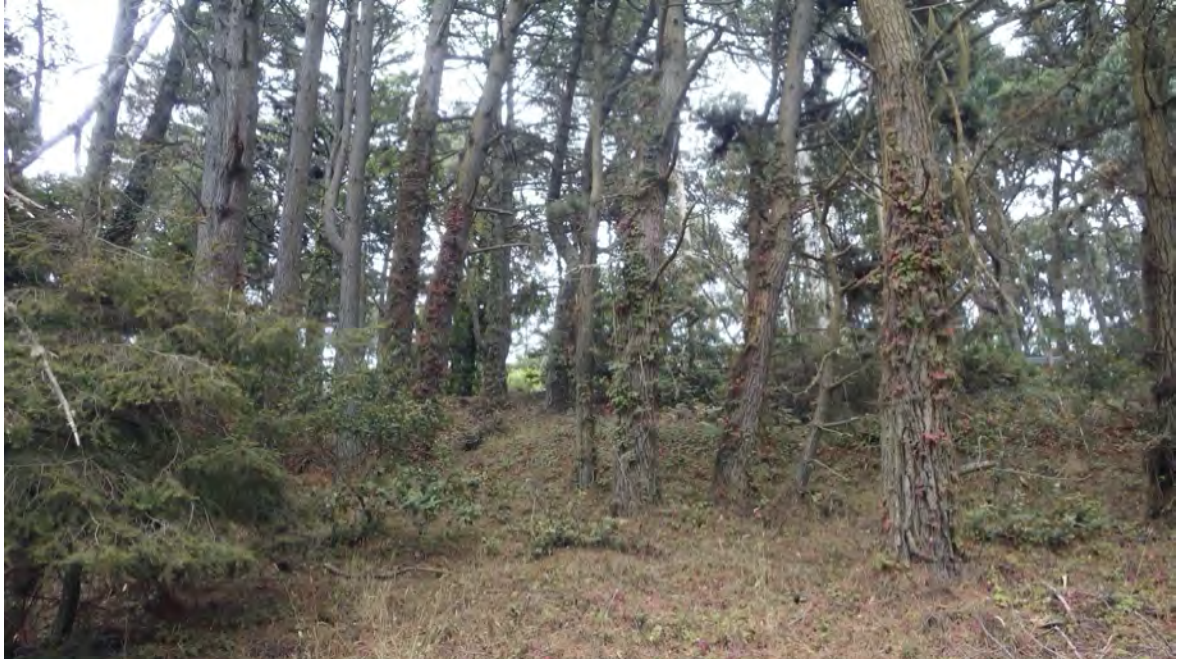
Figure 12. Bishop pine understory in northern portion of property near Highway One.

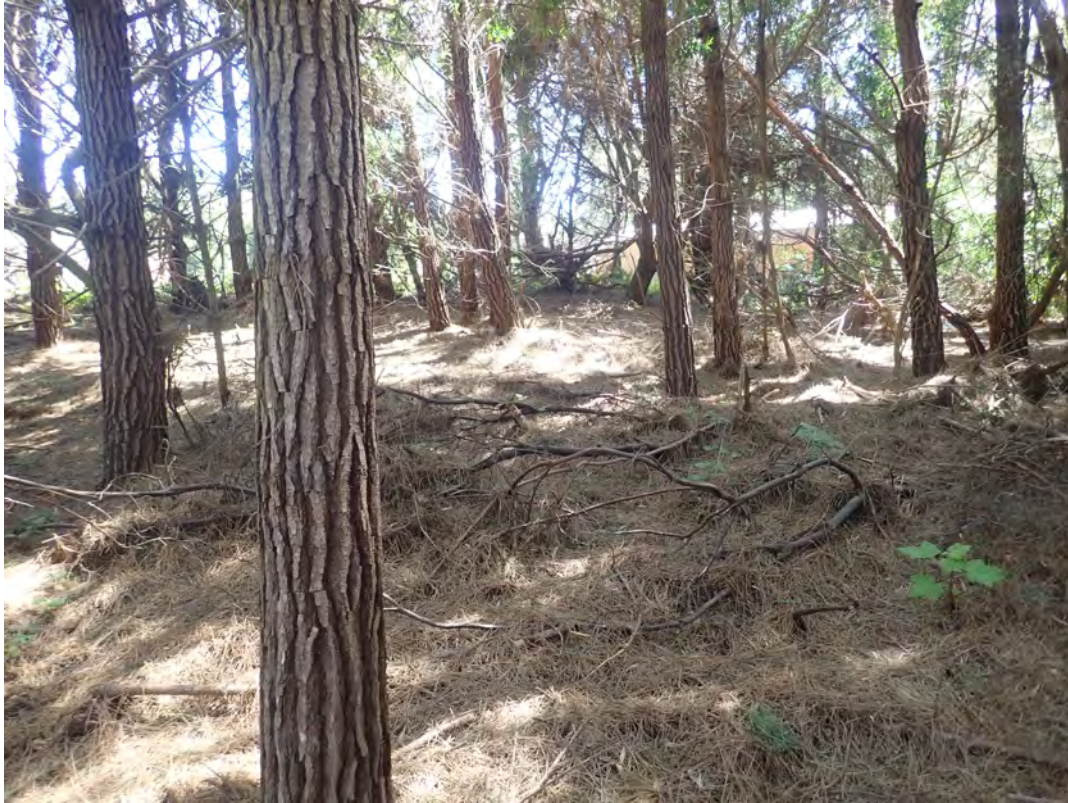
Figure 13. Bishop pine understory just west of existing wastewater treatment plant. Trees are in rows and were potentially planted in the past.

The forest in the northern portion of the property directly west of the current sanitation plant and workshops is younger, closely spaced, and may have been planted in the past as many of the trees appear to be in rows. Vegetation in the understory was sparse and the ground was covered with pine needle duff. Species observed in this area included: redwood manzanita (*Arctostaphylos columbiana*), thimbleberry, California blackberry, and wax myrtle. The Bishop pine stand closer to the bluff edge along Smith Creek are dead and dying. Veiled polypore (*Cryptoporus volvatus*), a fungus which decomposes the sapwood of dead conifer trees, was observed on several trees within this stand.

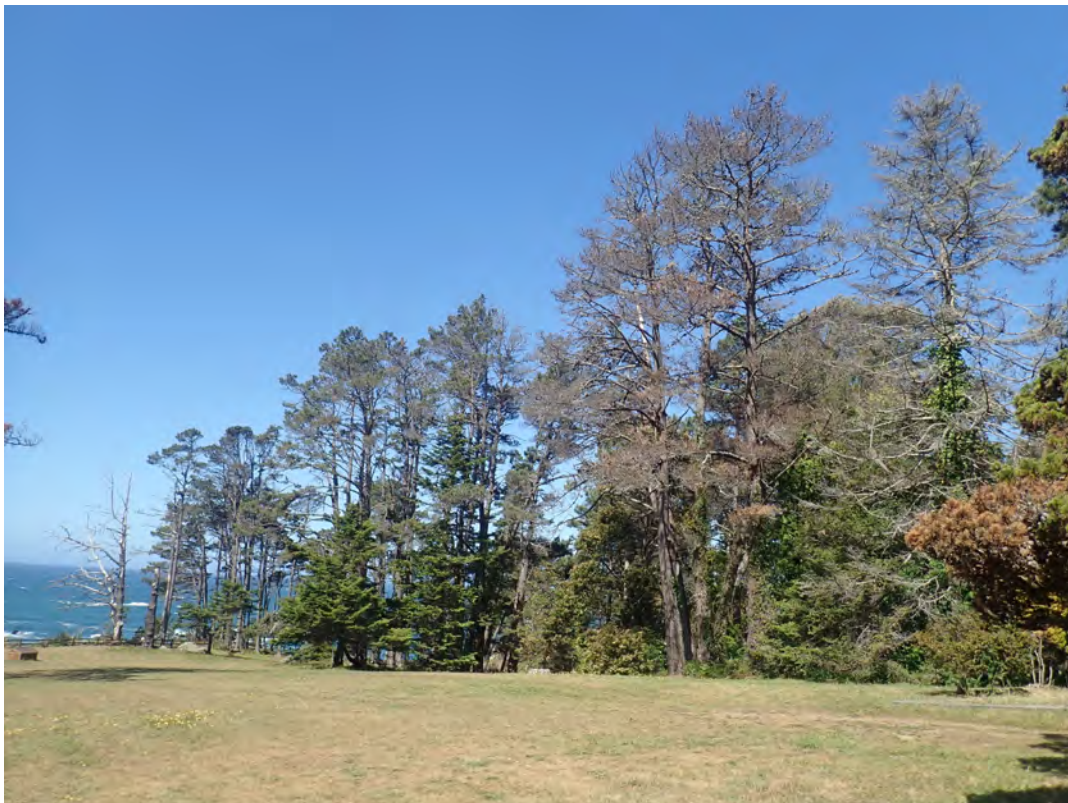
Figure 14. Dead and dying Bishop pine stand near bluff edge along Smith Creek.

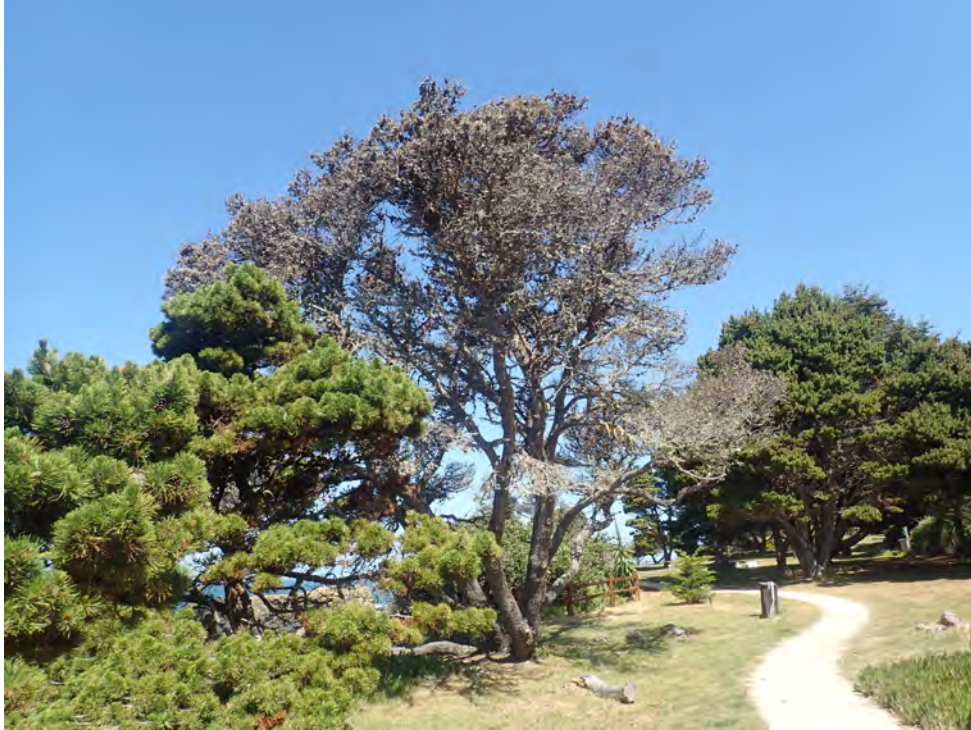
Figure 15. Shore pine trees along bluff edge.

Shore pines trees (*Pinus contorta* ssp. *contorta*) primarily occurred in the north western corner of the study area. Many of the shore pine trees exhibit slight krummholz features (e.g. stunted and deformed); presumably from the wind and salt spray. Individuals shore pines trees are spread out along the bluff in between visitor accommodation units. Like the individual Bishop pine trees, many of the individual shore pine trees were not considered a presumed ESHA because the understory of these trees is a mowed lawn with no other understory vegetation layers present that would characterize a shore pine forest community. The Manual of California Vegetation recognizes a “forest” as having a relatively closed canopy (usually with >60% canopy cover).

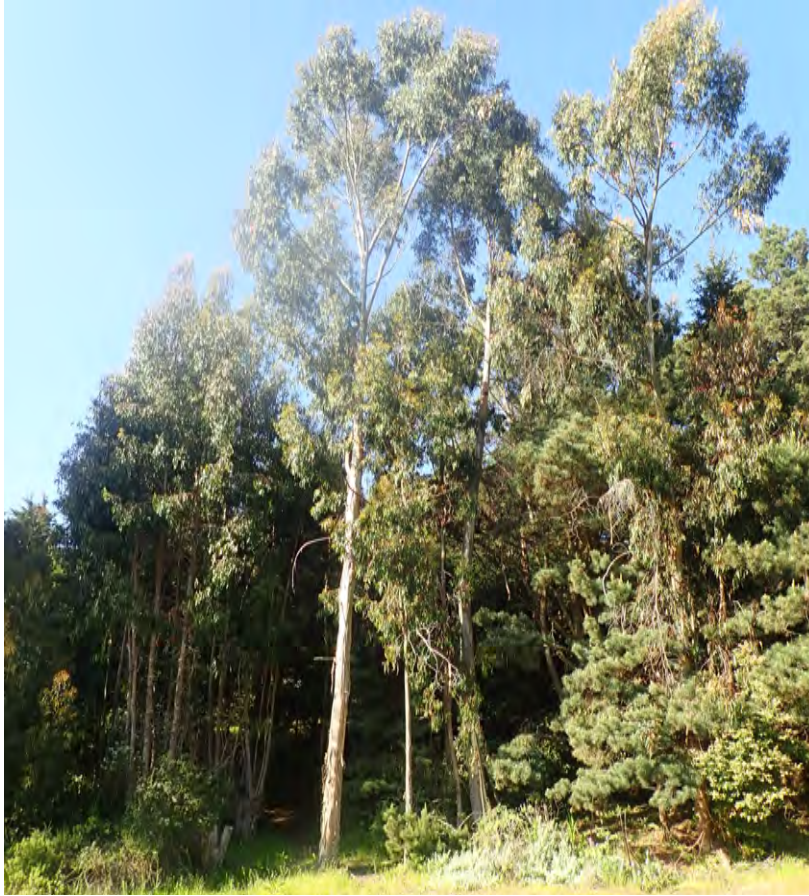
Figure 16. *Eucalyptus* groves.

A large eucalyptus (*Eucalyptus globulus*) grove is present in the center of the property and on the north side of Smith Creek. Many of the visitor accommodation units are located underneath or directly adjacent to this grove. In areas where the canopy is dense, the eucalyptus trees shade out most other vegetation and only a duff layer is present underneath the canopy. In other areas, eucalyptus saplings are growing in the understory with non-native grasses and shrubs such as ripgut brome, rattlesnake grass, English ivy, pine echium (*Echium pininana*), and English plantain.

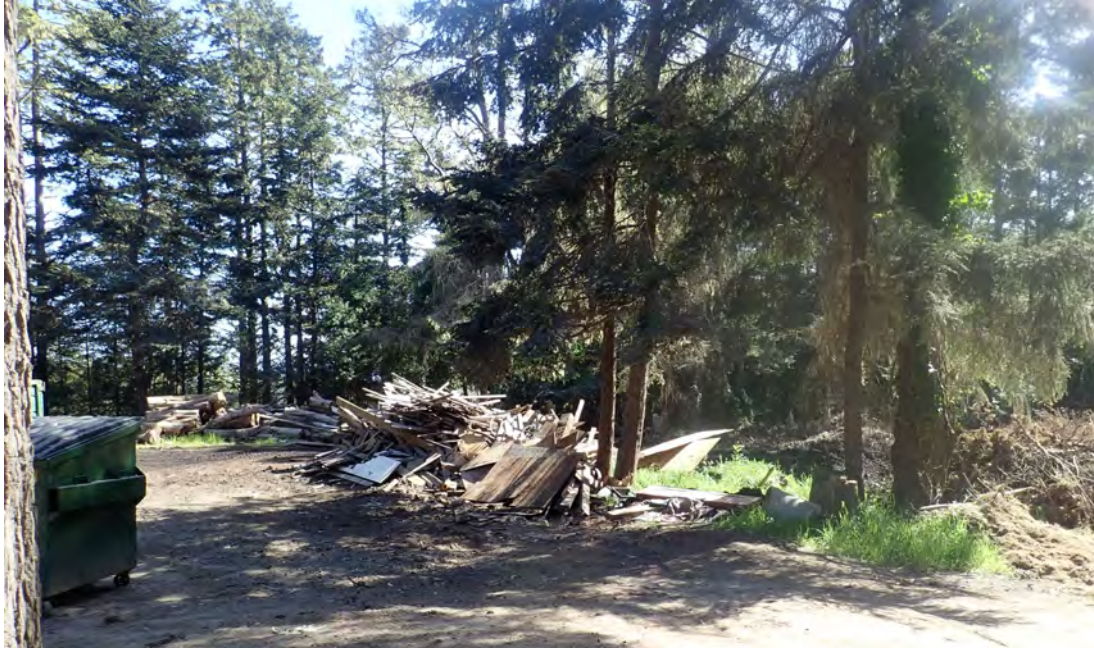
Figure 17. Douglas fir and grand fir trees behind facilities area.

The vegetation to the east of the northern facilities area and raw water storage pond is characterized by grand fir (*Abies grandis*) forest. Grand fir and Douglas fir (*Pseudotsuga menziesii*) dominated the canopy with Bishop pine, eucalyptus, and coast redwoods (*Sequoia sempervirens*) sporadically interspersed throughout the community. The understory was vegetated with wax myrtle (*Morella californica*), tan oak saplings, evergreen huckleberry, sword fern, California blackberry, broadleaf forget me not (*Myosotis latifolia*), Douglas iris, pampas grass, bracken fern, and Pacific rhododendron (*Rhododendron macrophyllum*).

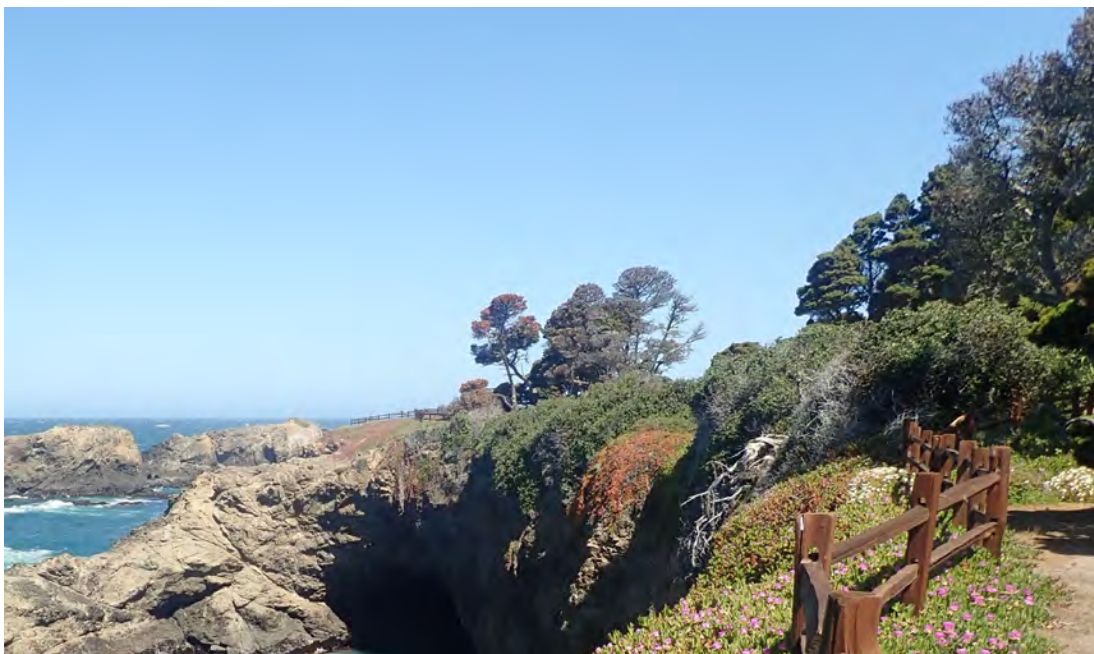
Figure 18. Coast silk tassel along bluff edge.

Coast silk tassel (*Garrya elliptica*) was observed along the bluff edge in several places on the property. In two patches on the northwestern side of the property, the coast silk tassel dominated the vegetation enough to be considered its own plant community. Other species adjacent to or mixed in with the silk tassel included: ice plant (*Carpobrotus edulis*), coyote bush (*Baccharis pilularis*), and ornamental plants.

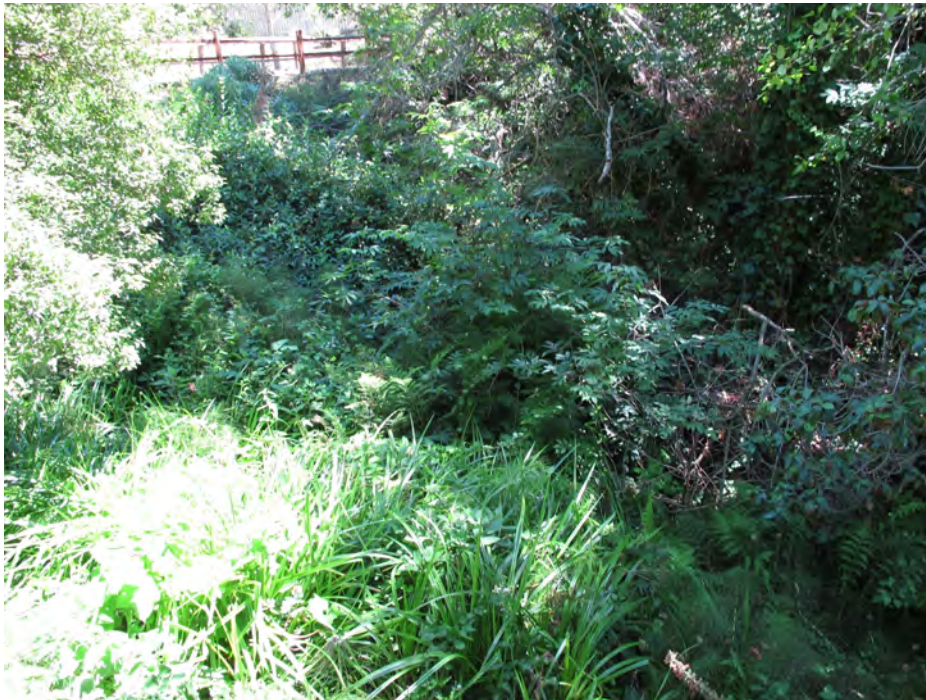
Figure 19. Dense stream riparian vegetation.

Red alder (*Alnus rubra*) forest runs along the intermittent stream and ponds on the property and along the south western corner of the property for Dark Gulch which is just south of the study area. Understory growth was thick and dense within and along the drainages while vegetation was manicured just to the edge of the ponds. Species observed in the understory along the drainages included: thimbleberry, California blackberry, salmonberry (*Rubus spectabilis*), hairy honeysuckle (*Lonicera hispidula*), twinberry (*L. involucrata*), paniced bulrush (*Scirpus microcarpus*), California bay (*Umbellularia californica*), common lady fern (*Athyrium filix-femina*), giant horsetail, stinging nettle (*Urtica dioica*), foxglove (*Digitalis purpurea*), arroyo willow (*Salix lasiolepis*), broadleaf forget me not, and English ivy. Additional species observed within and along the ponds included: water parsley (*Oenanthe sarmentosa*), tall flat sedge (*Cyperus eragrostis*), common bog rush (*Juncus effusus*), American brooklime (*Vicia americana*), self heal (*Prunella vulgaris*), and skunk cabbage (*Lysichiton americanus*).

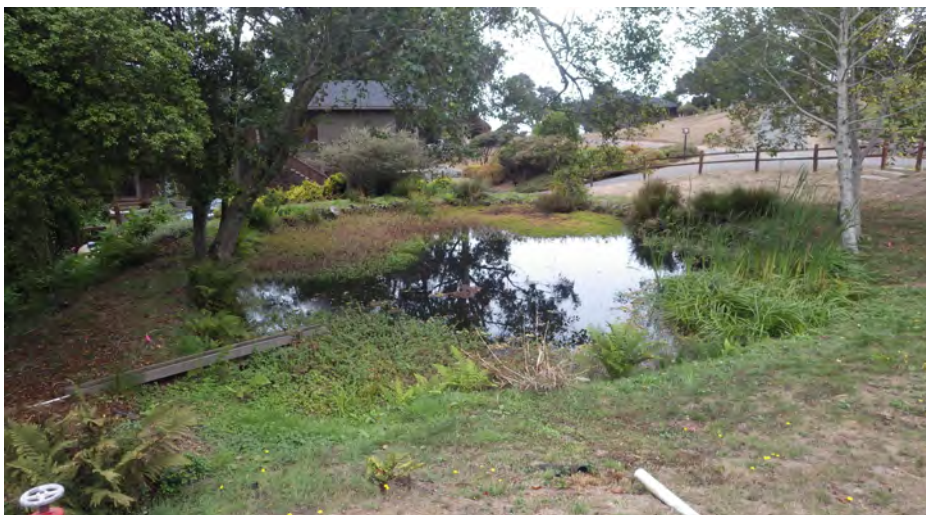
Figure 20. Manmade pond.

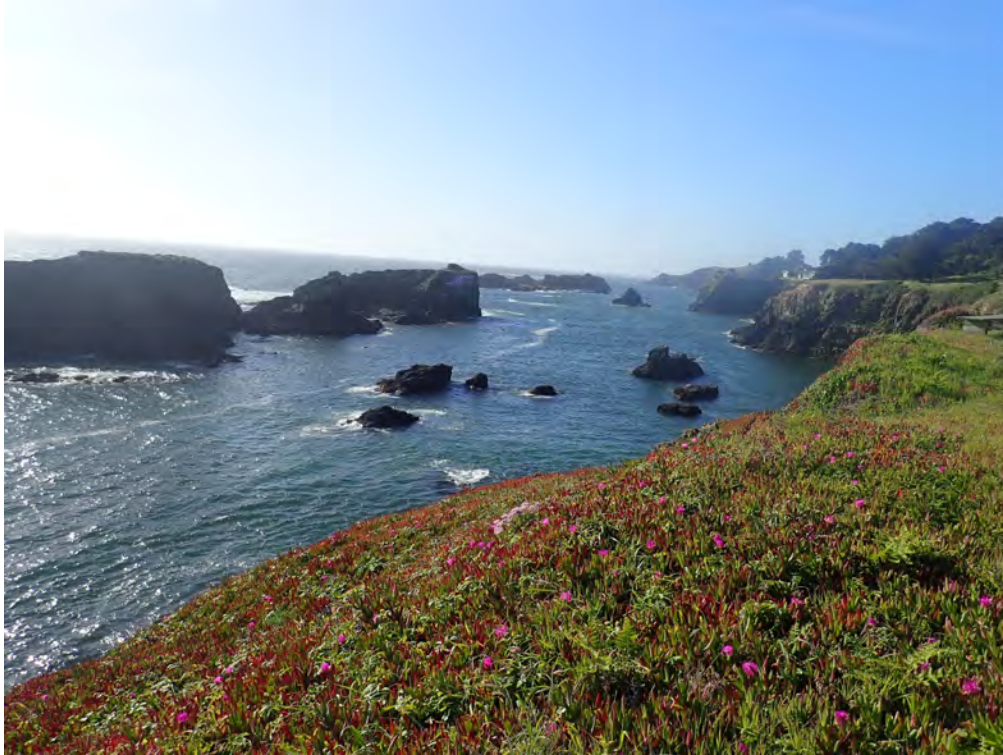
Figure 21. Ice plants mats along bluff top and edge.

Iceplant (*Carpobrotus edulis*) is present in patches along the bluff edge and bluff top in the study area. The iceplant is dominant enough in places to be its own plant community. The iceplant excludes most other plants, but a few other plants poke through in places. These plants includes bracken fern, rippgut brome, sweet vernal grass, and seaside daisy (*Erigeron glaucus*).

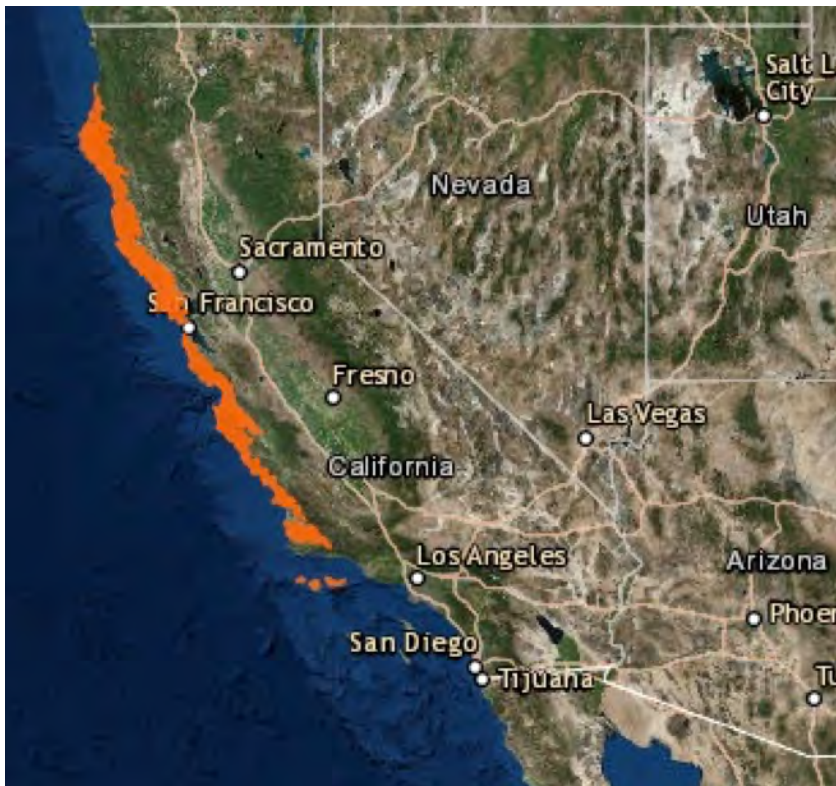
Figure 5. CNPS range of *Pinus muricata* & *Pinus radiata* alliance (CNPS 2019).

Bishop pine forest has a ranking of G3 S3, which indicates that the community is rare globally and throughout California. According to both the Manual of California Vegetation and USDA, Bishop pine forests typically occur in disjunct coastal populations from southern Oregon to Santa Barbara California (Figure 5 & Figure 6) (Sawyer 2009 & Cope 1993). Bishop pines are also located on Santa Cruz and Santa Rosa islands as well as Baja California, Mexico (Sawyer 2009 & Cope 1993). Populations of Bishop pines are typically located in Mediterranean climates between sea level and 400 meters in elevation (NPS 2015).

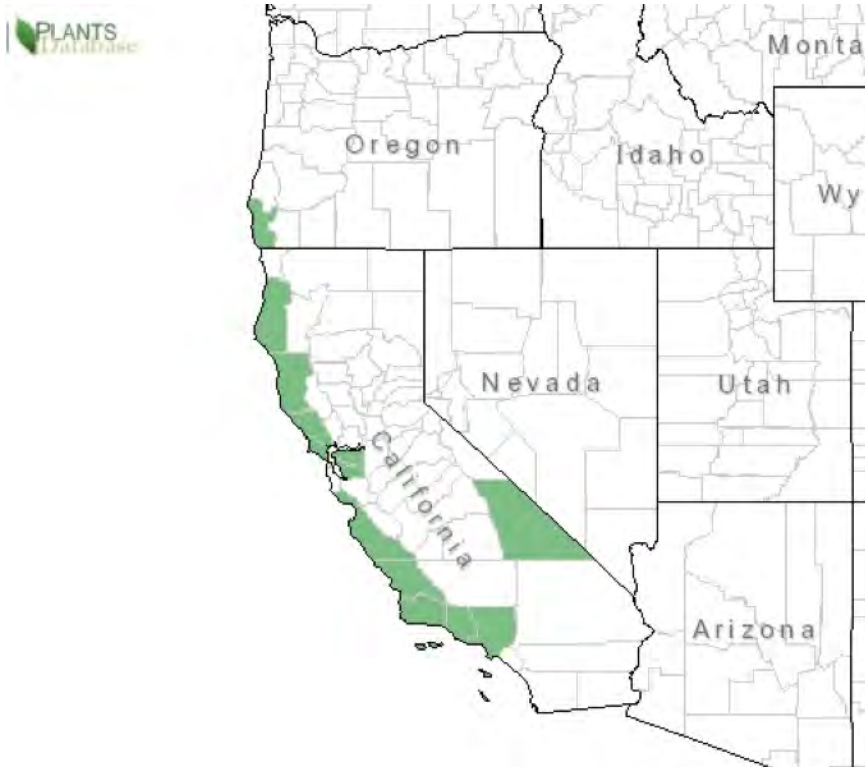
Figure 6. USDA & NRCP Bishop pine distribution (Cope 1993).

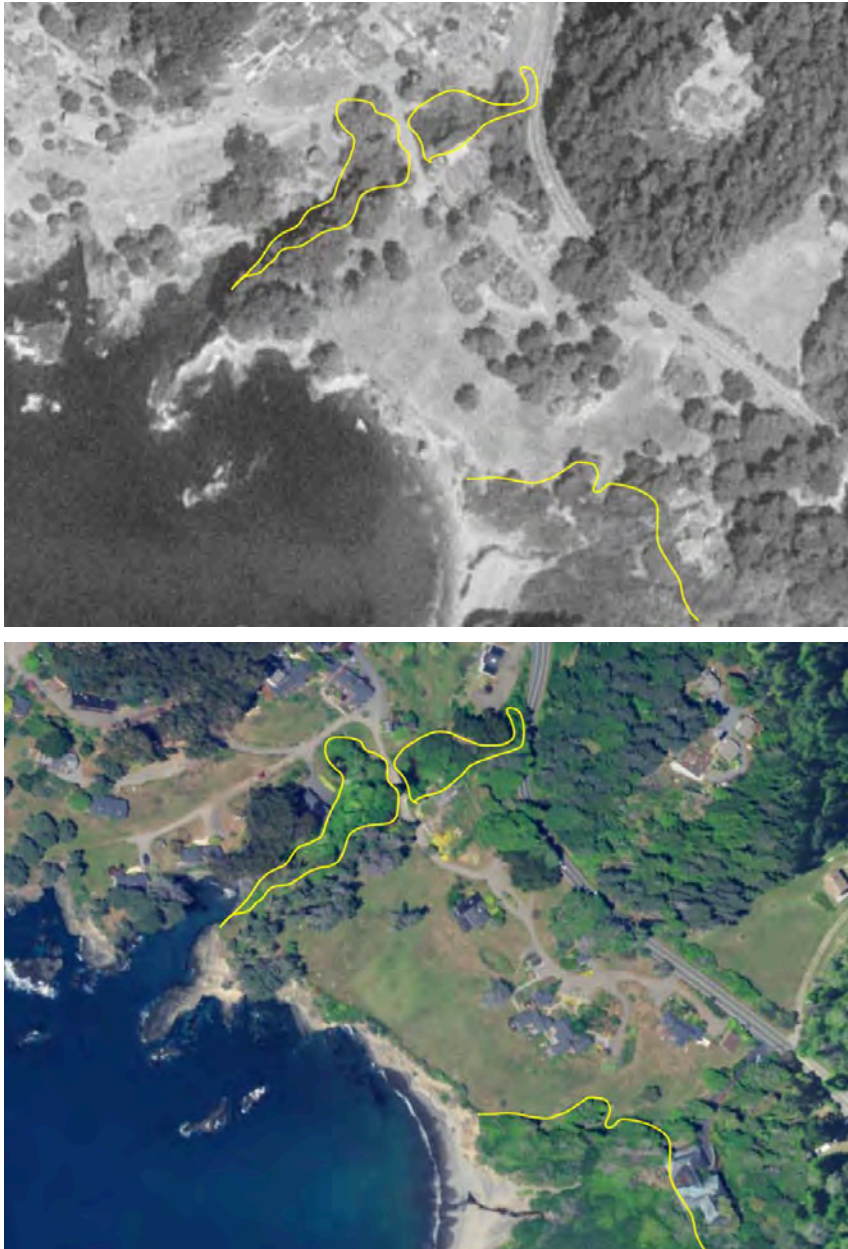
Figure 8. Comparison of the riparian area extent from 1998 (top) to 2020 (bottom).

The riparian areas are apparent in 1998 google earth imagery as dark patches of canopy. The southern riparian area canopy around Dark Gulch appears to have remained relatively the same over time (**Figure 8**). The riparian area along Smith Creek has grown in over time around the eastern pond. The pond was excavated from the gulch sometime around 1982 and the canopy layer was still relatively open when the aerial photo was taken in 1998. There is no prior documentation available in regards to the historical extent of the riparian area onsite.
