**COASTAL ZONE APPLICATION FORM**

A slope - protection structure to be constructed back (on the uphill side) of a failing cut slope for an access road owned by the State of California, Parks & Recreation Department. The structure will consist of a row of drilled piers connected with a subsurface, concrete grade beam that is supported by diagonally-drilled tie-back anchors.

**VICINITY FAULT MAP**  
KOPRIVA SLOPE STABILIZATION  
6170 South Highway 1  
Elk, California

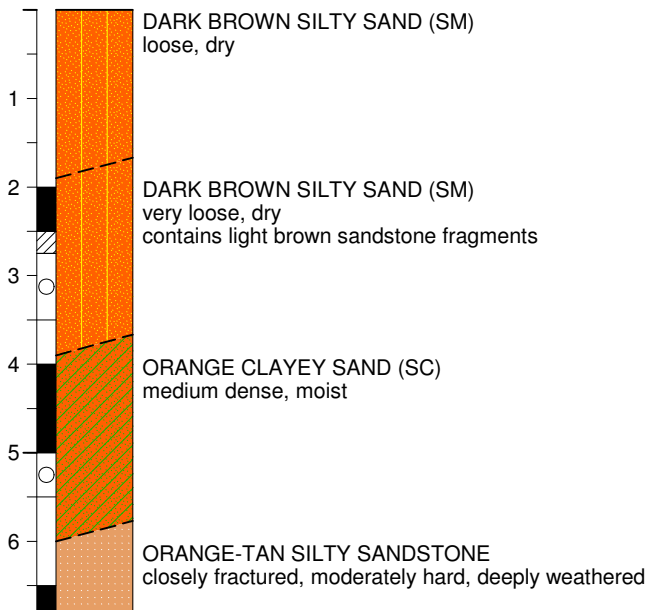
1. No water encountered
2. No caving
3. Practical drilling refusal at 6.5 feet

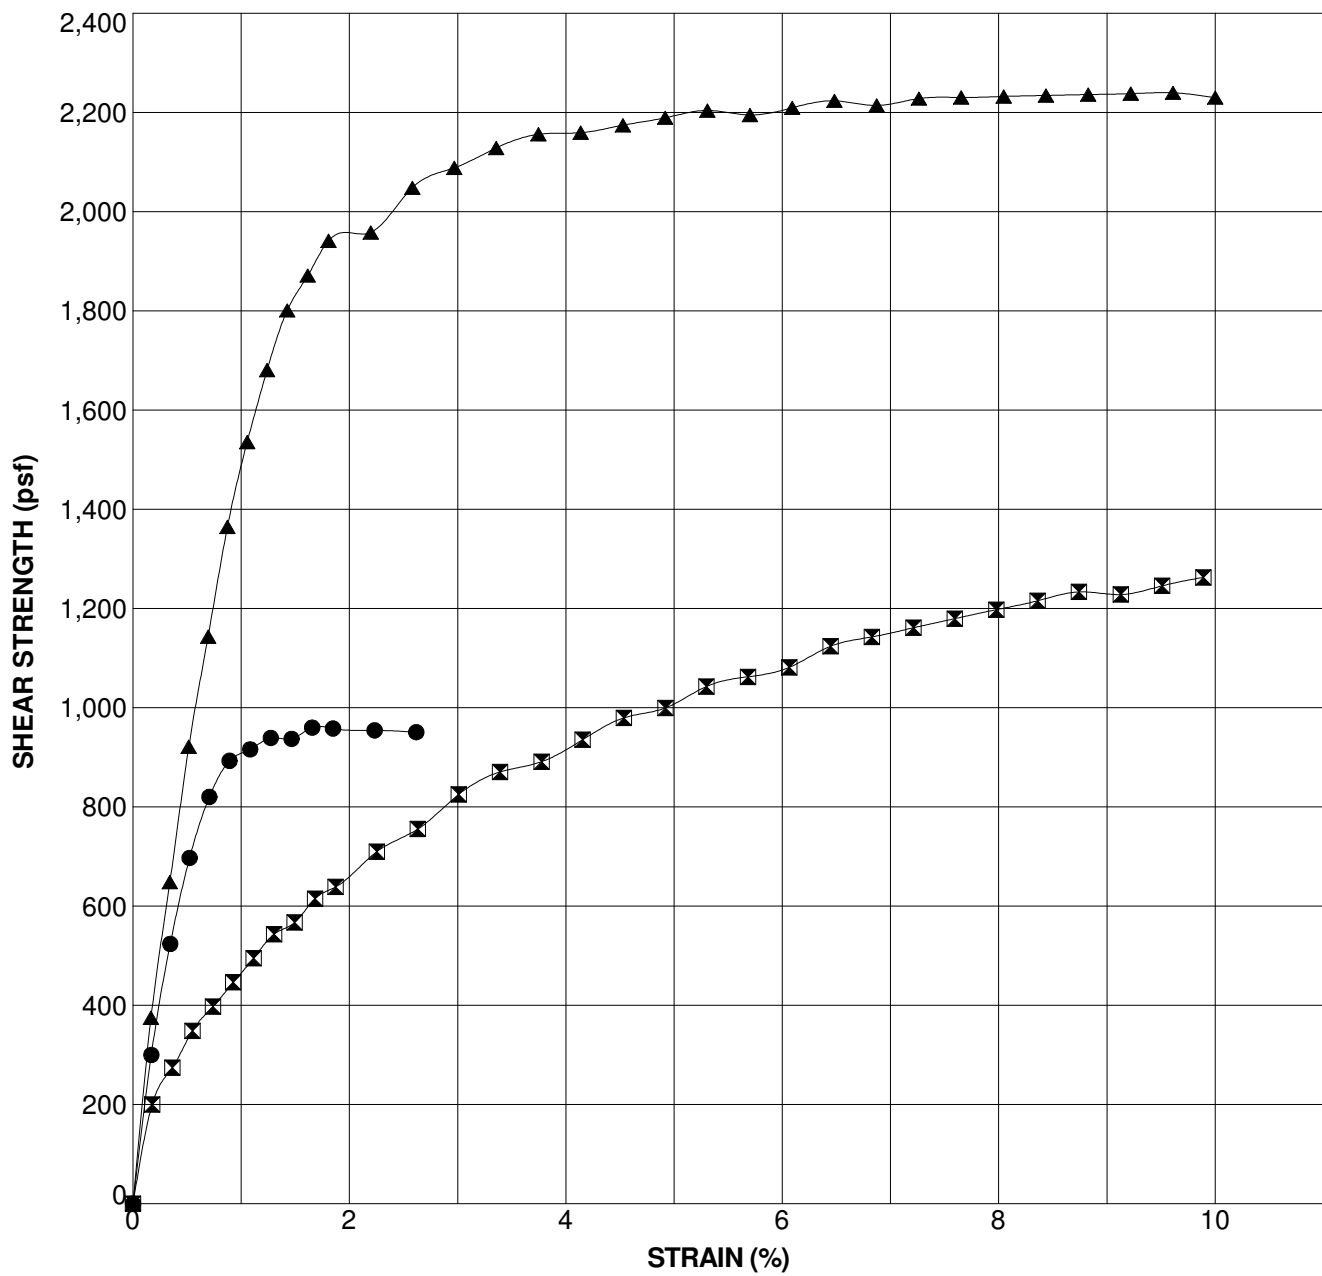
UNCONSOLIDATED TRIAXIAL (ULTIMATE), 13487.01 GINT.GPJ, 6/14/23

Sample Source	Classification	Confining Pressure (psf)	Ultimate Strength (psf)	Strain (%)	Dry Density (pcf)	Moisture Content (%)
● B-1 at 3.5 ft	BROWN-BLACK SILTY SAND (SM)	576	960	1.7	101	17.1
☒ B-1 at 8 ft	ORANGE AND BLACK CLAYEY SAND (SC)	1008	1263	9.9	94	21.7
▲ B-2 at 4.5 ft	ORANGE CLAYEY SAND (SC)	576	2240	9.6	103	16.9

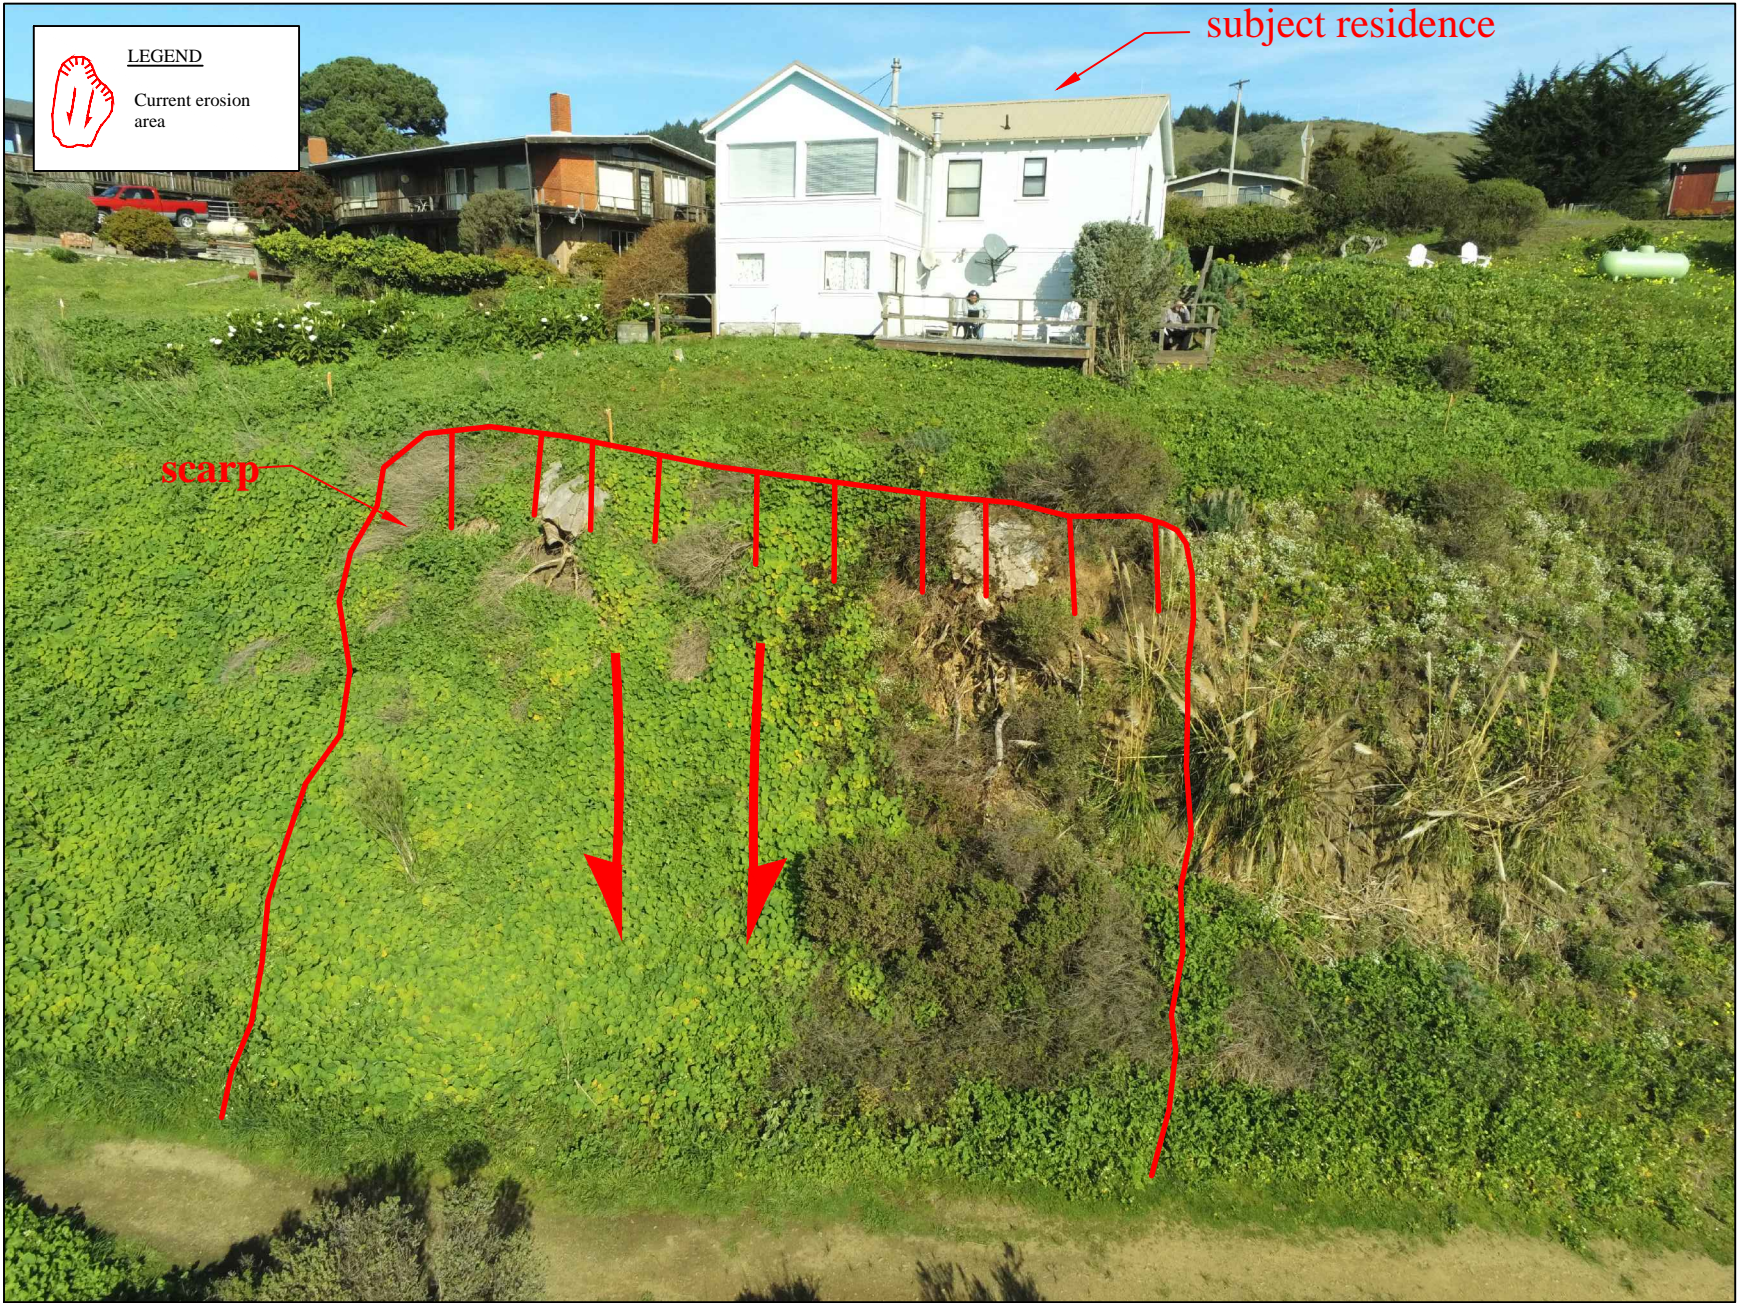
No deep-seated landslides were observed within or adjacent to the Kopriva property. Severe erosion is occurring on the beach access road cut slope below the Kopriva property as shown on Plate 9. The upper portion of the erosion area, just below the Kopriva property shows leaning tree stumps and small, bare scarps where the ground has dropped downslope. The stumps are from trees removed by the State of California prior to 2013. The hillside below the Kopriva property is mapped as a “debris slide slope” on California Division of Mines and Geology Open File Report 84-12 SF (OFR 84-12 SF). A debris slide slope” is defined as “a geomorphic feature characterized by steep..., usually well vegetated slopes that have been sculpted by numerous debris slide events; vegetated soils and colluvium above shallow soil/bedrock interface may be disrupted by active debris slides...”.

Current erosion area

The cut slope erosion should be mitigated as soon as possible before the unstable area further enlarges and causes more damage to the property. Eventually, erosion could enlarge further upslope and affect the residence. Therefore, a stabilization structure to protect the residence should be constructed along the property line just above the erosion area, as shown on Plate 2. The stabilization structure would be intended to halt uphill migration of the downslope erosion. The stabilization structure, consisting of drilled piers connected by a concrete grade beam, will be entirely below the ground surface when completed.

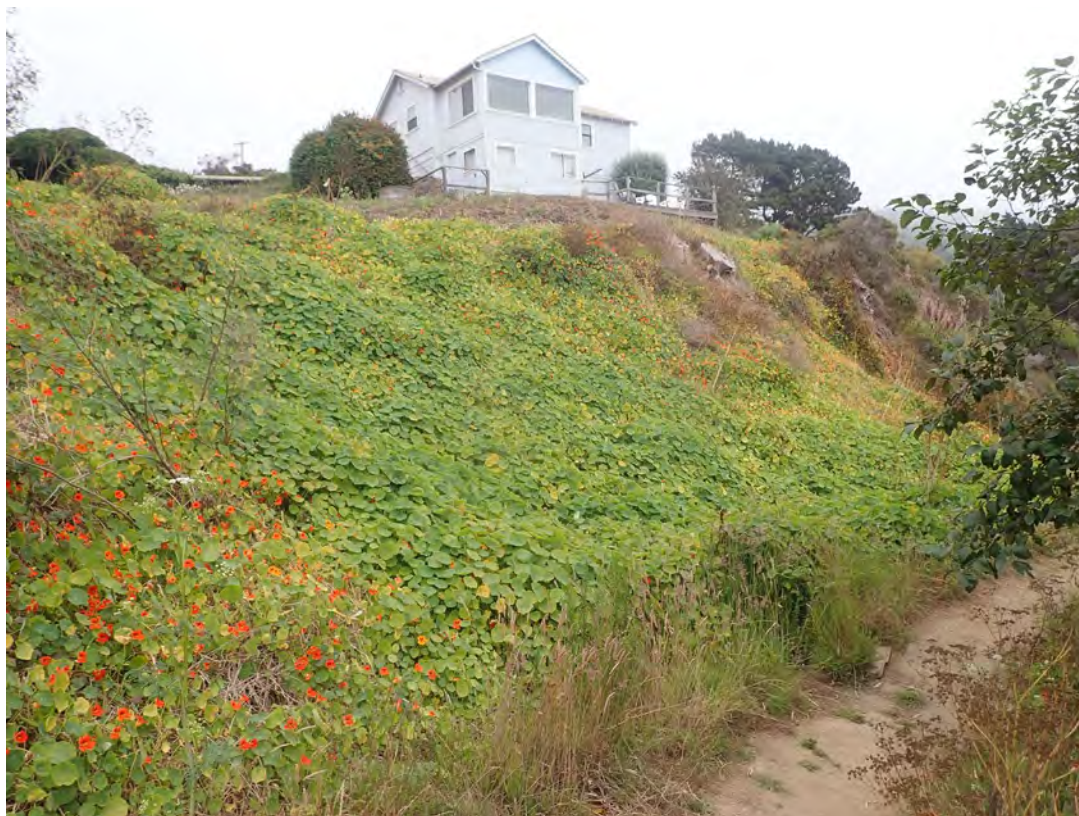
*Figure 5. Non-native plants dominating eroding hillslope beneath residence.*
