Oblique view of 10-acre marijuana-related
illegal timberland conversion –
there was extensive grading

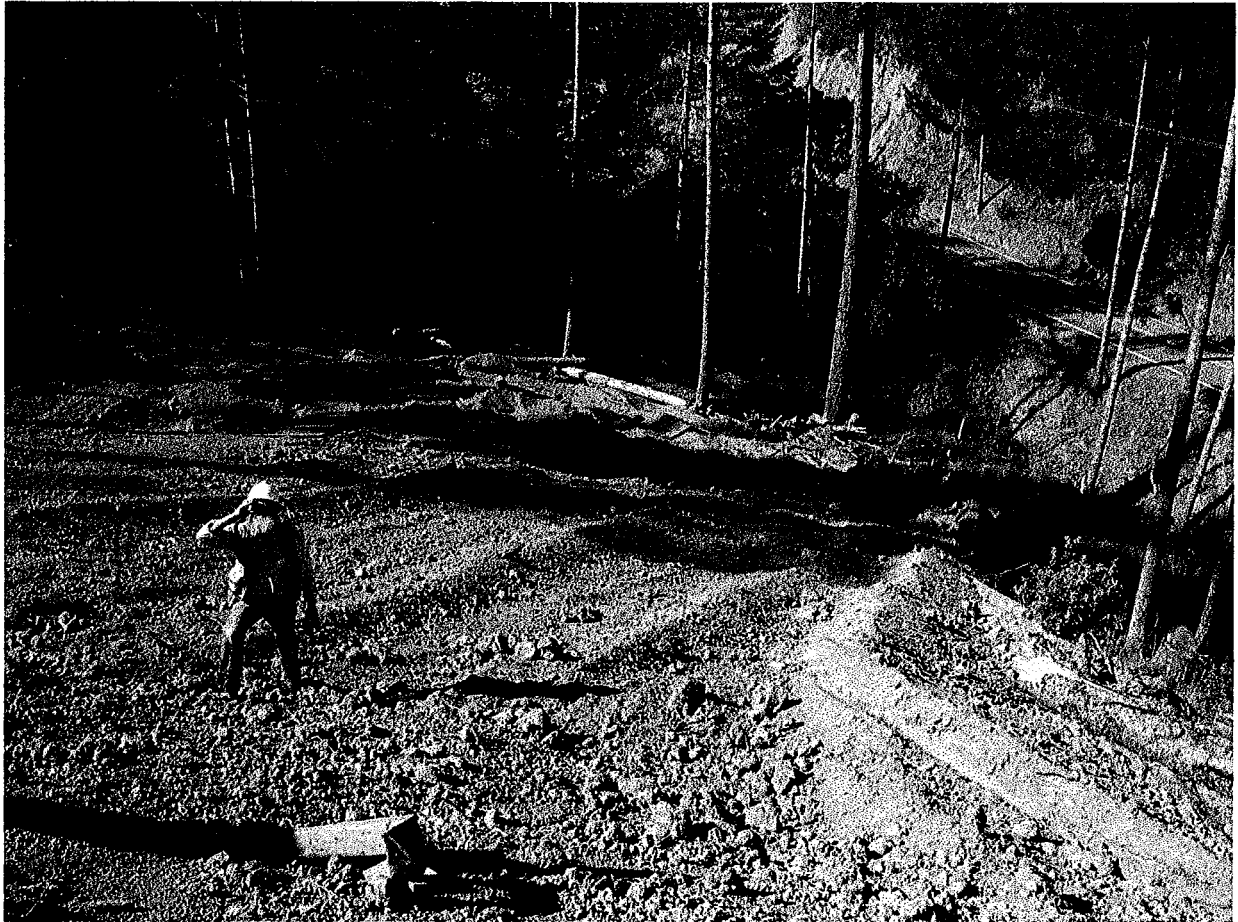
½-acre fill waste area that toes into a watercourse that supports non-fish aquatic species – same property (eventually drains into Tomki Creek then main Eel River system)

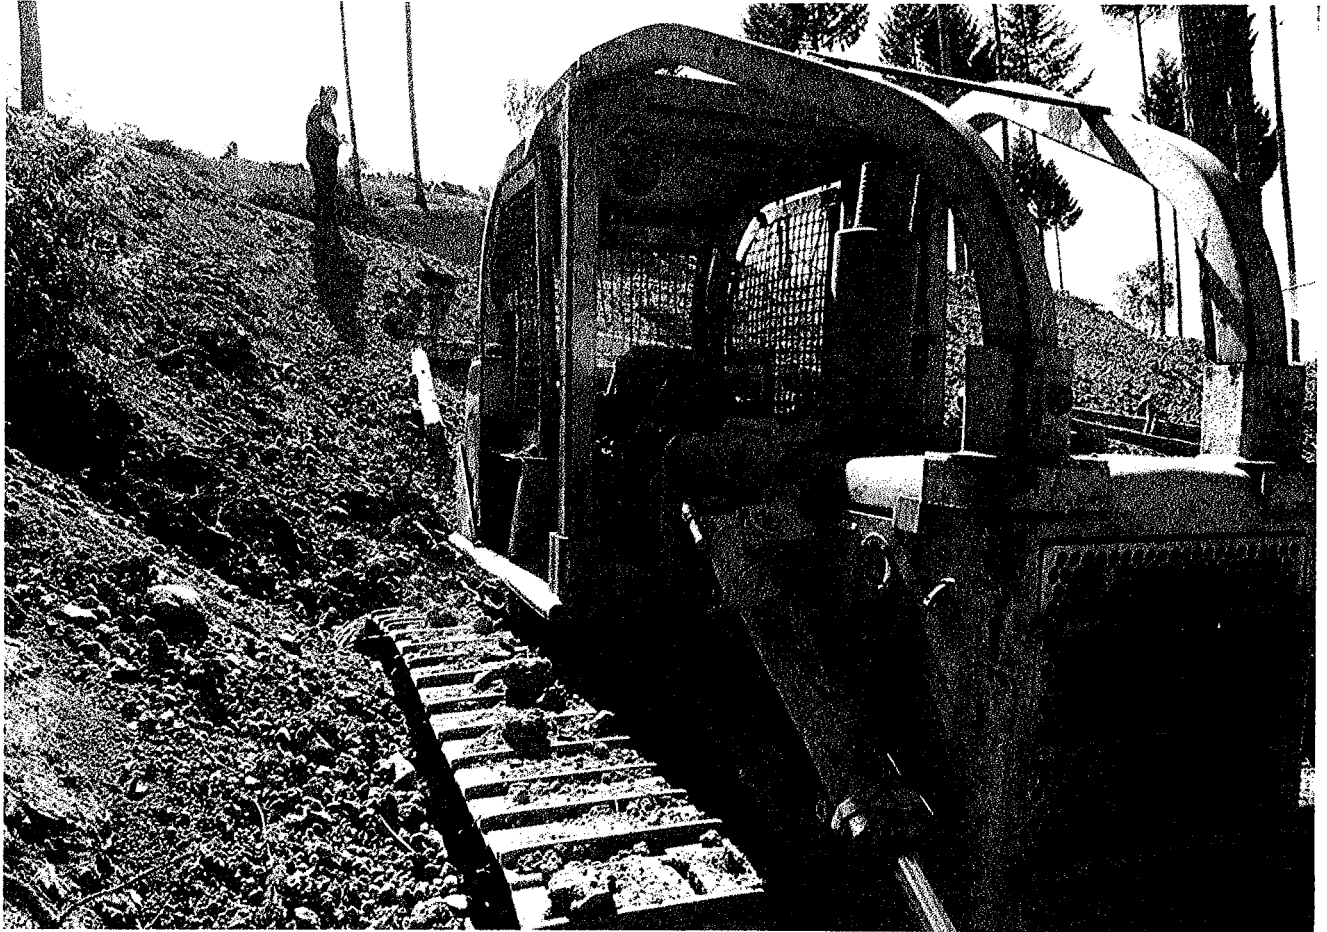
D-5 tractor buried in loose, thick, sidecast soil –
lack of training and experience with heavy equipment use –
the property owner told me he thought he was “... protecting
Mother Nature ...”

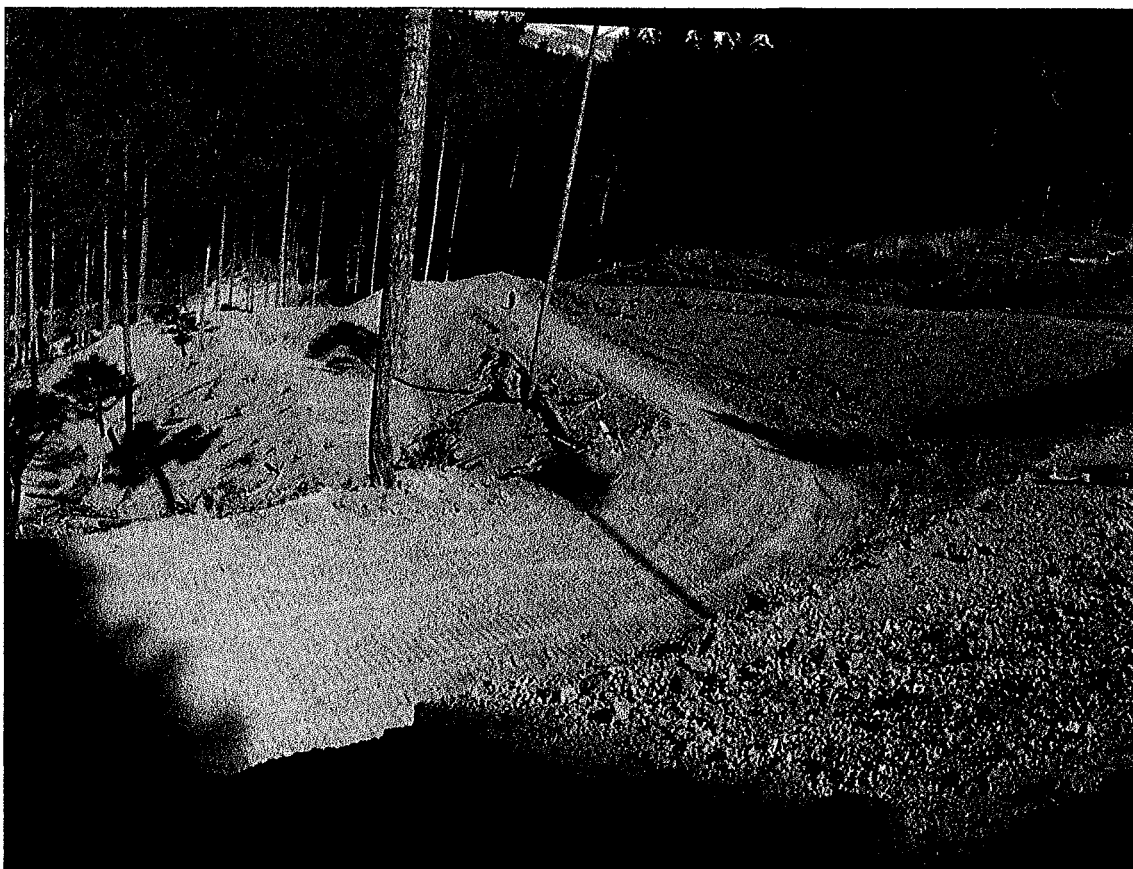
Large scale grading without the
necessary knowledge and experience
of potential resource impacts.

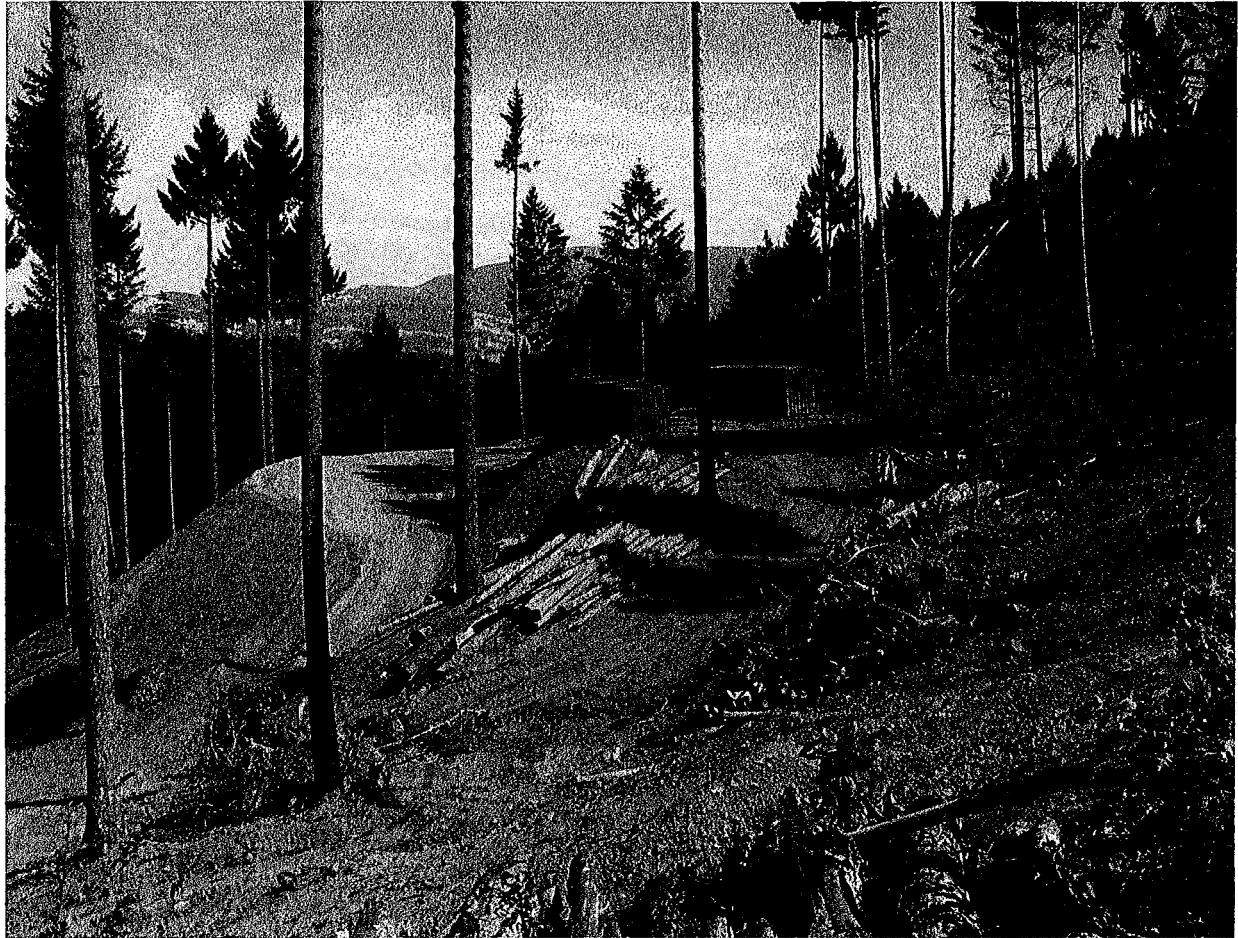
More illegal large scale grading and
lack of understanding of adverse impacts.

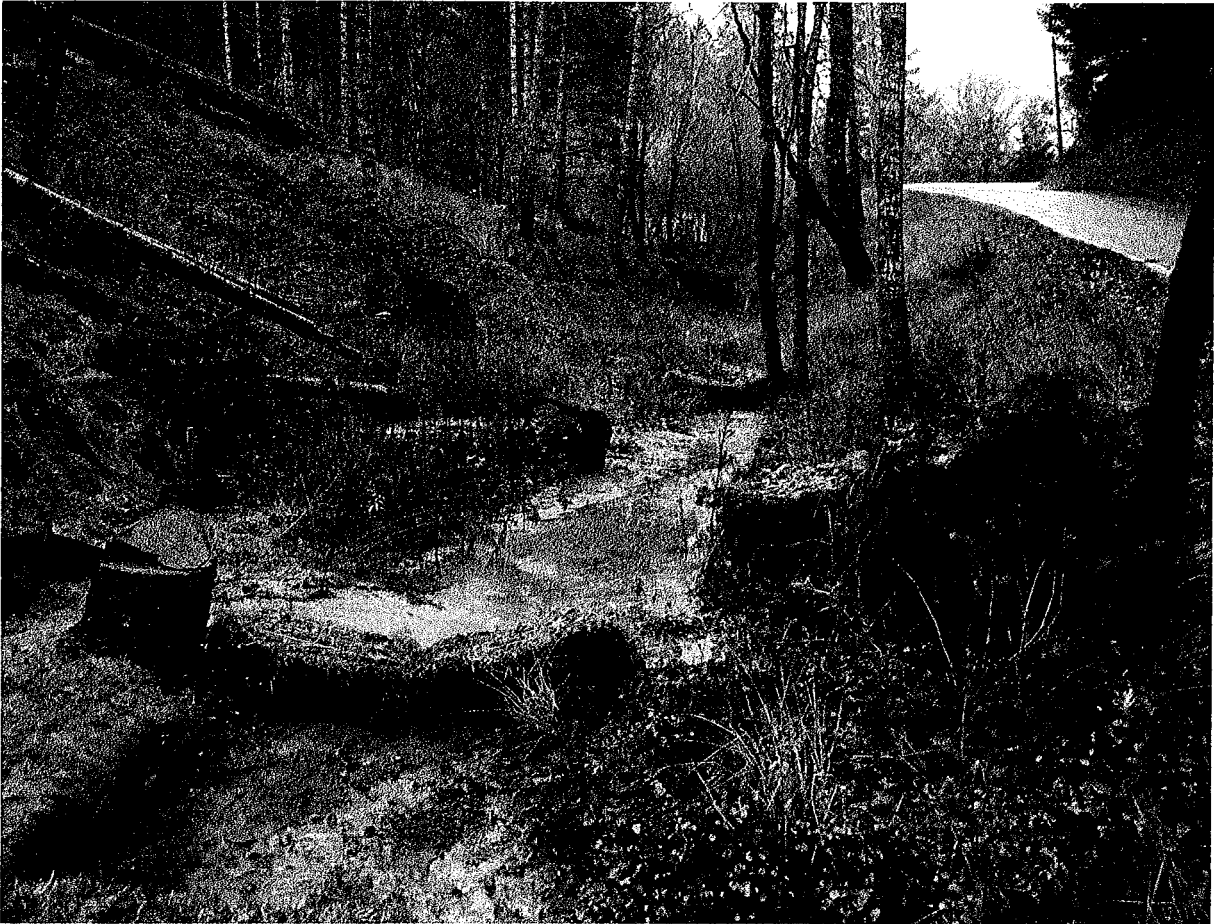
And the impacts do occur –
storm runoff (more aptly sediment/sludge).

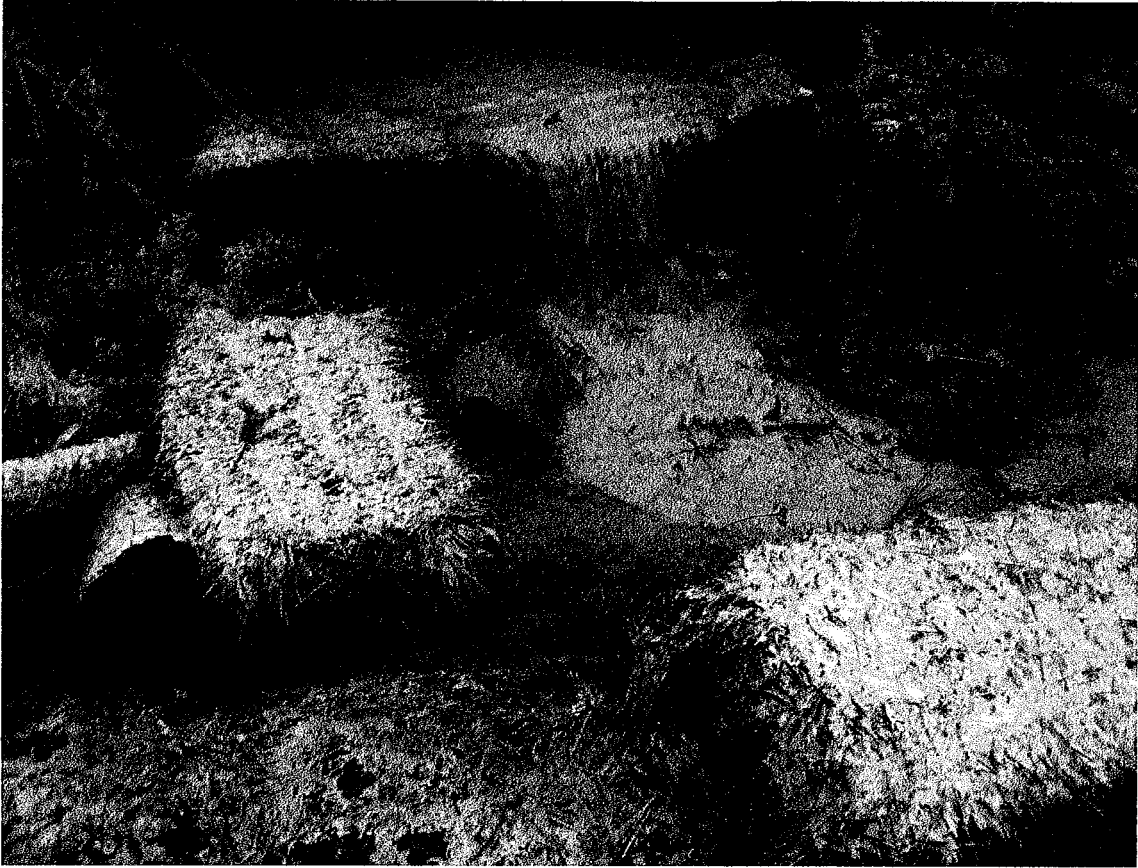
Storm runoff

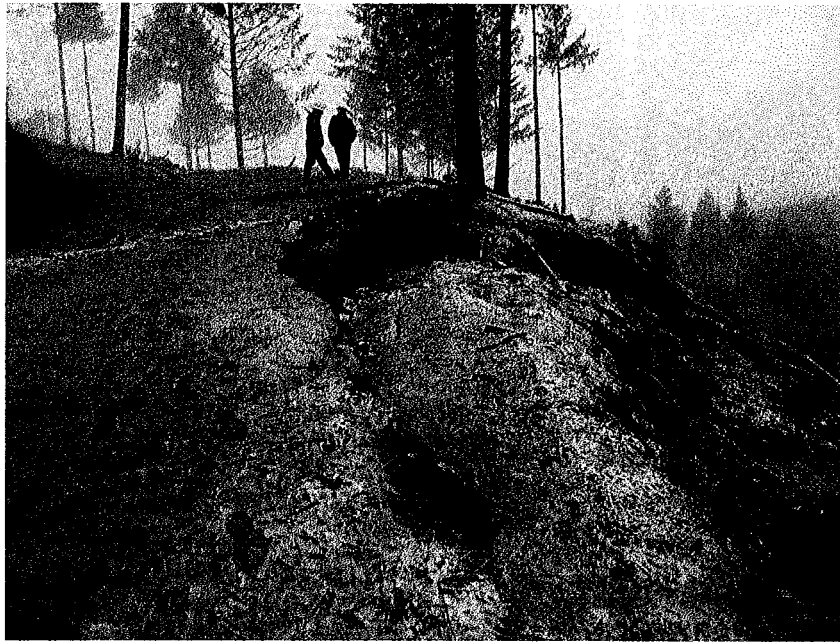
Sidecast failure first winter.
This site is above a well-traveled Mendocino County roadway –
a public safety hazard.

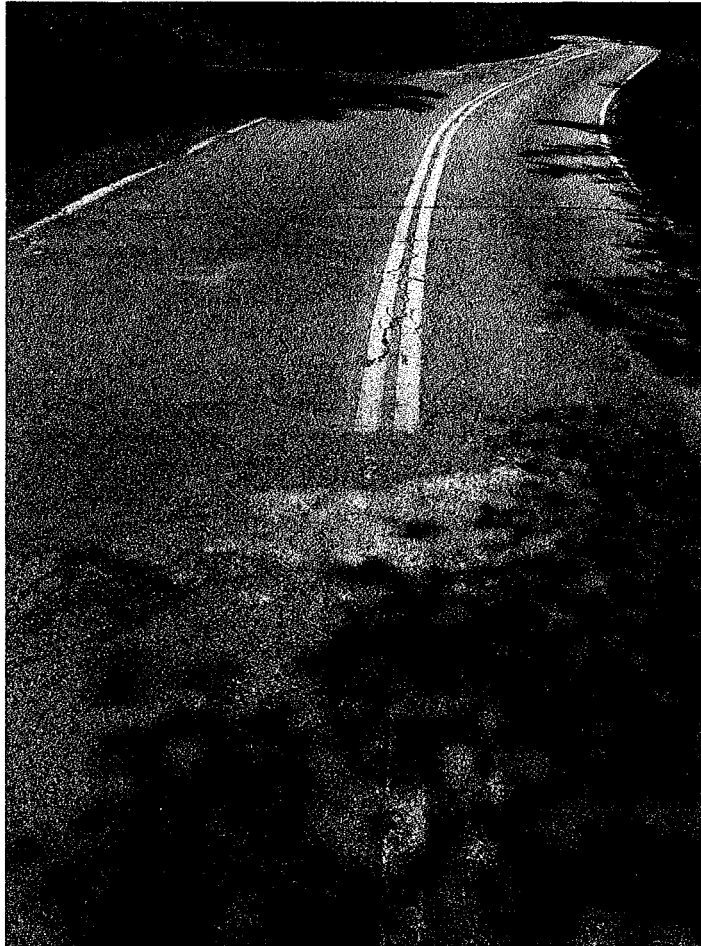
Resulting slope instability from illegal grading caused Mendocino County Road to shift as evidenced by offset double-solid lines.

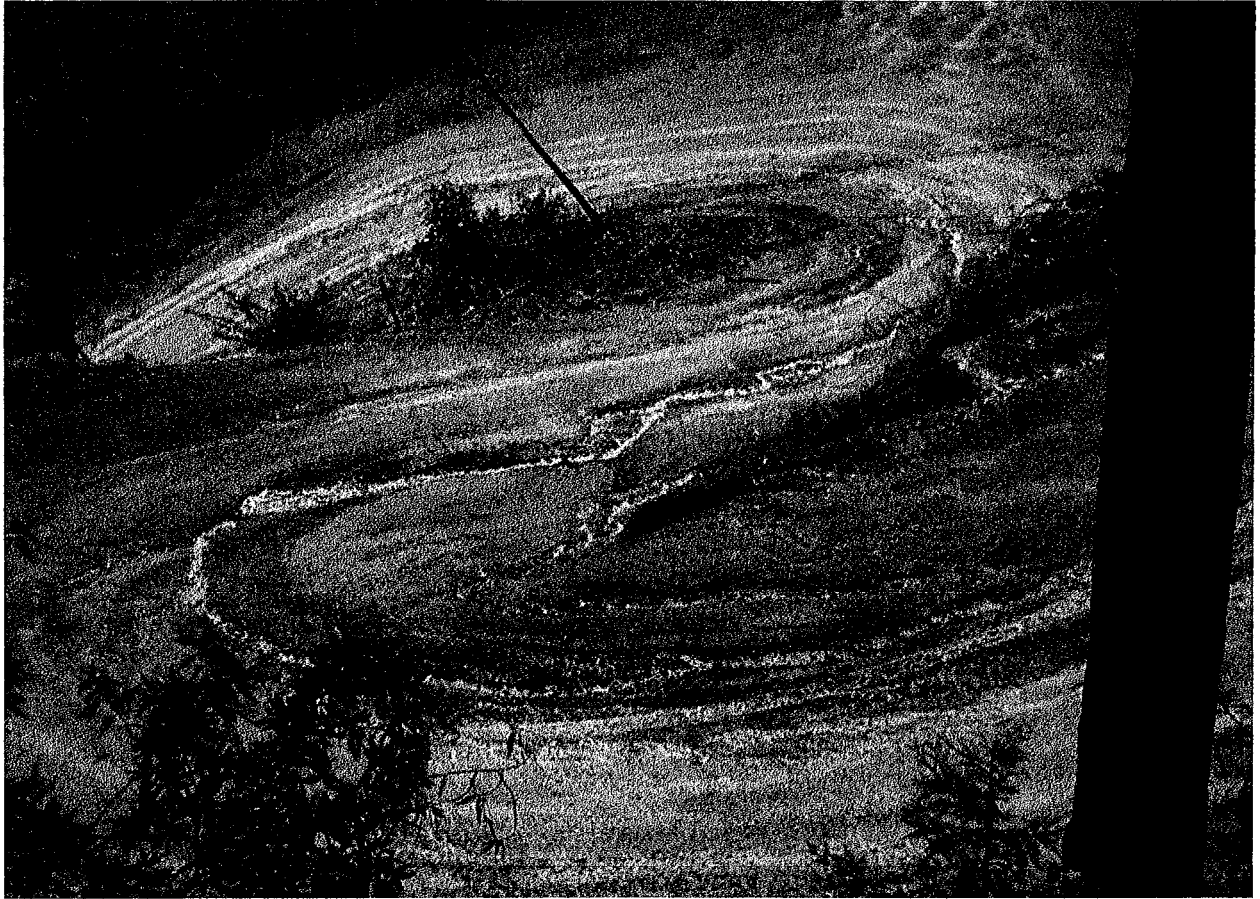
Lack of road maintenance on a poorly designed road system.

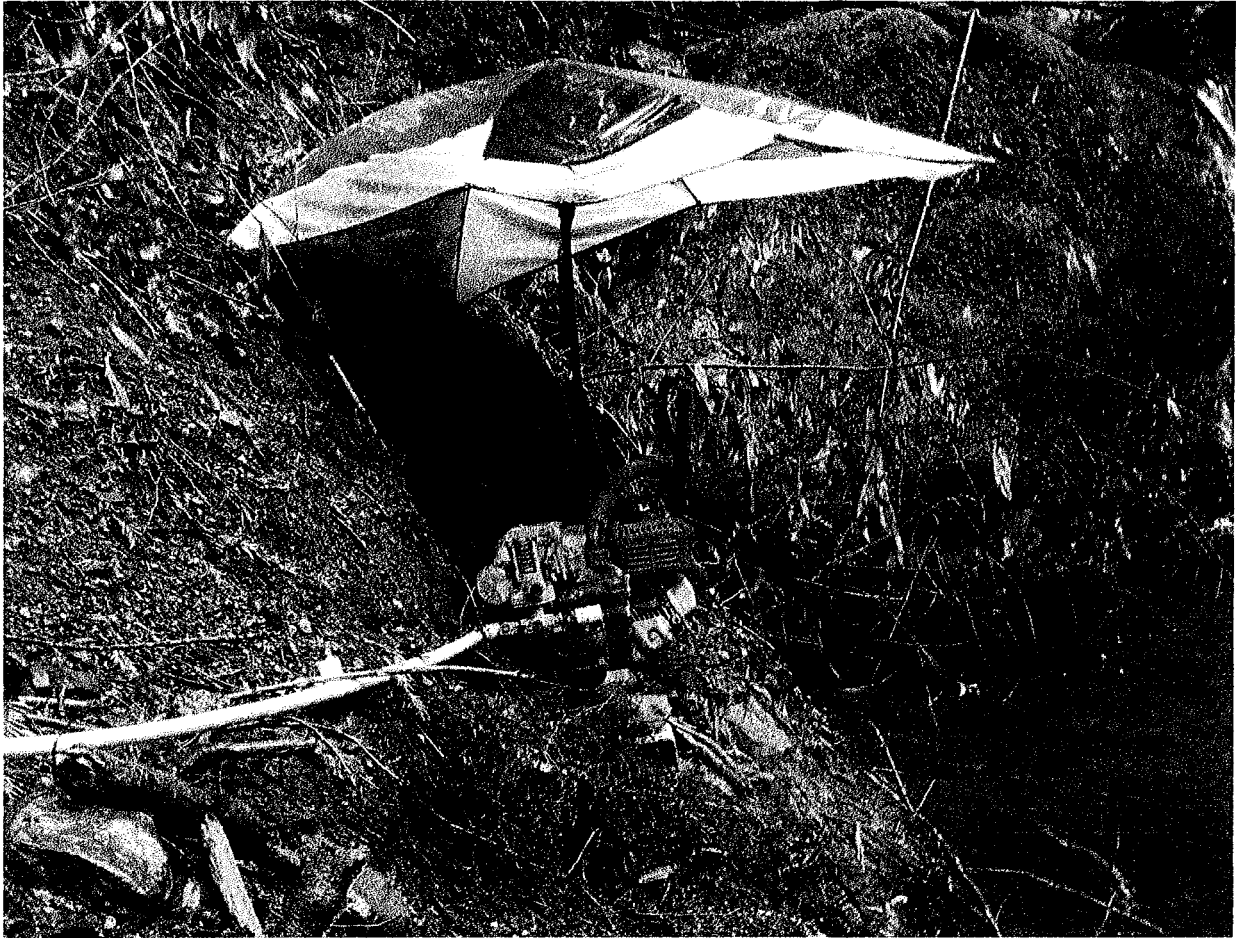
Impoundment of an anadromous fisher-bearing watercourse –
pump diverting water to tank.

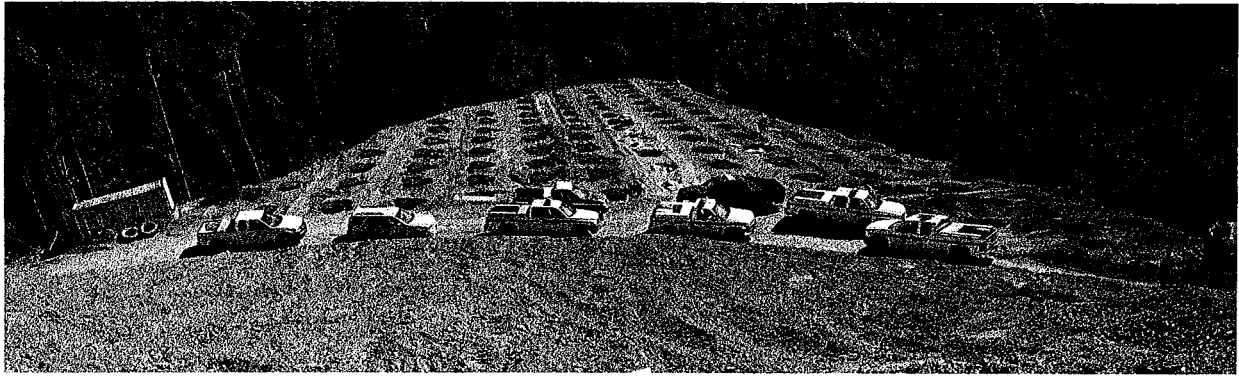
Grading activity (in fact, shaved mountain tops at two nearby locations) on illegally converted timberland sites. These “project” sites were approved under the 9.31 County Ordinance to cultivate 99-plants – the largest of the two (this image) was only ¼-acre in size – the irrigation source was water theft from a neighboring spring – there were two Mexican nationals (laborers) working in adverse conditions and I provided them cool, fresh drinking water that they gratefully accepted – there is lack of accountability regarding labor laws in many cases.

NO ENVIRONMENTAL (CEQA) REVIEW

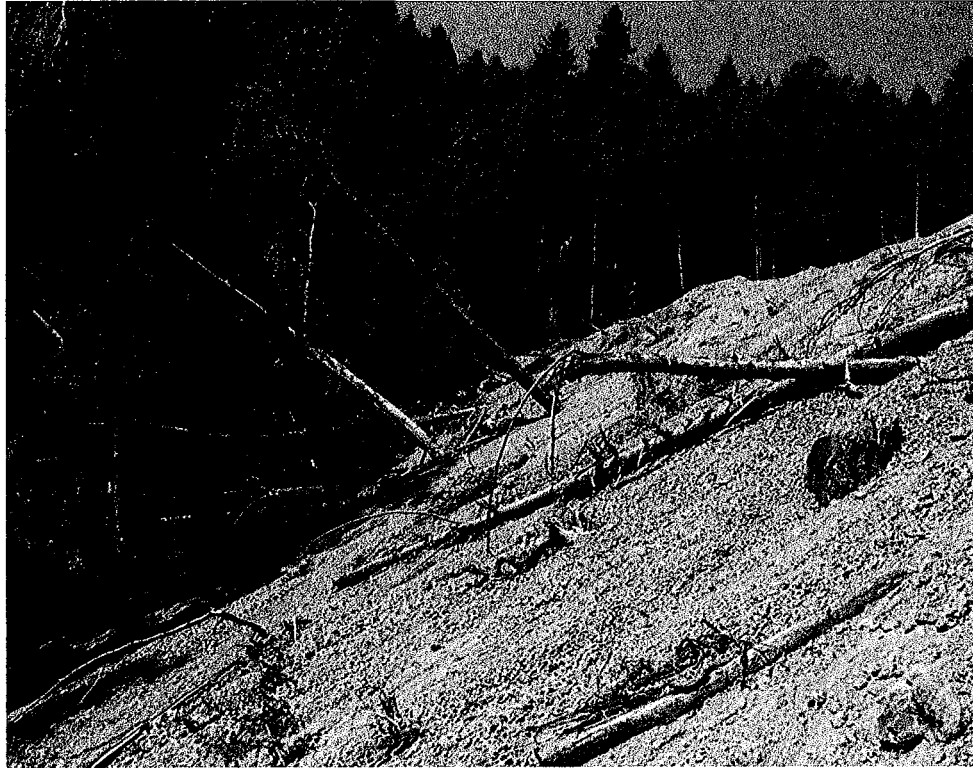
Same 9.31 project -- whole trees buried in unconsolidated (loose) fill on 90% slopes directly over State Highway 101 –

a public safety hazard

Also, young-of-year coho salmon (Federally and State-listed as endangered species) electrofished approximately ¼-mile downstream from this site.

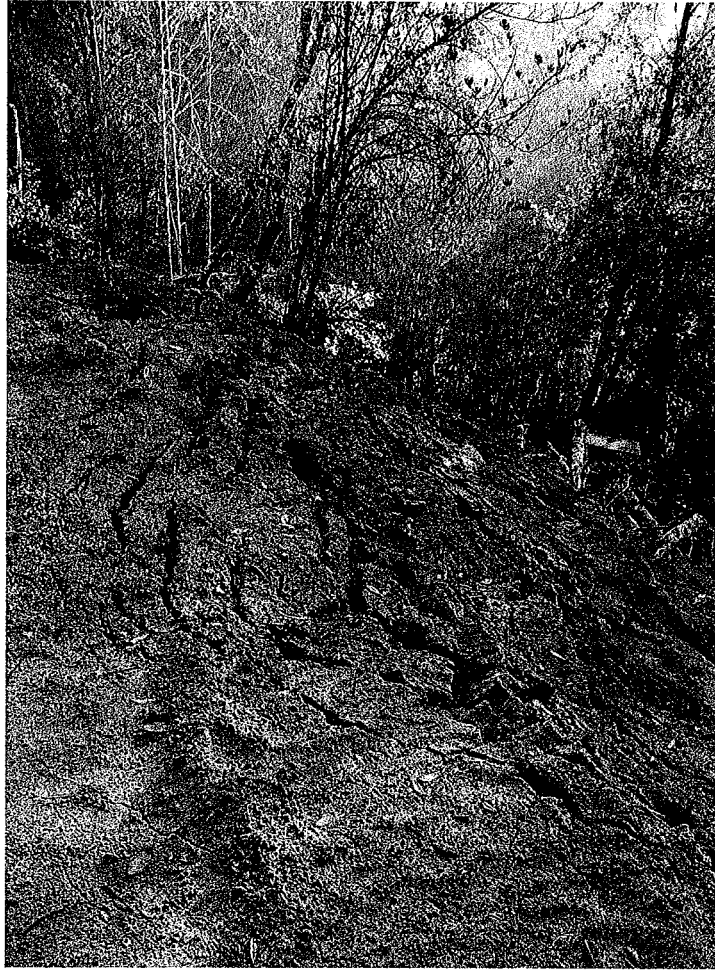
Same approved 9.31 (99-plant) project but on another adjacent illegally converted timbered area grow pad is less than ¼-acre.

Very steep slopes (80-90%) with improperly engineered fill slopes that are tension-cracking, due to gravity, and in a position to fail above State Highway 101 –

a public safety hazard

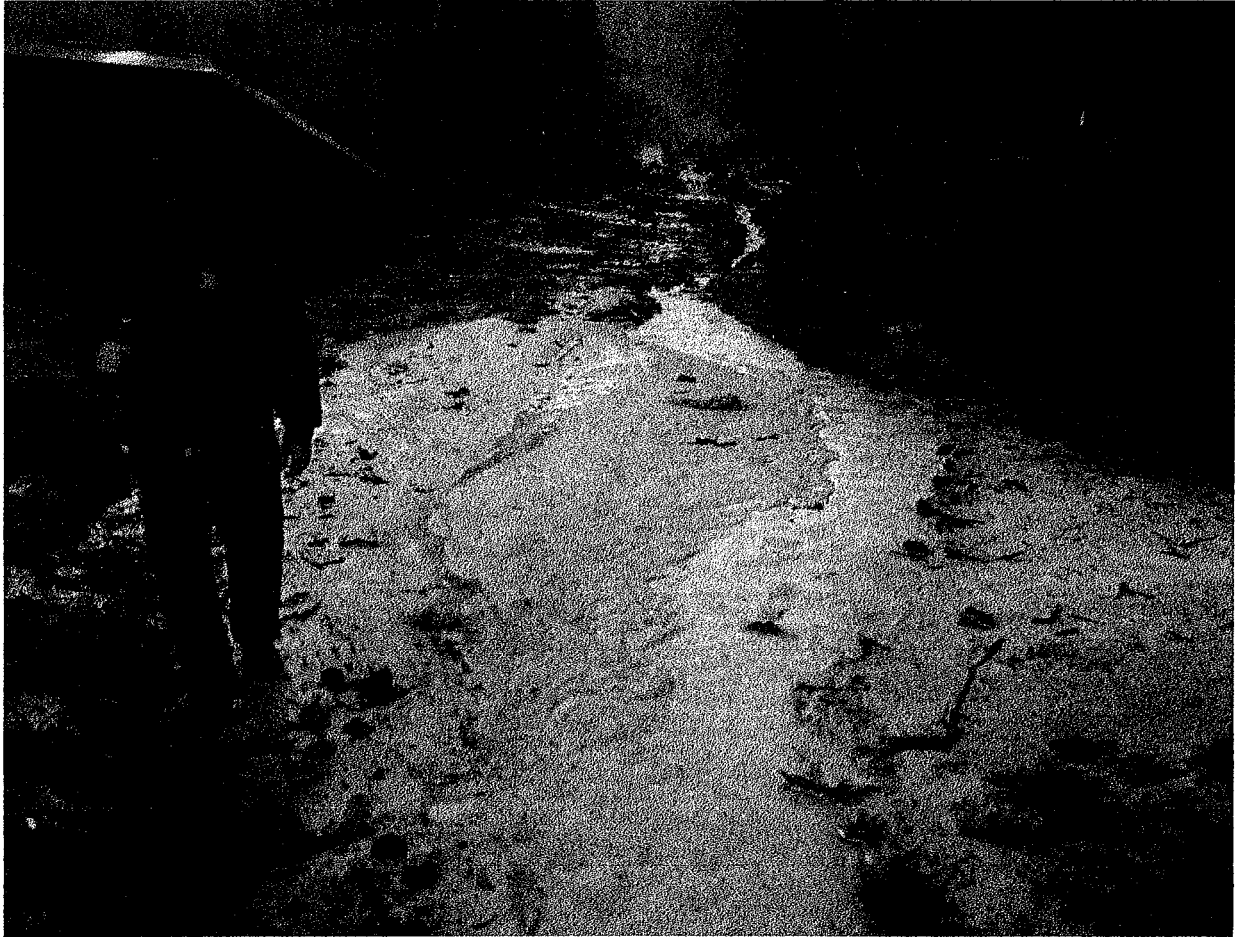
Lack of road maintenance – the excess sediment drains into watercourses that support Federally- and State-listed anadromous fish.

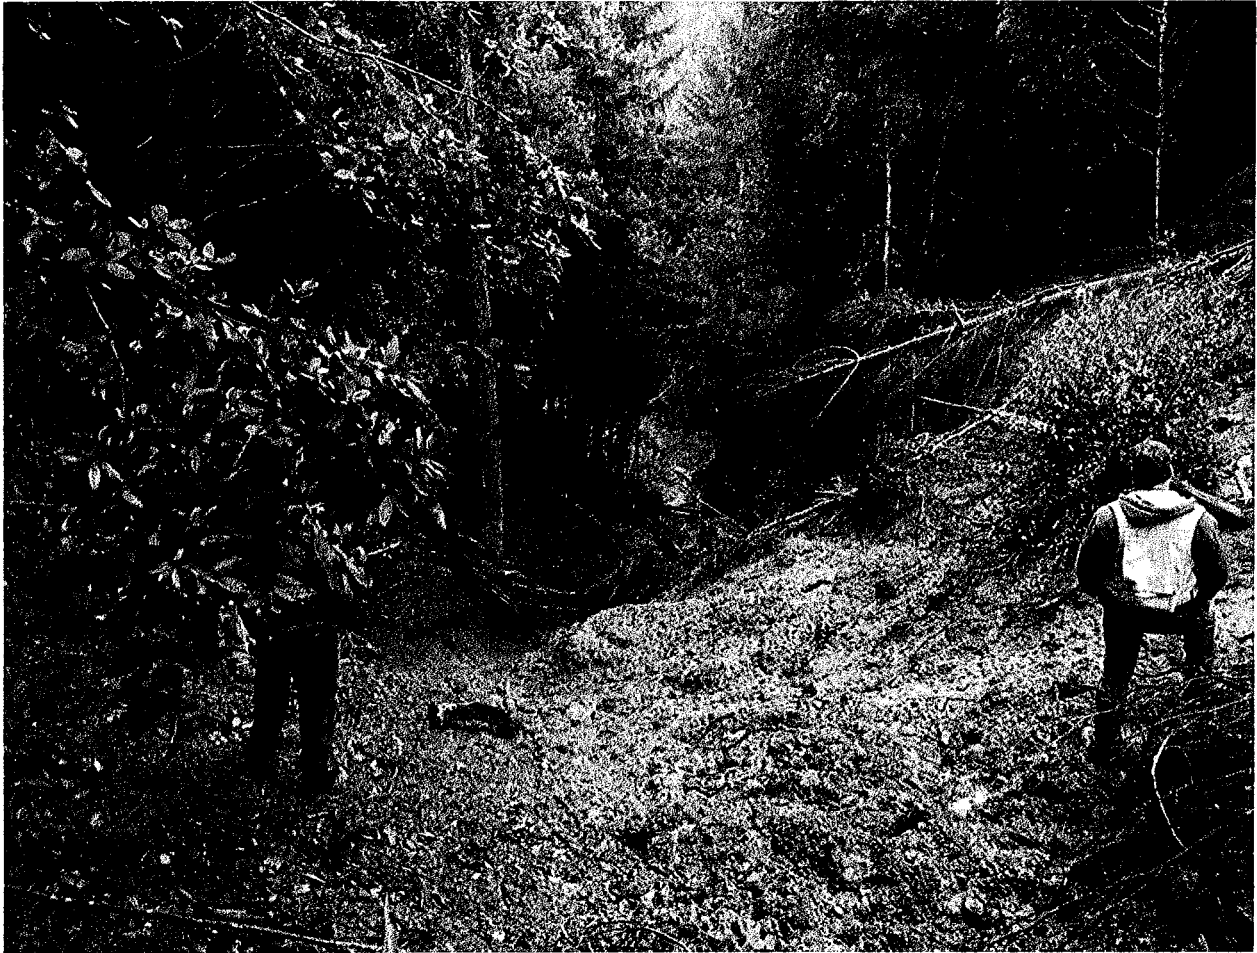
1/4-mile translational/rotational landslide with a debris torrent track which impacted three properties, toed into a stream supporting non-fish-bearing aquatic plant and animal species, and blocked road access in two places at a switchback to the neighboring property –

and by the way the landslide was triggered by tree cutting and terracing for marijuana cultivation and an illegally constructed house with improper drainage resulting in the landslide's head scarp being only five-feet from the house's roofline.

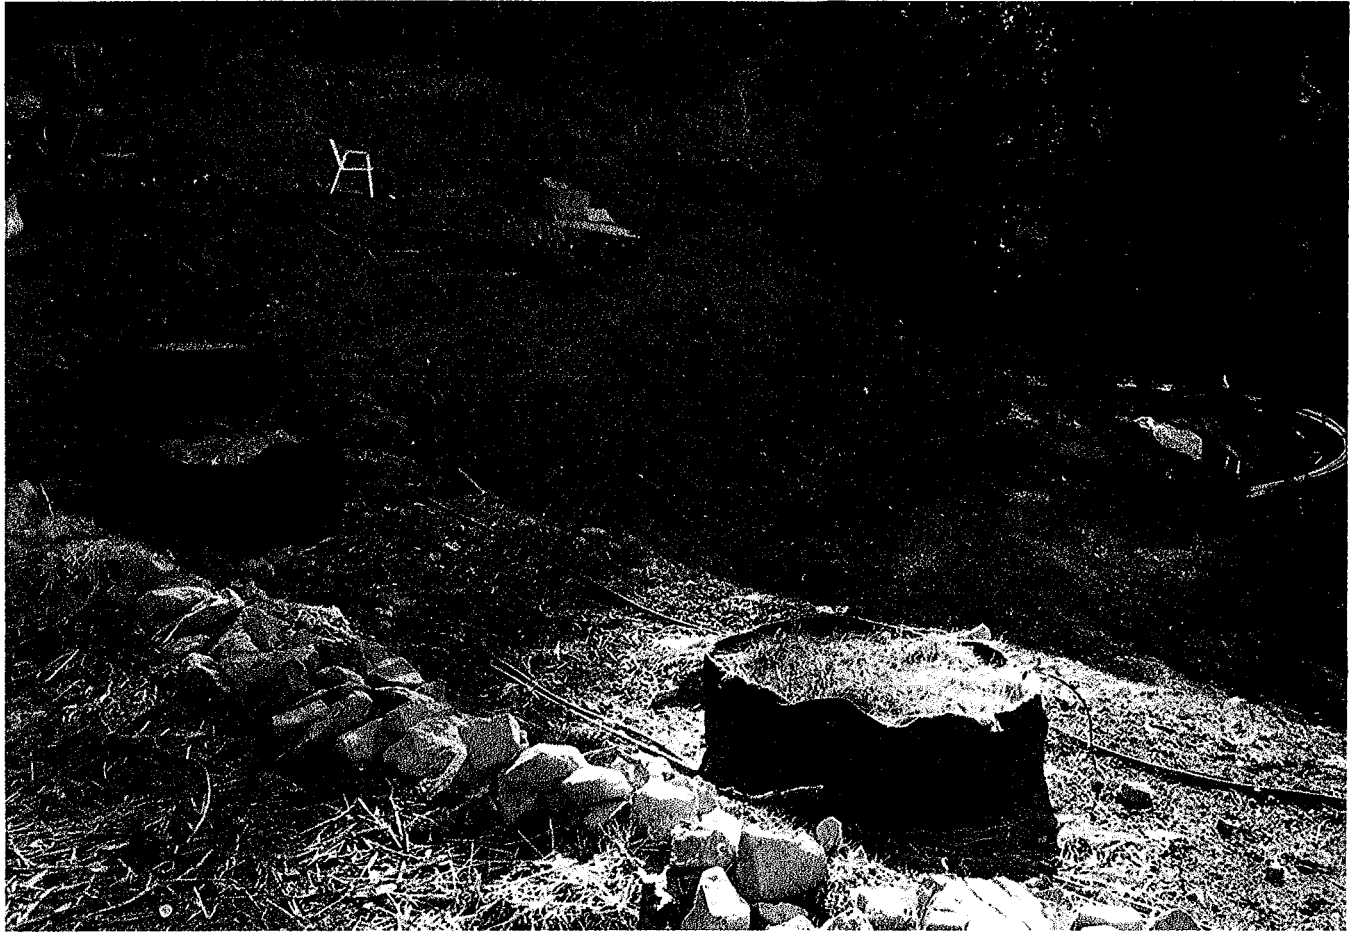
Terracing directly above a headwall swale and above of a seasonal watercourse – I was told by the growers they thought there was nothing wrong with this practice – note the erosion at the right-hand side of the photo.

A certified engineering geologist would likely tell you that given a certain set of conditions this practice is a potential landslide trigger. Without proper engineering geologic investigation and analysis (CEQA-driven) potential impacts would be impossible to determine until the damage was done.

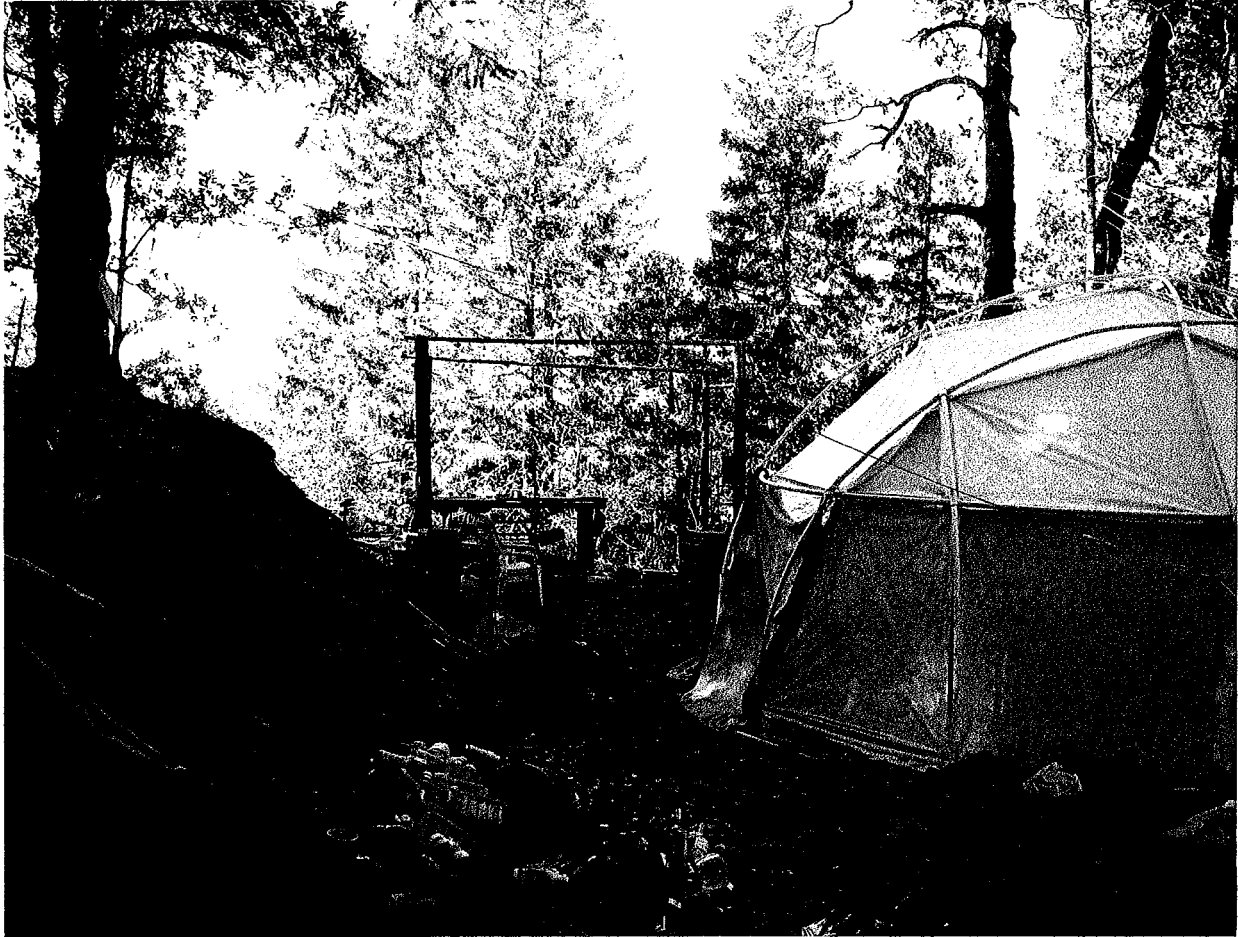
Illegal dwellings and trash – very commonly associated with marijuana grows. Amnesty should no longer be applied to illegal dwellings.

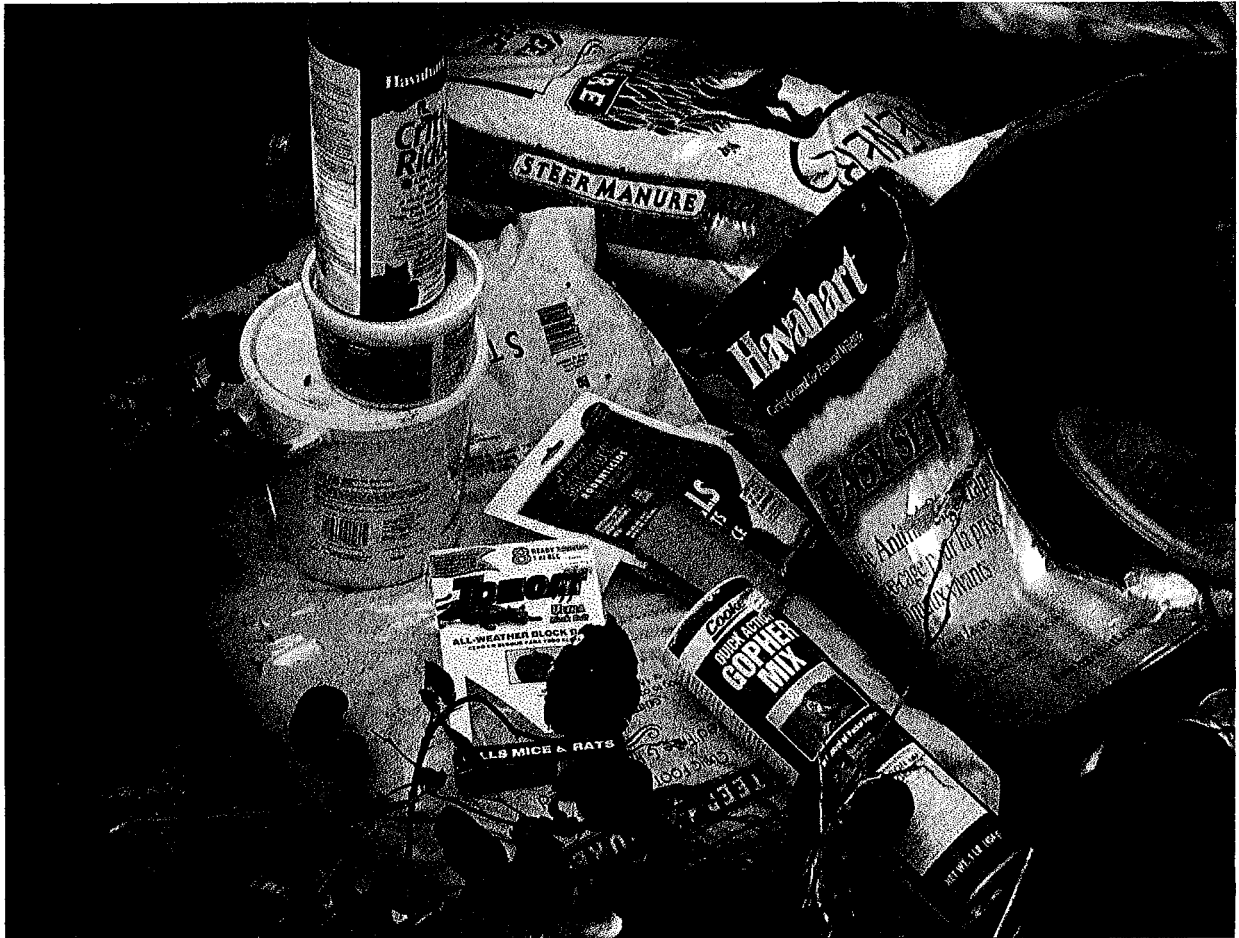
Poisons applied mainly in the form of rodenticides, but not always. Plus other organophosphate pesticides and heavy fertilizers frequently applied.

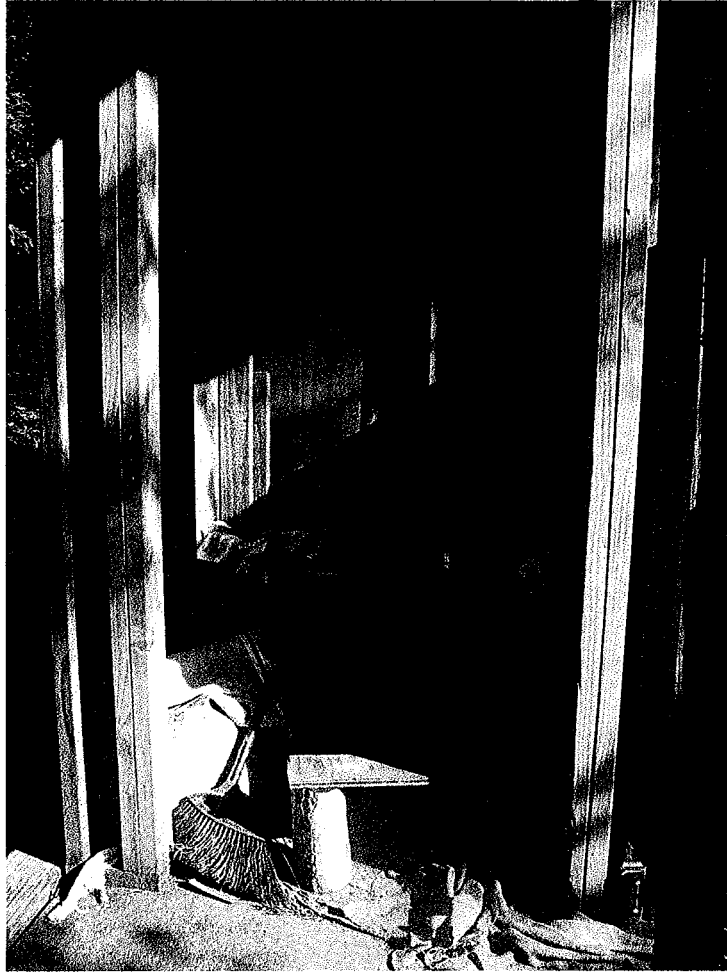
Pit latrines are also very common – they generate pathogens from improperly treated human waste.
