Eel River Monitoring and Water Quality Awareness Pilot Project Final Report

The Eel River Recovery Project

Funded by the CA Water Resources Control Board *Grant Agreement 14-679-550*

April 15, 2015

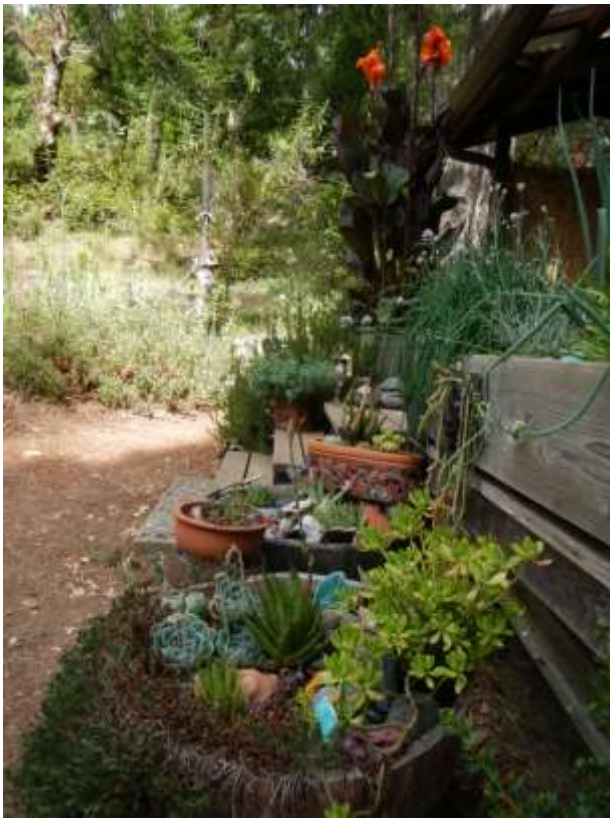
Figure 7 Planter boxes and pots watered with grey water. Fool's Farm 6/20/16.

Kyle Keegan provided data on rural residential water use when water conservation is put into full practice. His family of three uses less than 40 GPD or less than 15 GPD per family member. They achieve savings by taking showers of no more than two to three minutes, which use about a gallon a minute. Dish water and shower water are captured and distributed in a grey water system that waters garden spaces and pots through drip systems and by direct application.

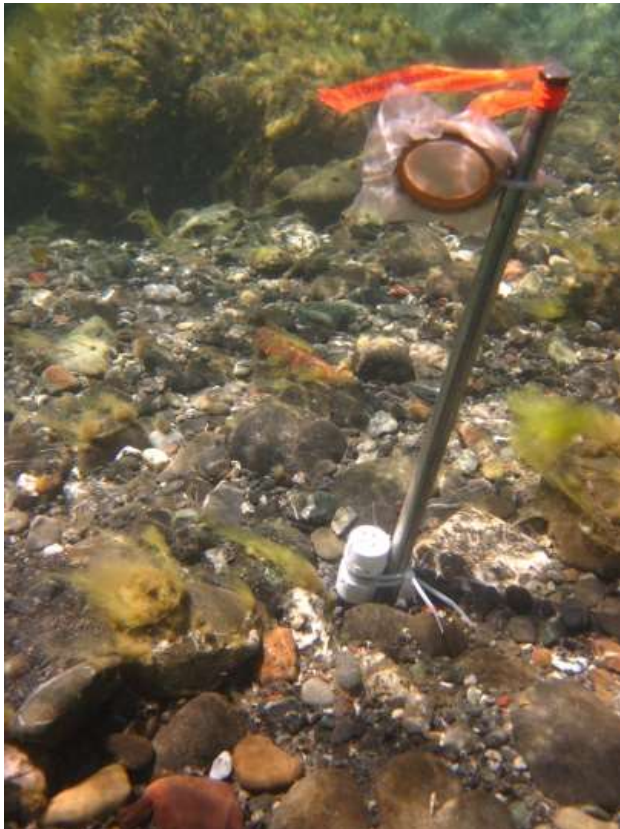
Figure 9 Alderpoint SPATT at top and encased I-Button temperature gauge below.

Outreach to and Monitoring Cooperation with Small Water Districts (Task 1.5.1) ERRP initiated contact with the Redway Community Services District (RCSD), the Garberville Services District (GCSD) and the Alderpoint Water District (AWD) to explore cooperative monitoring at the beginning of the project. Although there was some interest from RCSD Board Chair Michael McKaskle, their staff thought it premature for their participation in 2015 monitoring, and GSD Executive Director Ralph Emerson also declined participation. Despite numerous attempts, ERRP was never able to establish contact with the AWD. To fulfill the requirements of this grant, ERRP took initiative and deployed SPATTs upstream of the GSD and RCSD intakes on the South Fork Eel River and on the main Eel River proximate to the AWD intake at Alderpoint. ERRP volunteer Larry Bruckenstein helped cleaned and replace the SPATT below Sproul Creek from July through September 2015 and volunteer Willie Grover assisted with the Alderpoint SPATT . ERRP placed SPATTs above the intake for the AWD.

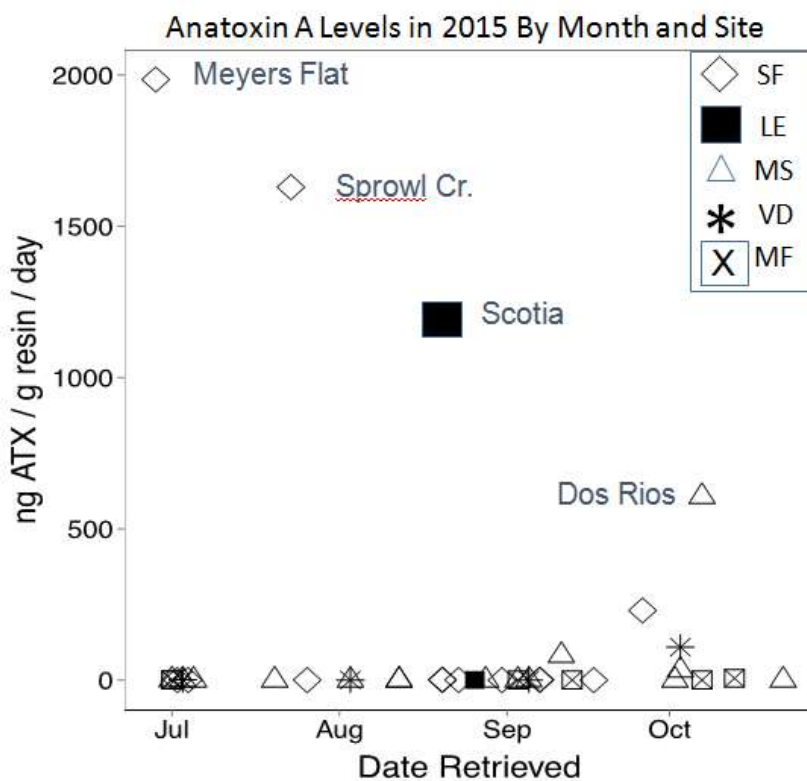
Figure 11 Chart indicating the highest levels of ATX in July and August on South Fork and lower Eel in September.

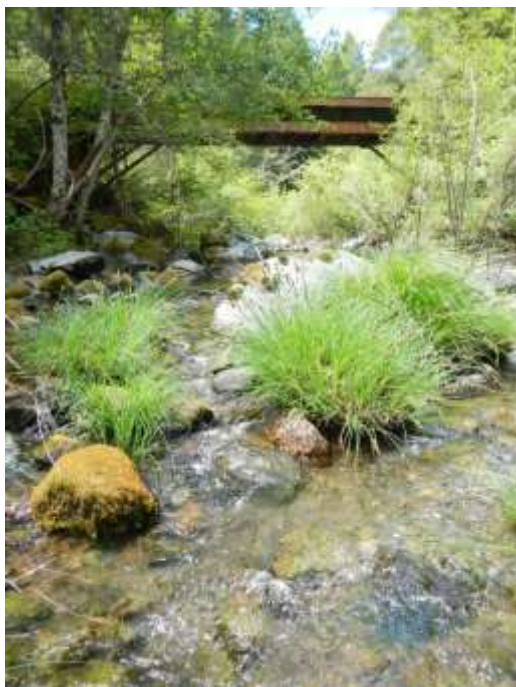
Figure 12 South Fork Eel River tributary Redwood Creek just above the convergence with Seeley Creek. May 22, 2015.

Photo points: Grant requirements specified that photopoints be established at all ERRP temperature probe locations, with photos taken in an upstream and downstream direction. In addition to photos at the time of probe placement and retrieval, the proposal specifies that photos also be taken during a mid-season probe check. These requirements were based on a grant opening date of April 2015, but the grant did not open until May. Probe placement was as late as July at some locations and time did not allow for a mid-season check or taking associated photos. However, photopoint locations have been augmented to include sites where no probes were placed in order to provide records of channel changes over time and to document low flow conditions throughout the Eel River basin. Also, ERRP personnel visited a number of locations where probes were to be placed, only to find the stream reach dry. Photopoints were established at these sites although probes were not in use there. Observations and photo documentation of stream desiccations provided the basis for the development of the map of dry stream segments that are part of the final report and are posted to the Internet as well. Photos have been acquired for 114 locations throughout the Eel River basin and are posted to the Internet and linked in Google Earth maps ([See Map](#)).

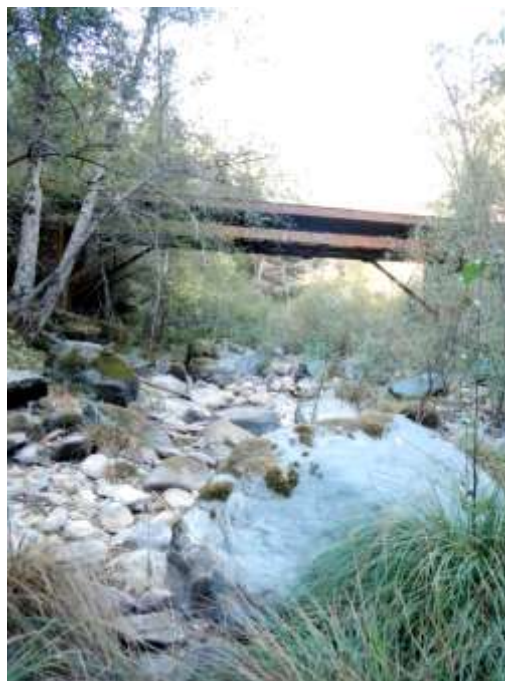
Figure 13 Redwood Creek lacking surface flow on October 3, 2015.

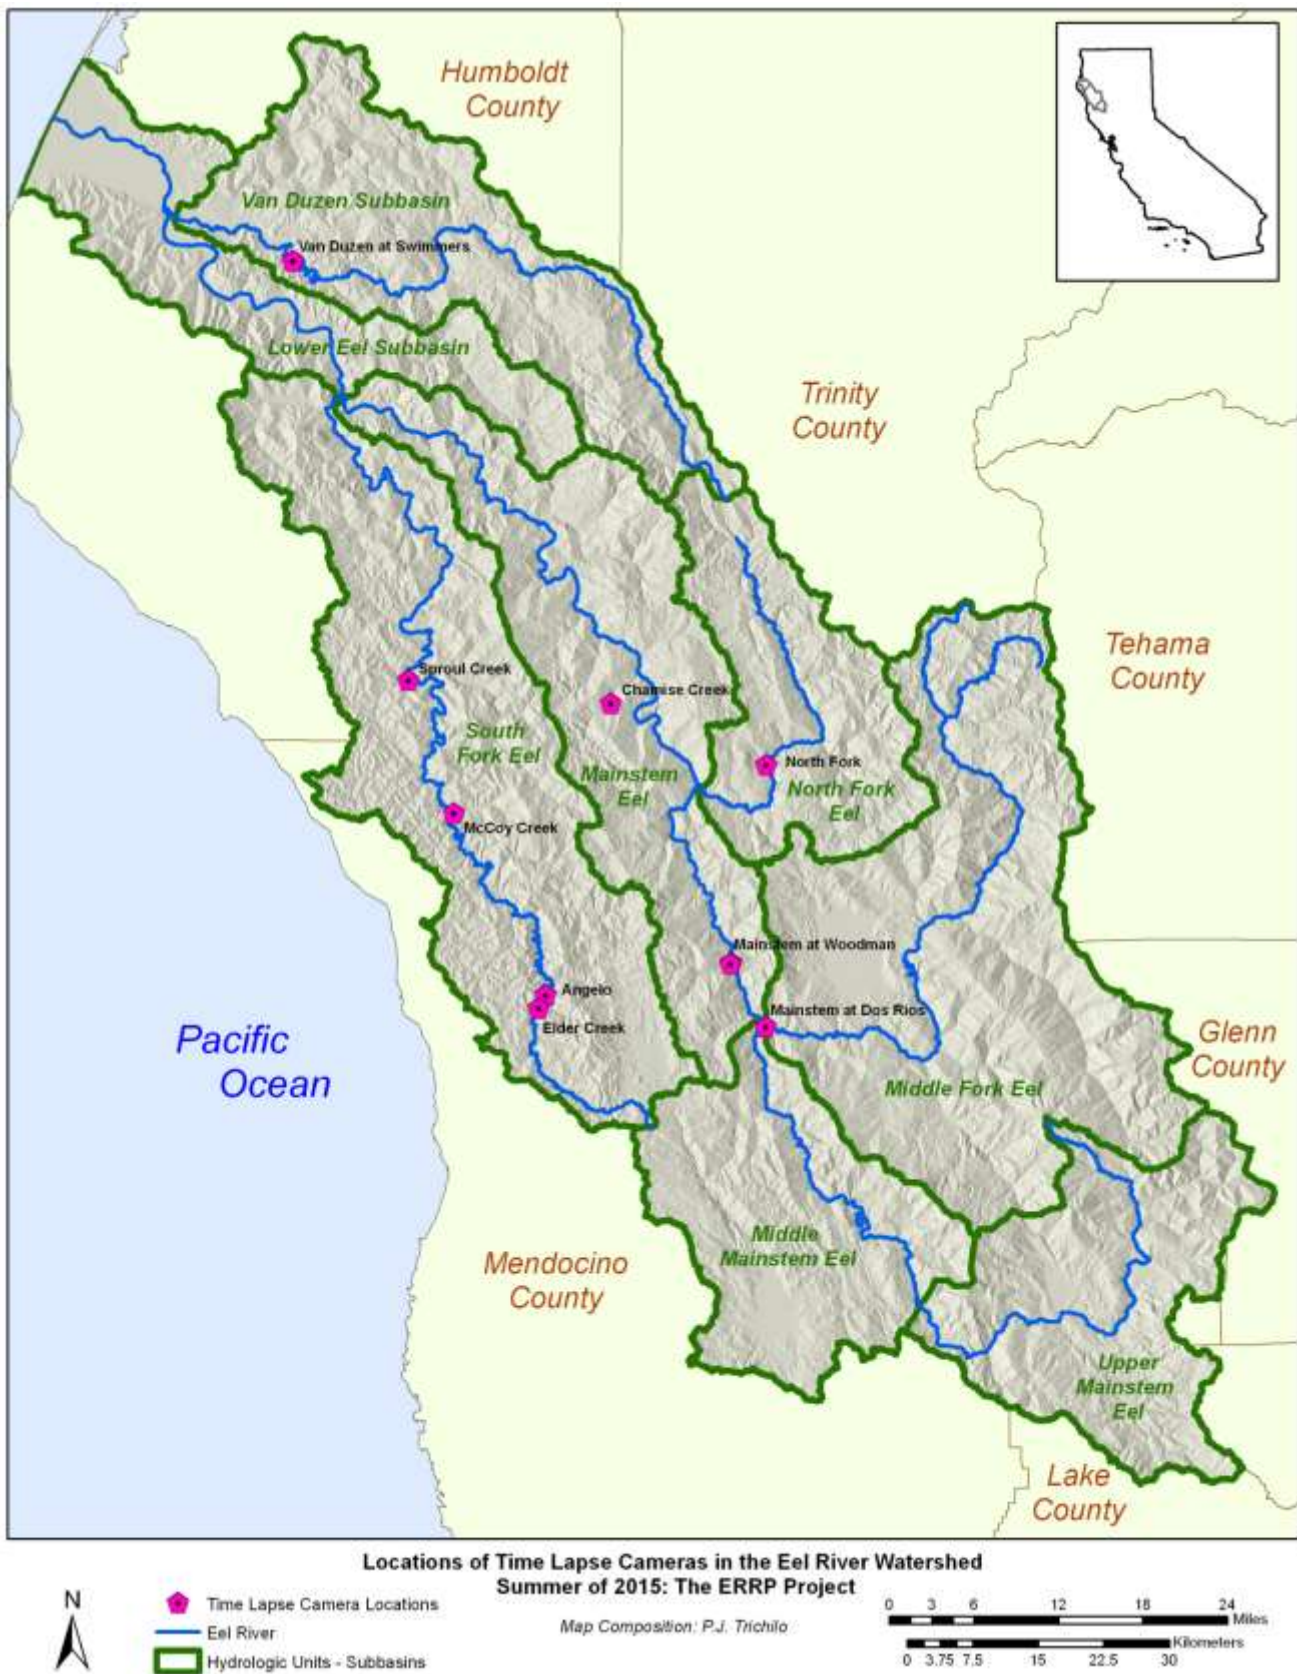
Figure 14 Map of time-lapse camera locations.

Time Lapse Cameras (2.1.4, 2.2.2, 2.2.3) Ten time-lapse cameras were purchased and placed in cooperation with the assistance of volunteers at strategic locations throughout the Eel River basin (Table 4). This was a new activity for ERRP and results from time lapse camera placement were less than optimal at some locations, but very useful at others. Camera imagery illustrates drought stress at some mainstem Eel River locations as well as in tributaries where baseline conditions can be established for flow monitoring. See the location of time-lapse cameras (Figure)

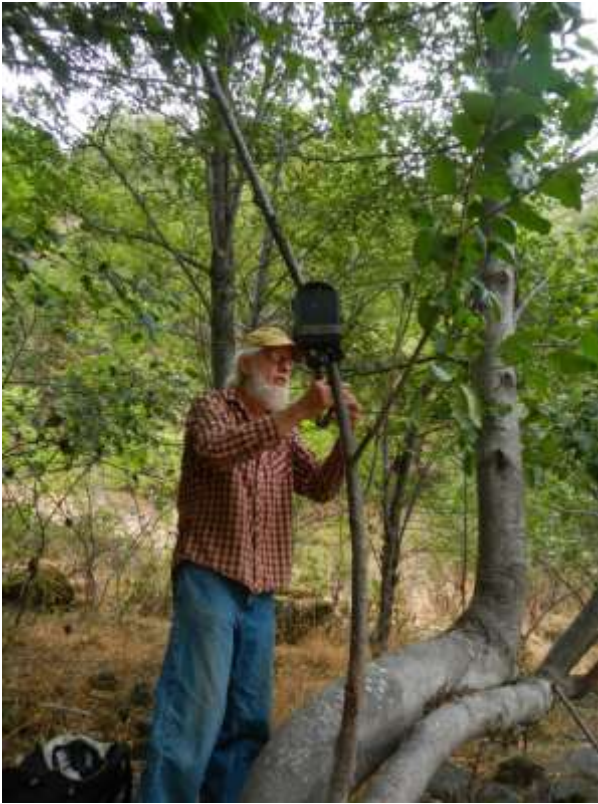
Figure 15 Volunteer Proud Savage tightens clamps holding Chamise Creek time lapse camera. 8/28/15.

Chamise Creek: This stream has an important steelhead population and joins the middle fork mainstem Eel River from the west side just downstream of Island Mountain. Volunteer Proud Savage has deployed water temperature gauges in the creek on his property since 2012 and allowed placement of the time lapse camera in 2015. The camera was placed on August 28 and imagery was downloaded on January 10, 2016. While Chamise Creek maintained surface flow at the location of the camera, flow was disconnected in a reach just upstream. The flow fluctuation shown in the composite film of the time-lapse imagery is dramatic with videos for both July-Dec 2015 <https://vimeo.com/152285876> and early 2016 <https://vimeo.com/162623242>.

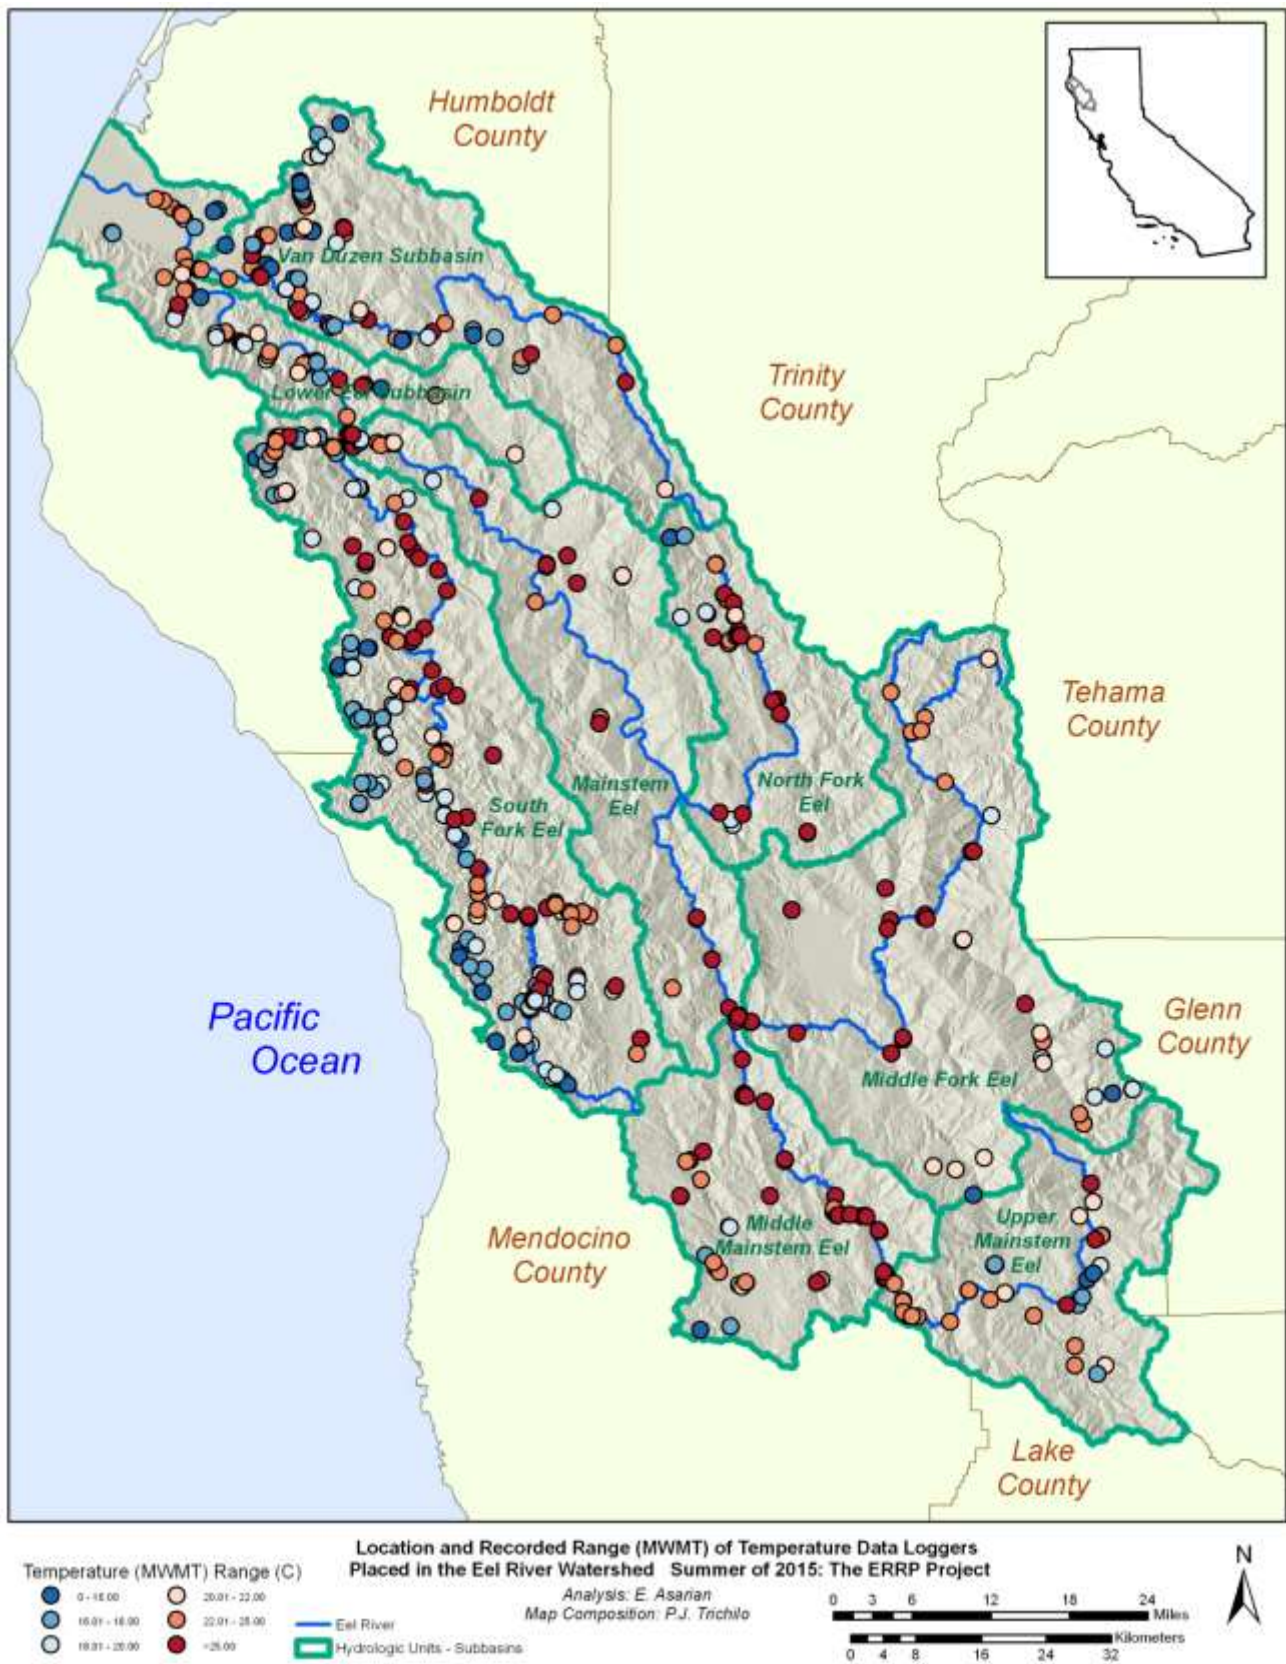
Figure 16 All Eel River water temperature monitoring locations with color coding based on the average of maximum floating weekly maximums (MWMT) for all years of data from 1980 to 2015.

Temperature Range	Steelhead Suitability	Color Code
< 16 C	Optimal	Dark Blue
16 C – 20 C	Suitable	Light Blue
20 C – 25 C	Stressful	Yellow
25 C – 28 C	Acutely Stressful	Orange
> 28 C	Lethal	Red

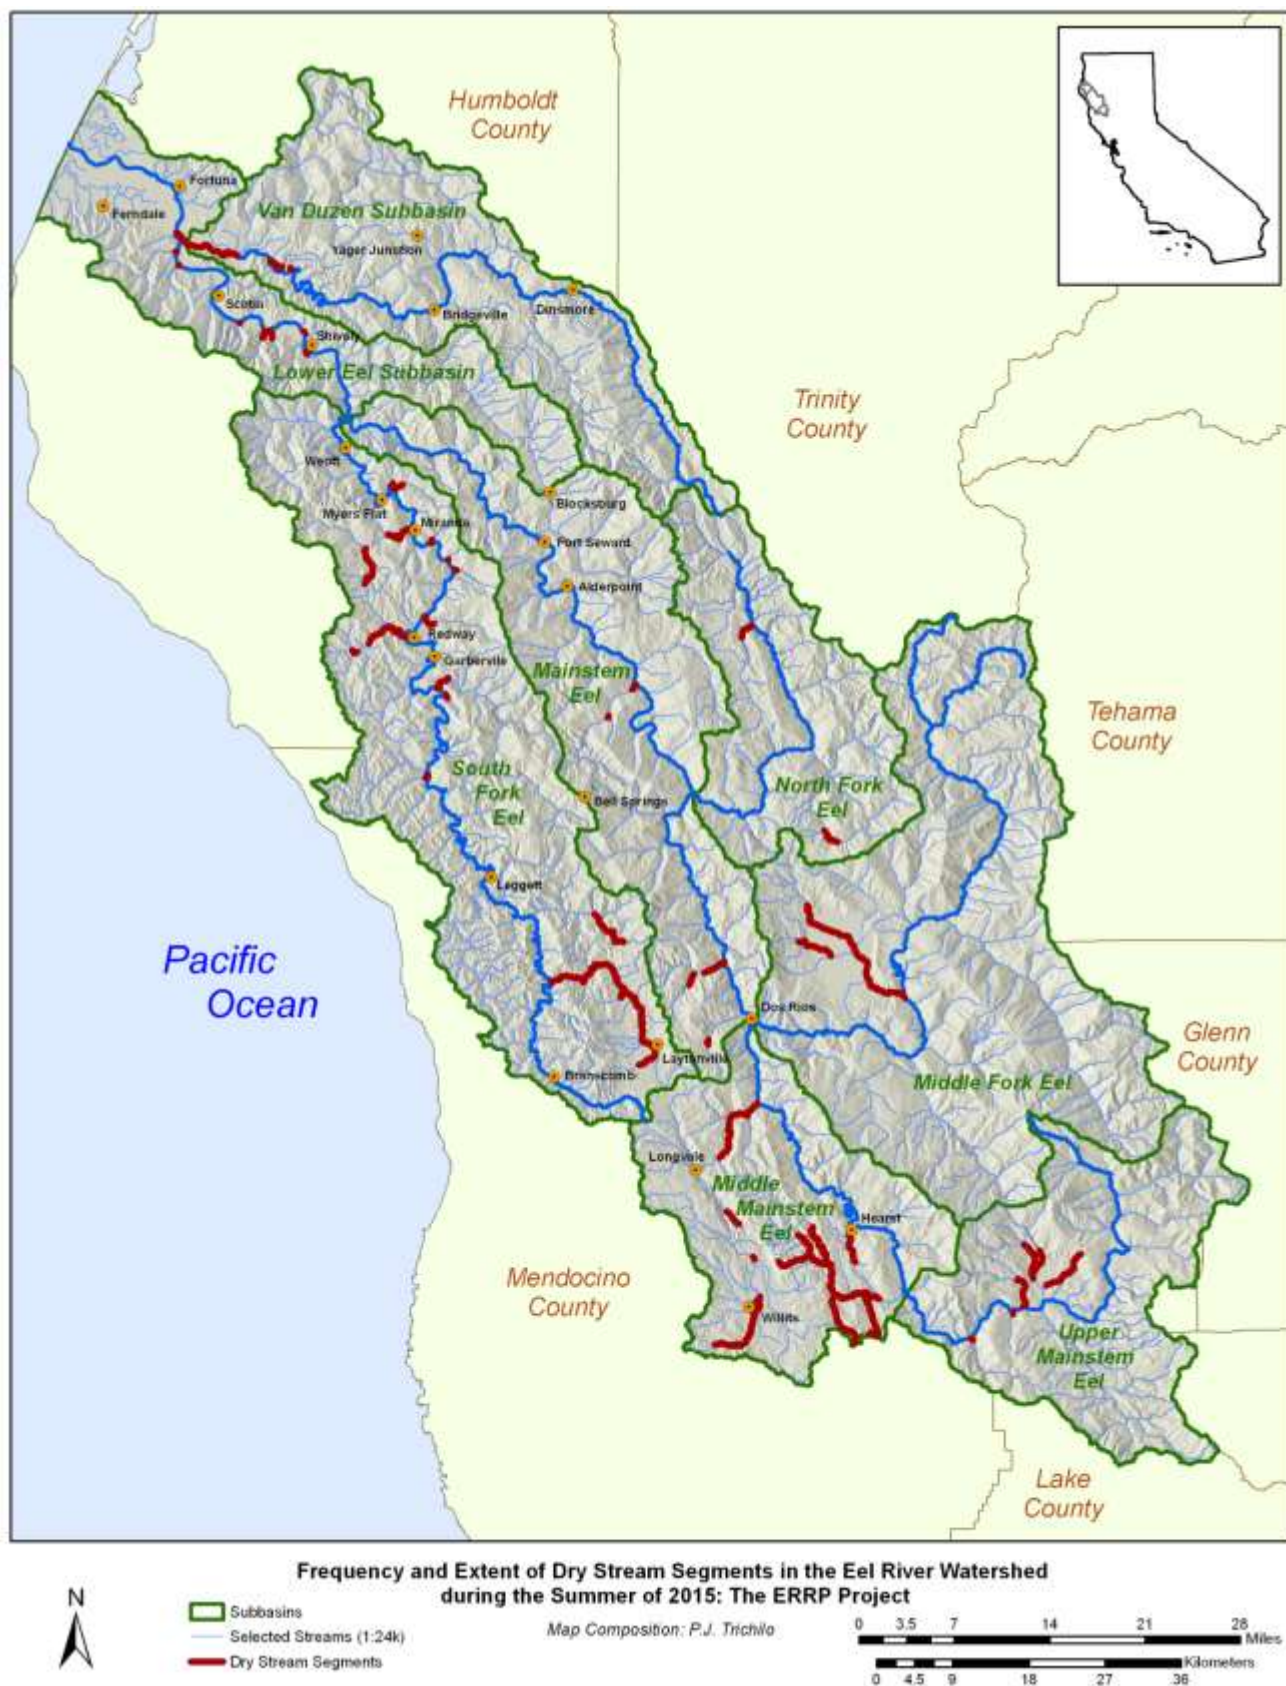
Figure 17 Location and extent of dry stream segments throughout the Eel River Watershed during the summer of 2015. This map is very conservative in that it represents only reaches where ERRP was surveying.

Eel River Tributary Dry Reaches 2015: As ERRP conducted field work related to temperature data collection and photopoint establishment, where streams were becoming disconnected or dry became apparent. Figure 13 shows maps of dry stream reaches where ERRP observed such conditions and was able to photo-document them. This map should be viewed as an extremely conservative look at the problem Eel River Basin-wide and underestimates where streams went dry, but it is useful as a start and for future trend monitoring. Extensive dry reaches are apparent in Outlet, Ten Mile, Tomki, Redwood (near Redway), and Salmon Creek near Miranda. Factors that are causing desiccation include young over-stocked forest evapotranspiration, extensive road networks that alter hydrology, changes in wetland and grassland complexes, de-watering for agricultural uses, and aggradation. The latter problem may be the dominant problem for loss of surface flow in erodible lower Eel River, Van Duzen and lower South Fork Eel River watersheds.
