**RESOLUTION OF THE MENDOCINO COUNTY BOARD OF SUPERVISORS ADOPTING AN INITIAL STUDY/MITIGATED NEGATIVE DECLARATION AND MITIGATION MONITORING REPORTING PROGRAM IN COMPLIANCE WITH CALIFORNIA ENVIRONMENTAL QUALITY ACT REQUIREMENTS FOR THE REPLACEMENT OF BRIDGE NUMBER 10C-0146, ON LAMBERT LANE, COUNTY ROAD 123A, MILEPOST 0.10, OVER ROBINSON CREEK (BOONVILLE AREA)**

## Robinson Creek Bridge Replacement on Lambert Lane

- A. Project Title: Robinson Creek Bridge Replacement on Lambert Lane, County Road 123A, Boonville. Bridge No. 10C0146. BRLO-5910(099)
- B. Project Sponsor/Lead Agency:  
County of Mendocino  
Department of Transportation  
340 Lake Mendocino Drive  
Ukiah, CA 95482, Willows, CA 95988

## **Robinson Creek Channel Design Report for the Lambert Lane Bridge Replacement Project**

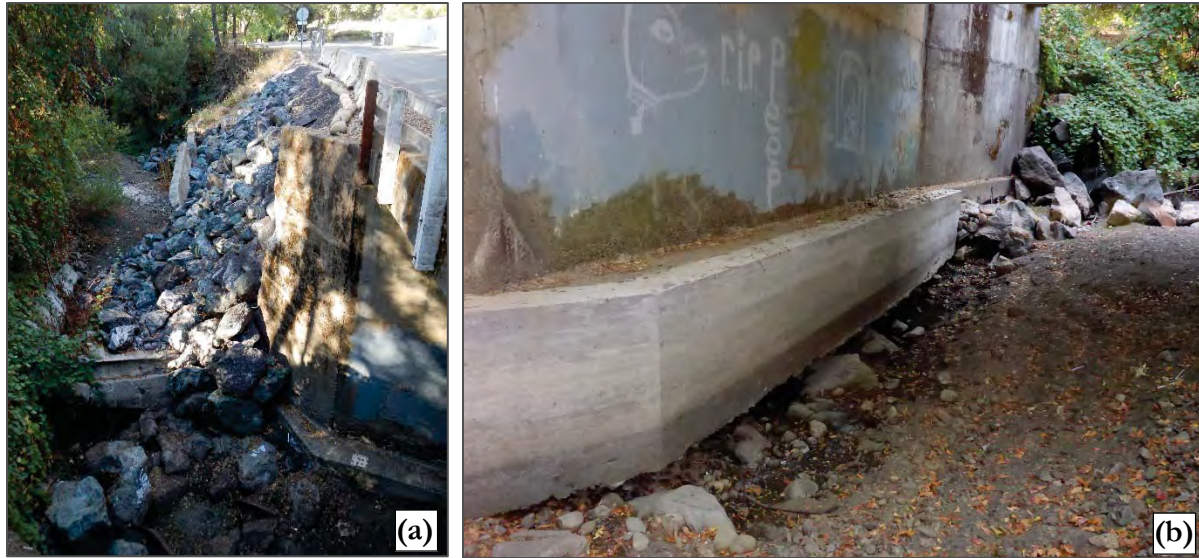
**Figure 2. Current condition of the channel at the Lambert Lane Bridge, with (a) riprap placed along roadway embankment at location of collapsed retaining wall and (b) a new concrete skirt along the undermined footing.**

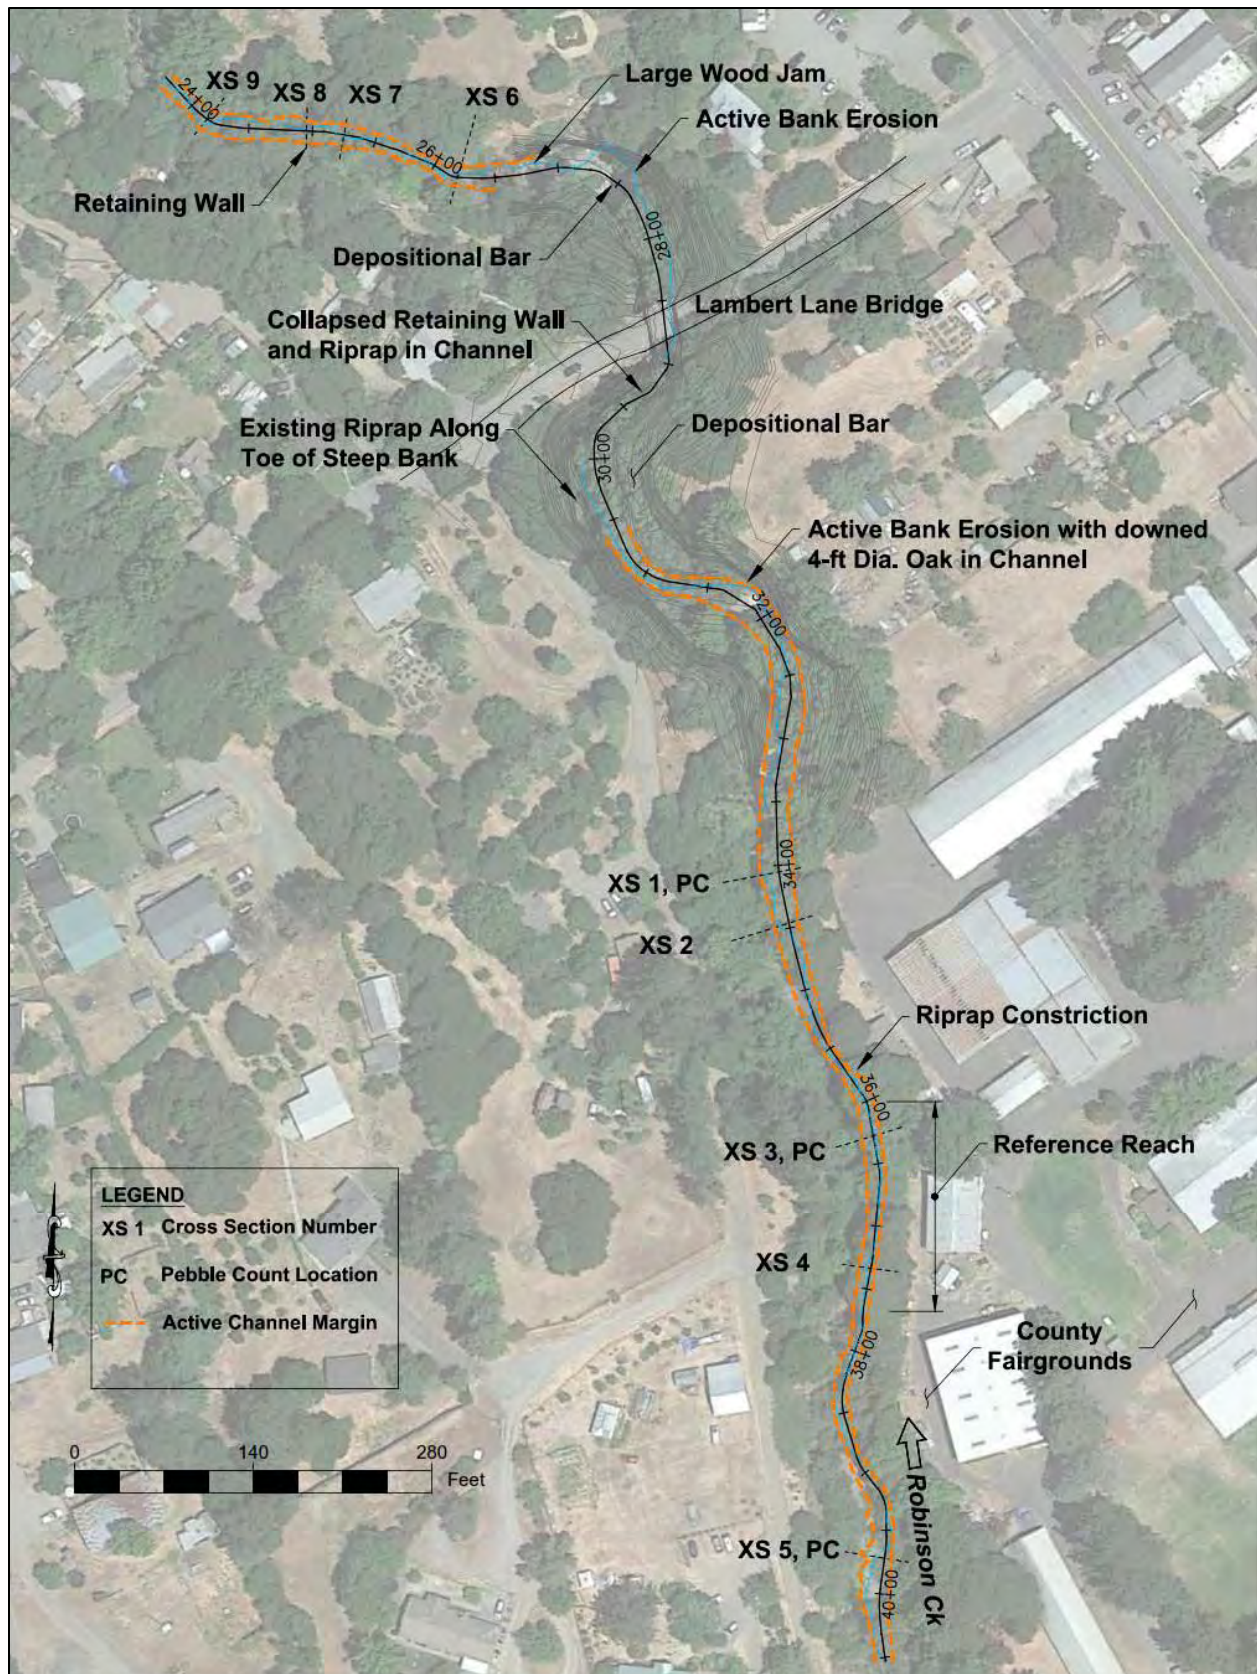
Figure 3. Robinson Creek plan view extents of the geomorphic survey of the channel.

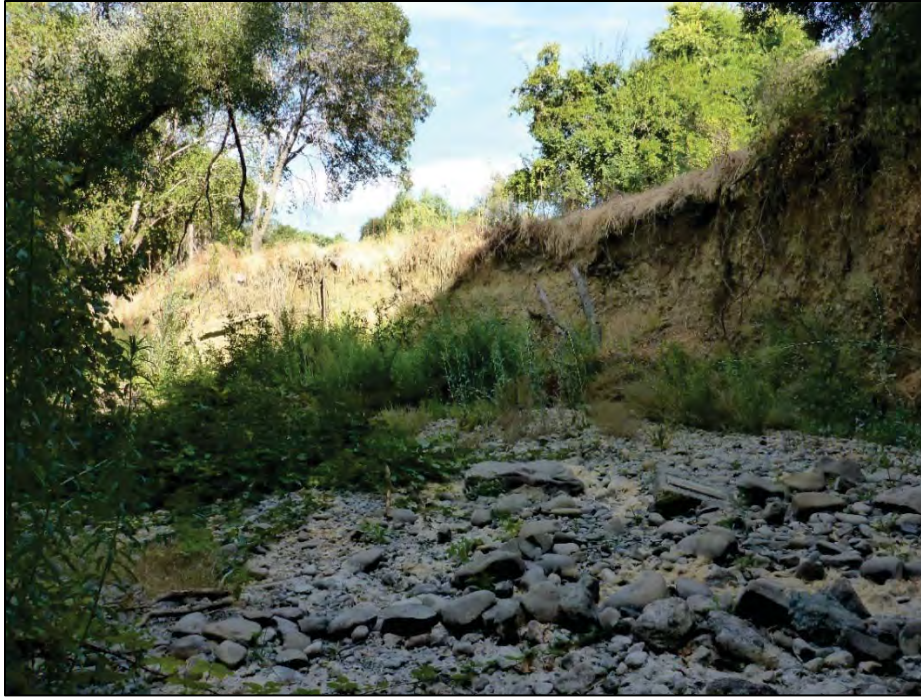
**Figure 5. Looking downstream at the active bank failure and local sediment aggradation upstream of large wood jam, 150 feet downstream of the Lambert Lane bridge (near station 27+50).**

Immediately downstream of the bridge there is a tight left bend in the channel. The bank along the outside of the bend located on the property of the Boonville Hotel is oversteepened and actively eroding (Figure 5). The resulting bank failures have toppled numerous mature trees into the channel, creating a large wood jam near station 28+00. This bank failure started in 2012 with the loss of a heritage oak tree (personal communication, Linda MacElwee, RCD), but became more extensive during the winter of 2017. Between the 2016 and 2018 surveys, the height of the channel bed upstream of the large wood jam aggraded approximately 1.6 feet.

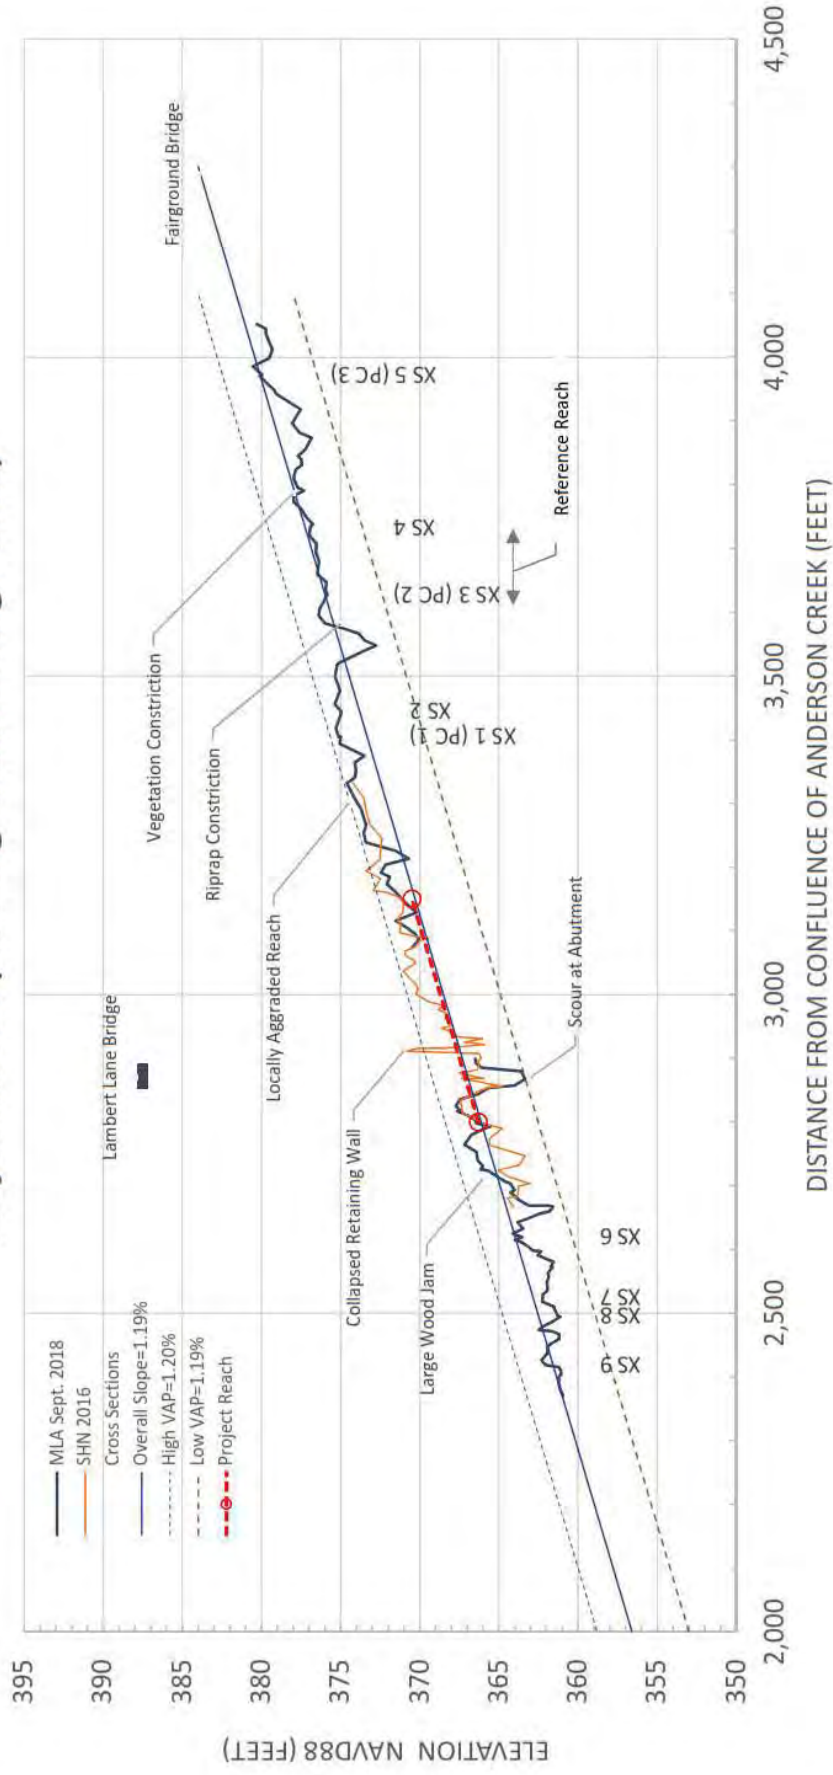
Figure 6: Robinson Creek channel thalweg profile upstream and downstream of the existing bridge crossing at Lambert Lane. Also plotted are the overall channel slope based on the entire lower Robinson Creek profile, the current project extents, and the low and high vertical adjustment potential (VAP) profiles for the project.

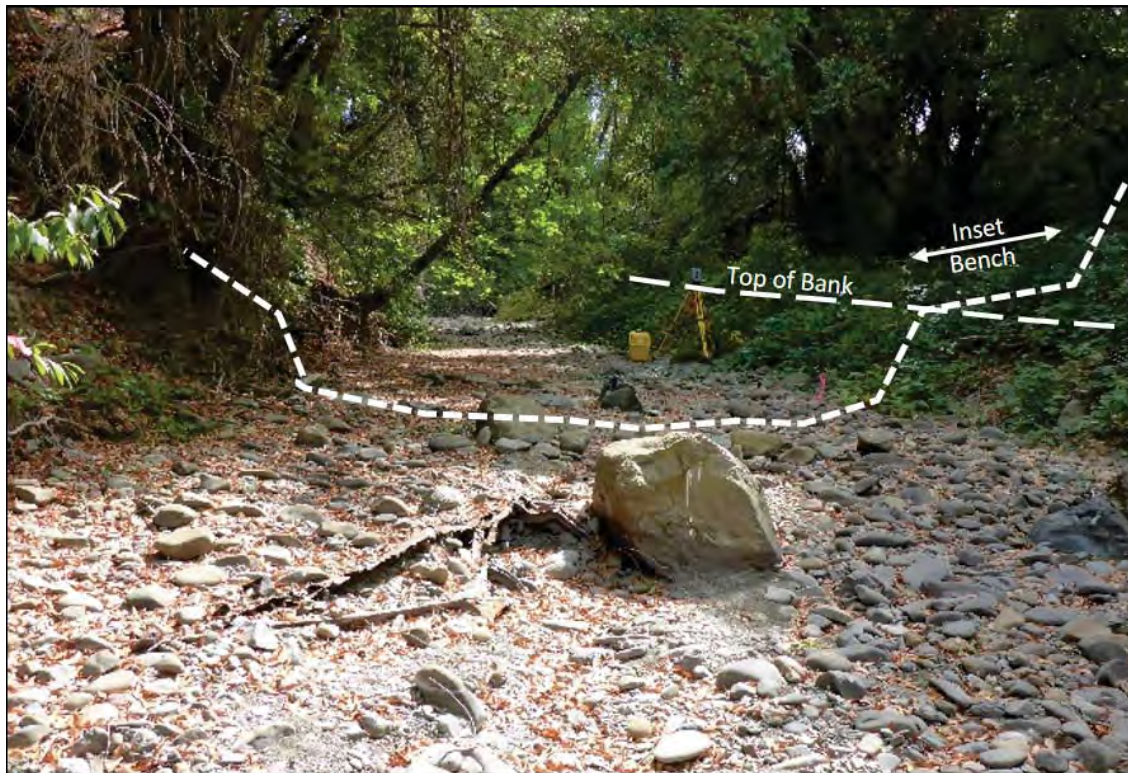
**Figure 7. Looking upstream at selected reference reach, with typical channel cross section and location of inset floodplain bench noted.**

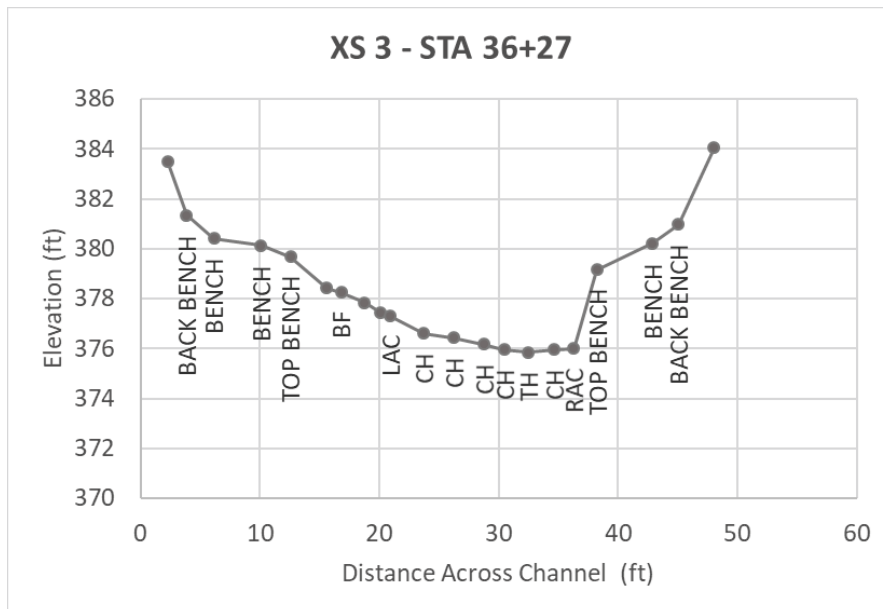
**Figure 8. Reference reach cross sections, looking downstream, with typical bench geometry. Where LAC and RAC are left and right sides of active channel, BF is bankfull, and TH is thalweg.**

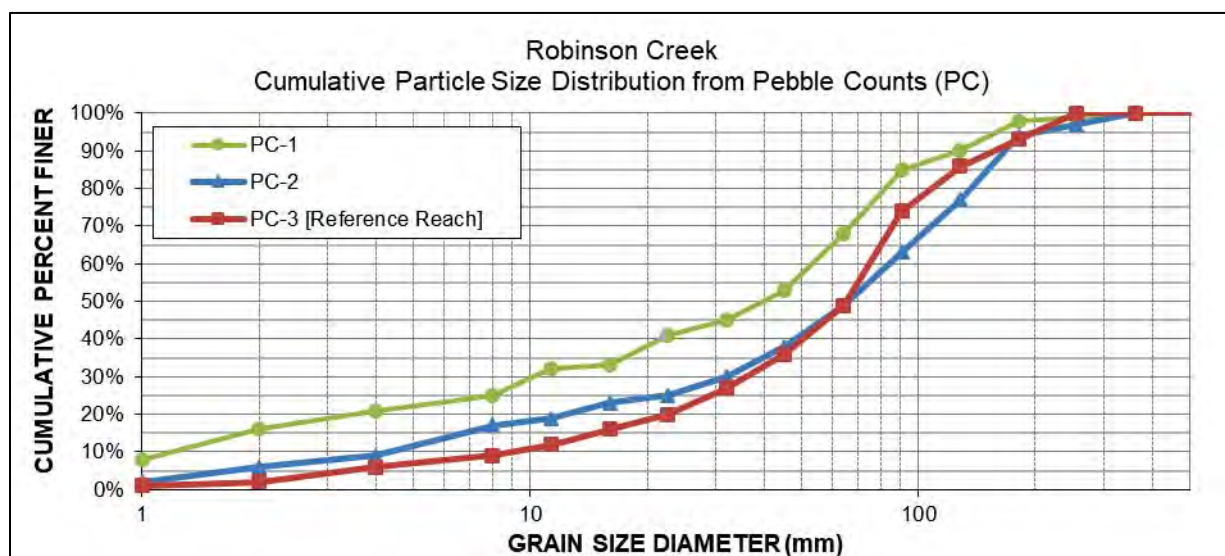
**Figure 9. Gradation of streambed material from pebble counts in Robinson Creek upstream of Lambert Lane. PC-1 is closest to the bridge crossing.**

Pebble counts of the surface streambed material were conducted at three locations upstream of the Lambert Lane crossing to characterize the sediment size (Figure 9). Pebble count (PC) 1 was the furthest downstream and well within the influence of the existing bridge and failed retaining wall. It had substantially finer material than the other two pebble counts. PC-2 was within the reference reach. The median particle size within this reach was very coarse gravel (64 mm) and the D84 was medium cobble (128 mm).

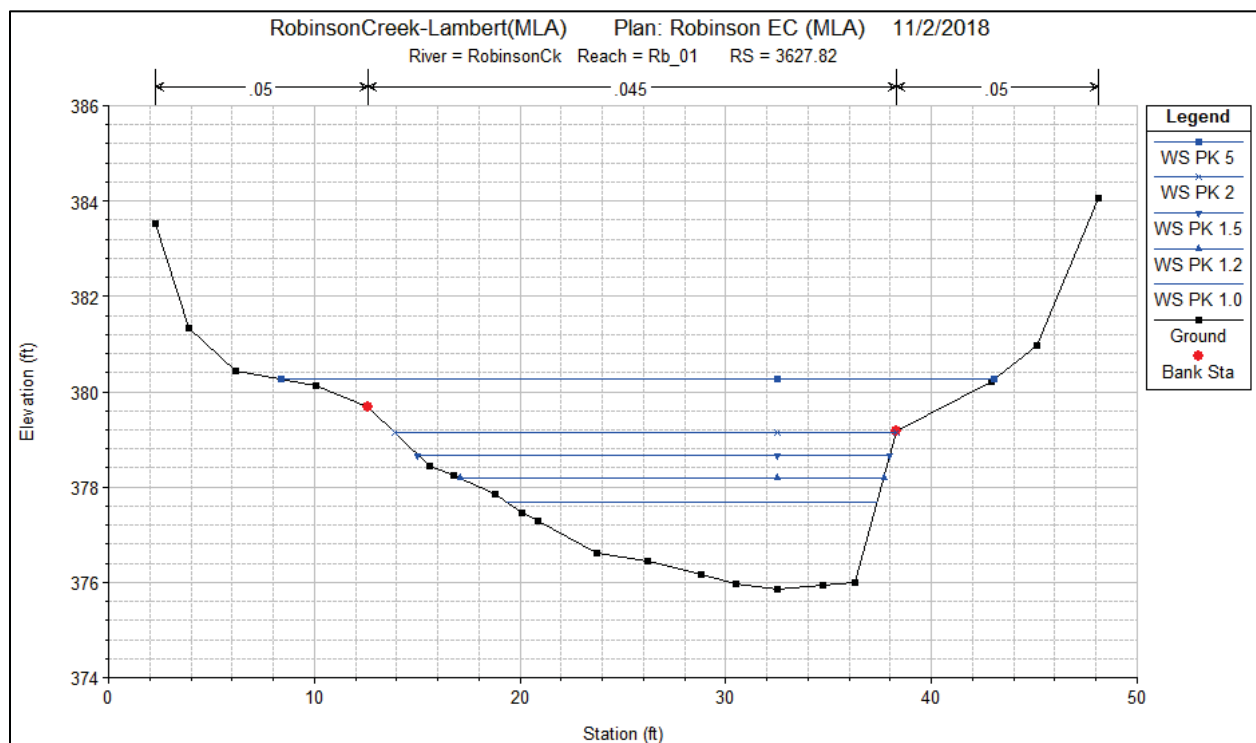
**Figure 10. Existing condition HEC-RAS model results for the cross section XS3 in the selected reference reach. The bankfull field indicators correspond to the 1.2-year return flow and the benches inundate between a 2-year and 5 -year flow.**

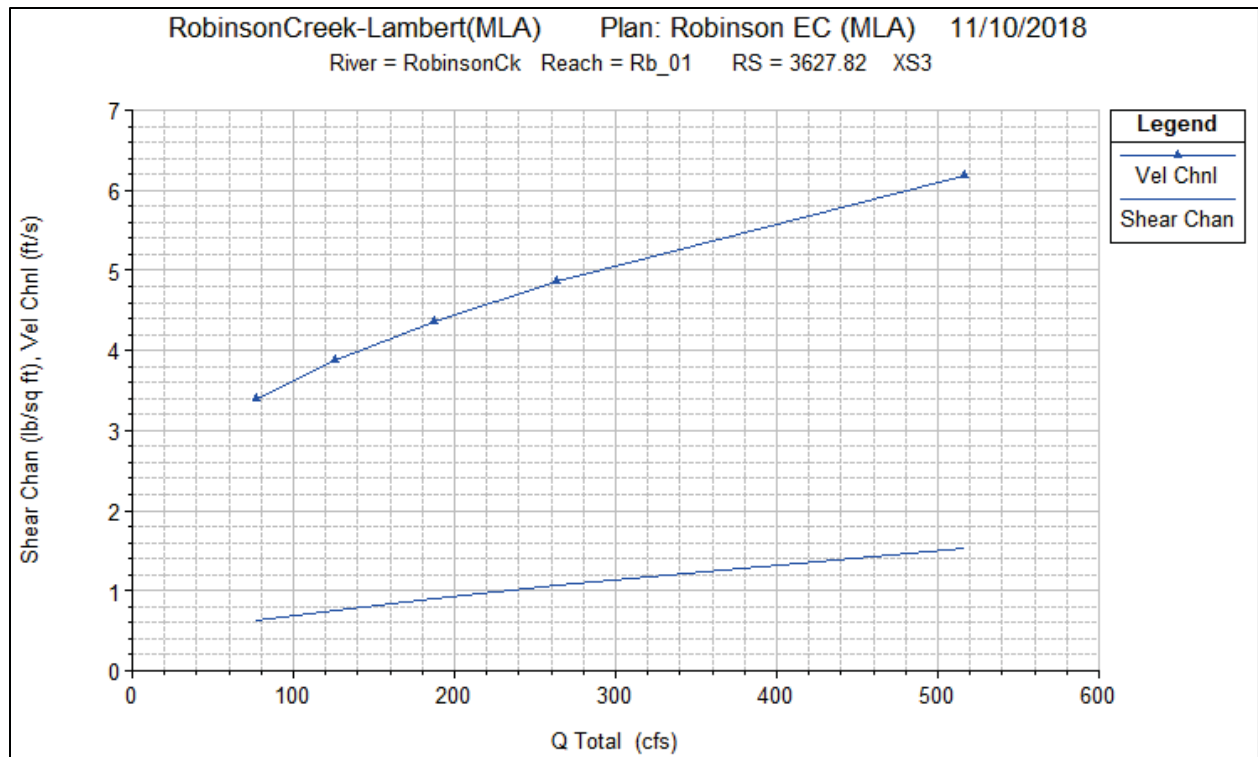
Figure 11. Water velocities and channel shear stress for cross section XS3 between the 1.01-year flow (77 cfs) and 5-year flow (517 cfs).

Water velocity and channel shear stress for flows with 1- to 5-year return periods is shown in Figure 11. At 1.2-year bankfull flow of 126 cfs the cross-sectional average channel velocity is 3.9 ft/s and shear stress is 0.76 lb/ft<sup>2</sup>. Bankfull flow is typically associated with initiation of bedload movement. Using a dimensionless Shields parameter of 0.052 for very coarse gravel (Julien, 1998), the median particle size, the estimated critical shear stress to initiate movement ranges between 0.54 and 1.12 lb/ft<sup>2</sup>. This falls within the model-estimated shear stress at the 1.2-year flow, supporting the observed bankfull estimate.

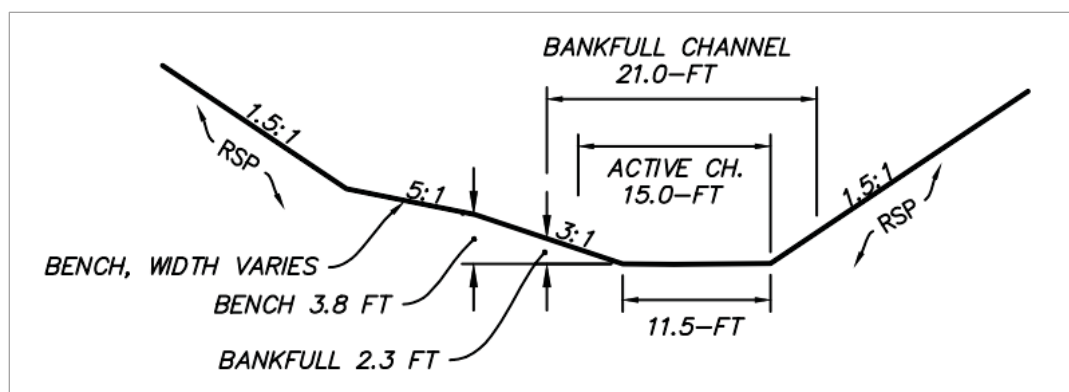
**Figure 12. Typical channel geometry under the bridge for Robinson Creek at Lambert Lane Bridge replacement.**

Nearly the entire project reach is on one of two bends. The design channel cross section shape and dimensions were based on the reference reach, which includes cross section XS3 on a bend. A narrower bottom width of 11.5 feet and an anticipated actively scoured channel width of 15 feet is proposed to accommodate a point bar and bench on the inside of the bend (Figure 12). Although bench width will vary and is expected to adjust with time, for design purposes a bench height of 3.8 feet and a side slope of 5:1 (H:V) was selected based on reference reach observations. Bank side slopes between 1.5:1 and 2:1 are proposed for the outside of the bends and for the slope at the back of the benches.

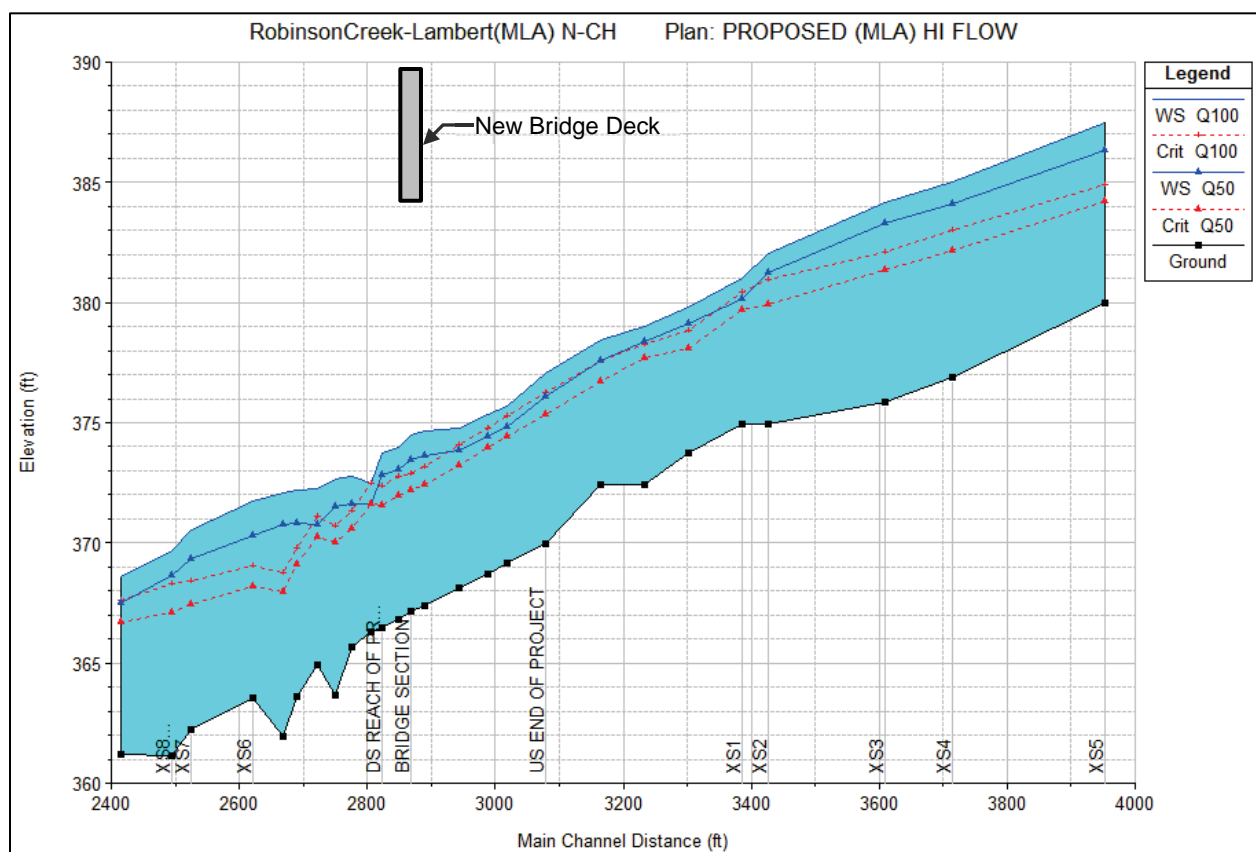
Figure 13. HEC-RAS proposed conditions water surface profiles of the 50- and 100-year flows in Robinson Creek at Lambert Lane Crossing.

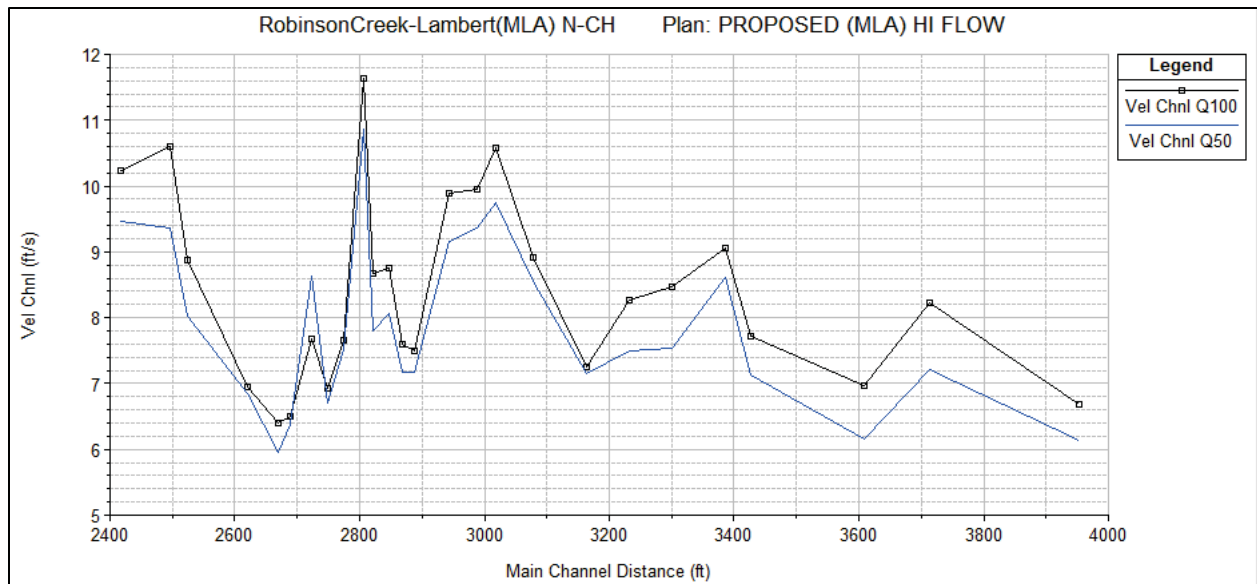
Figure 14. HEC-RAS proposed conditions channel velocity profiles for the 50- and 100-year flows in Robinson Creek at Lambert Lane Crossing.

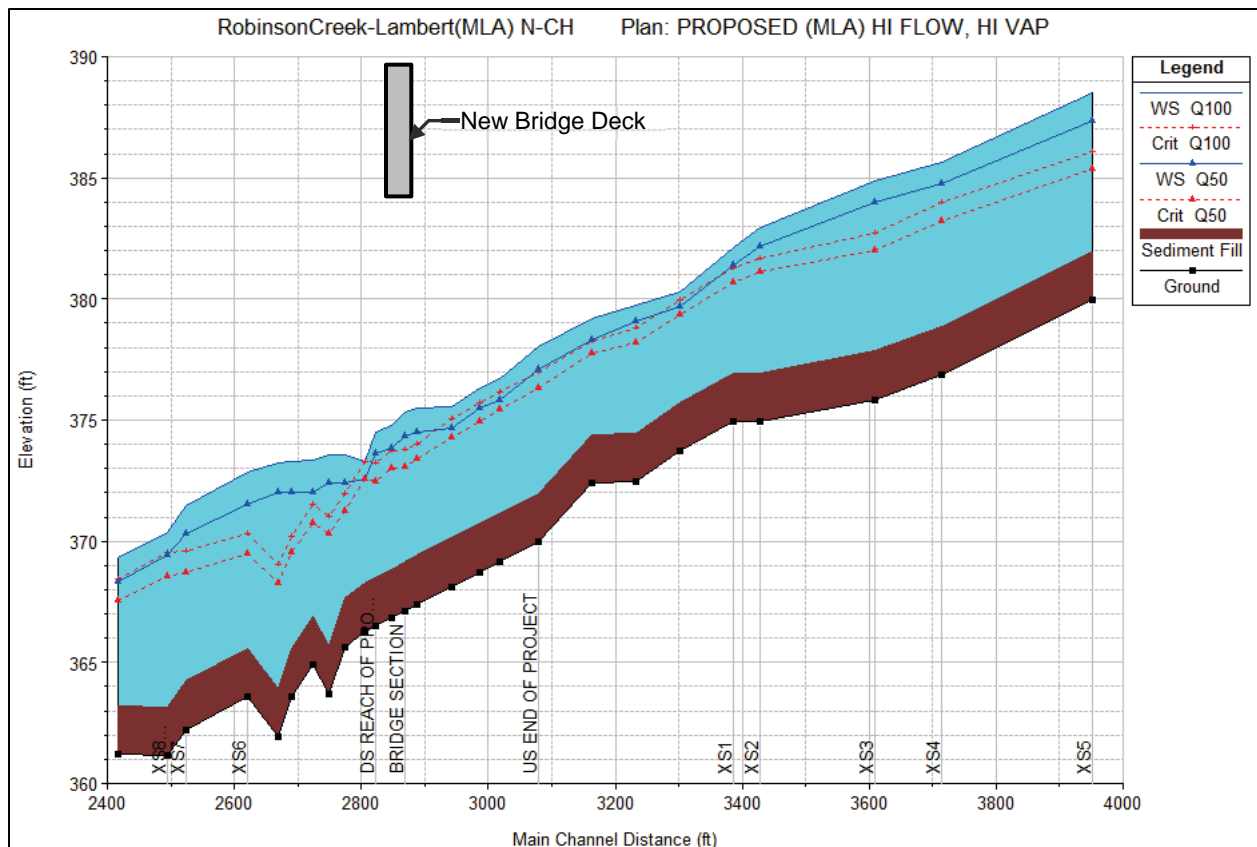
Figure 15. HEC-RAS high VAP conditions (2 feet of aggradation) with water surface profiles for the 50- and 100-year flows in Robinson Creek at Lambert Lane Crossing.

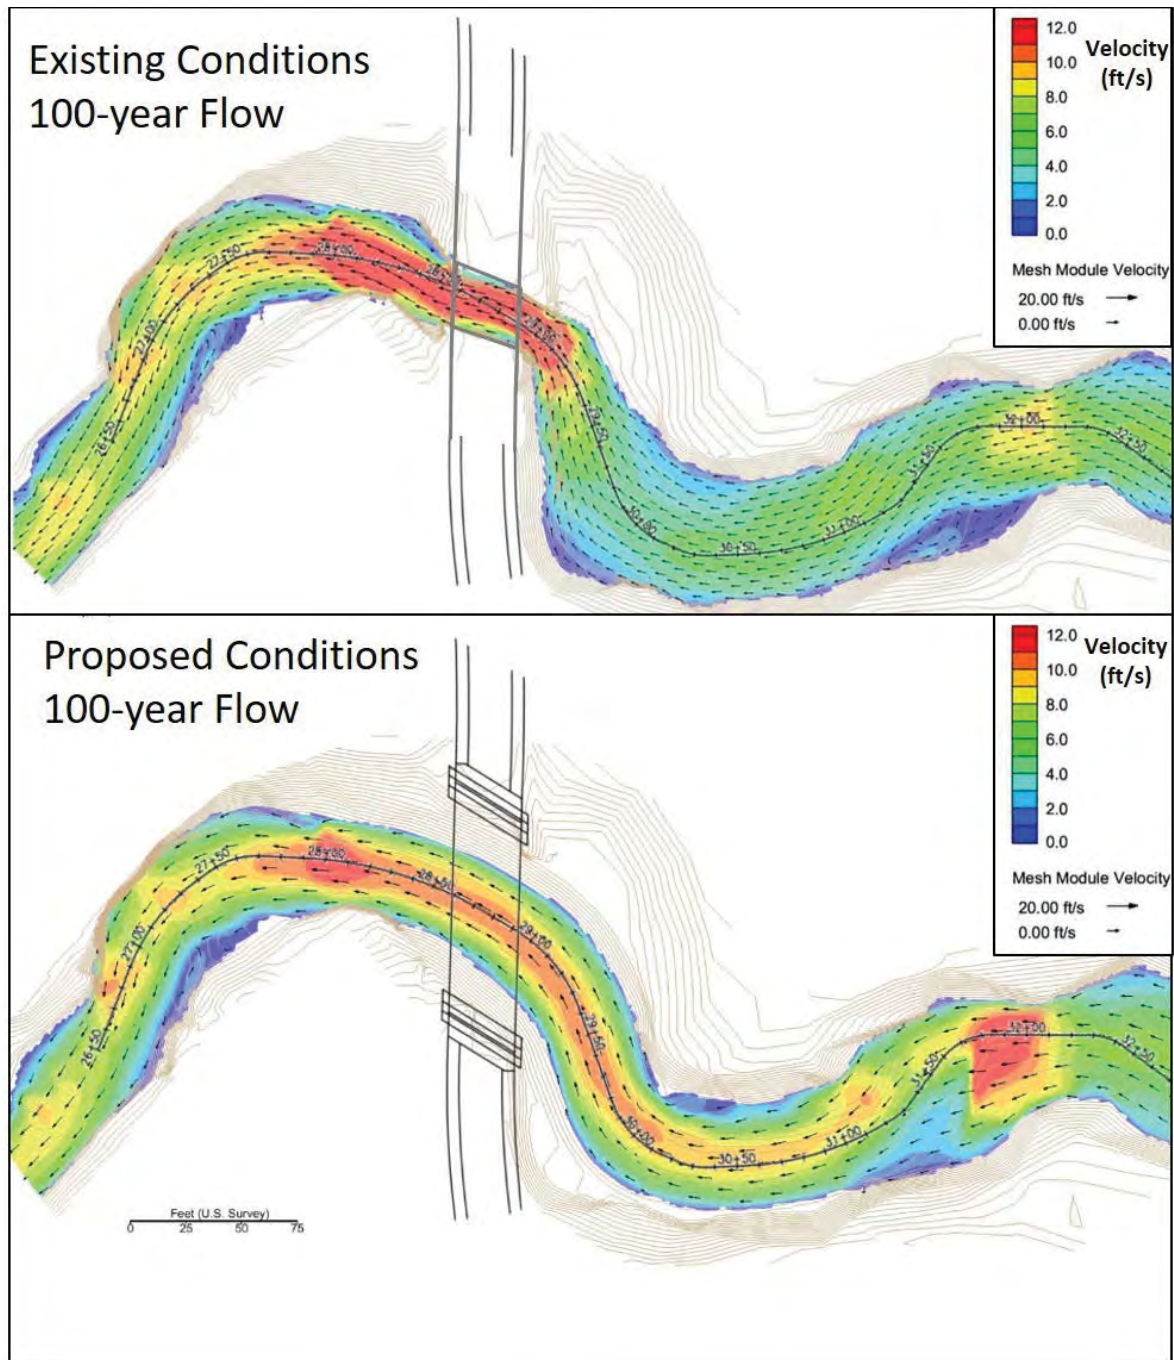
Figure 16. SRH-2D predicted water velocities associated with the 100-year flow of 1,750 cfs for existing and proposed.

Downstream of the bridge crossing the proposed condition velocity distribution against the existing bank failure remain effectively unchanged from existing conditions. There is an area of high velocities at station 28+00, immediately downstream of the project grading. This is caused by an existing large oak tree on the bank, with its root mass protruding into the channel. Under existing conditions this is masked by the extremely high velocities discharging from under the bridge.

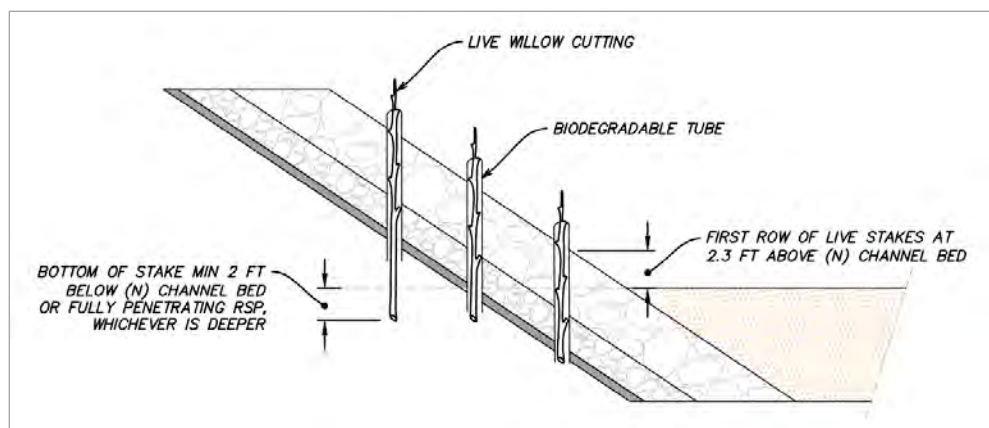
**Figure 17. Typical live stake placement for hybrid RSP revetment.**

Preliminary spacing of live willow stakes is assumed to be 5 feet on-center. Prior to final design a qualified landscape architect or botanist should be retained to provide recommendations for lateral spacing, live willow stake diameter range, embedment depths into subgrade and type of soil backfill for the tubes. They should also provide provisions for harvesting and storage of cutting stock and irrigation design.

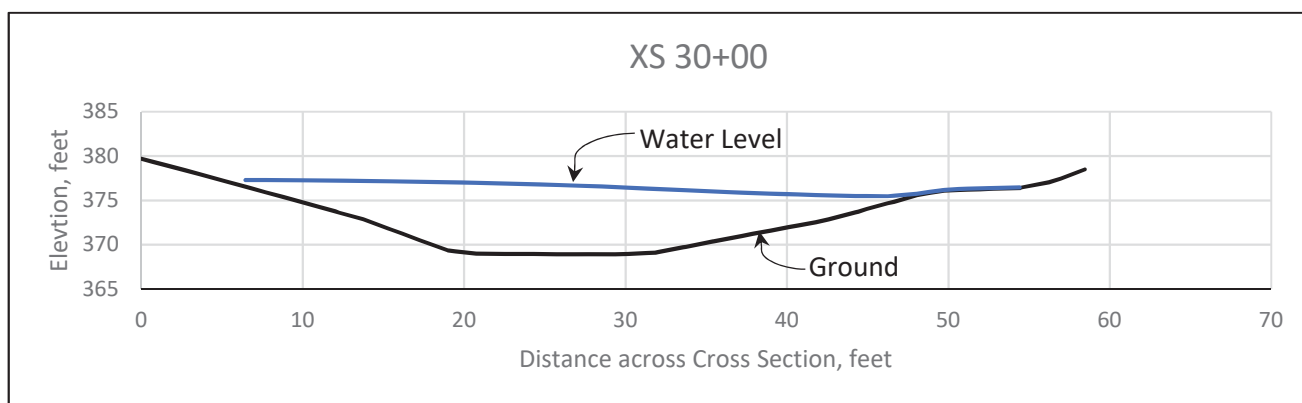
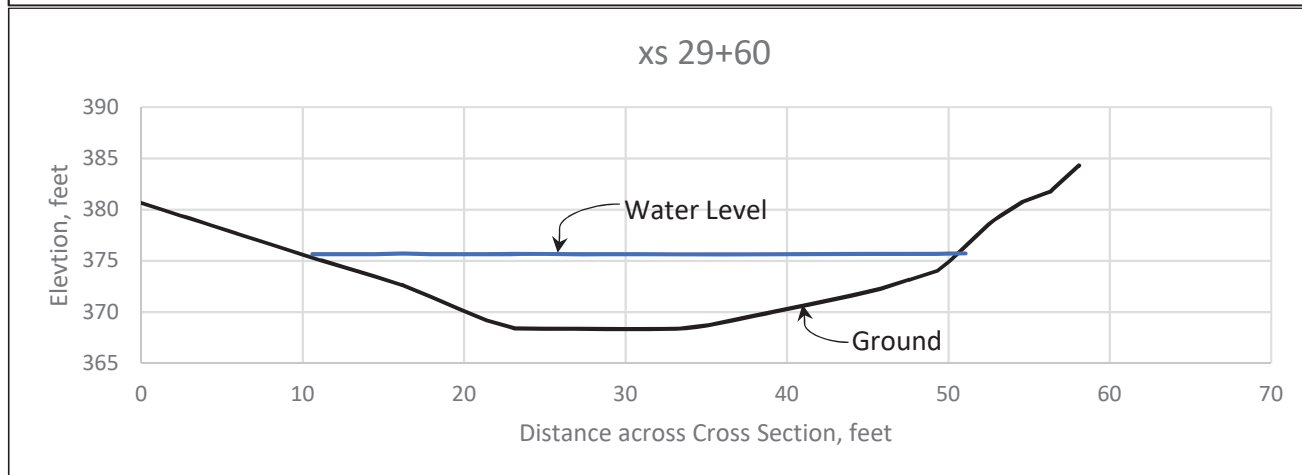
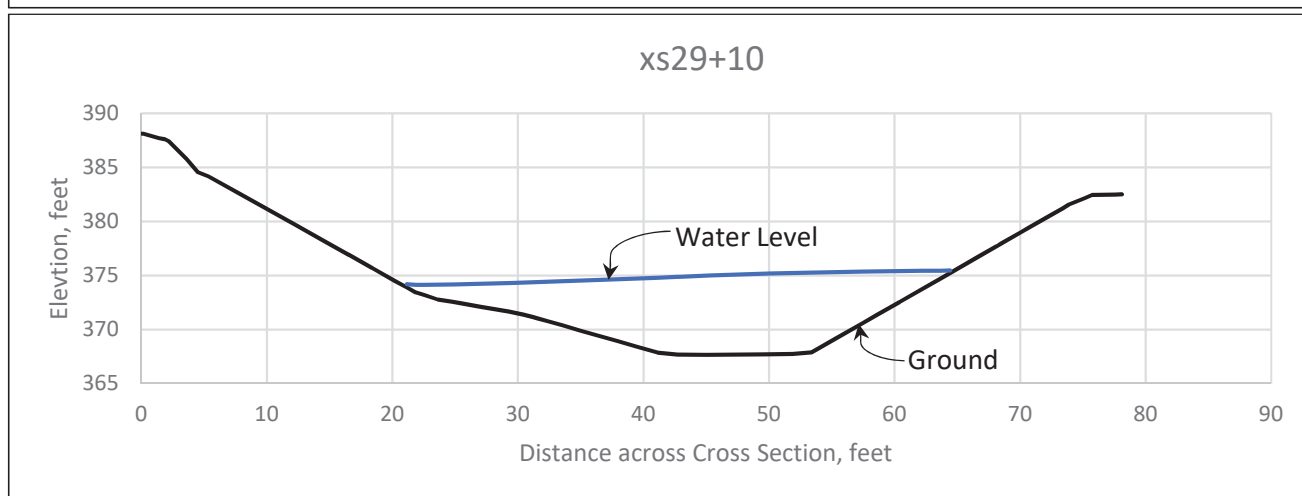
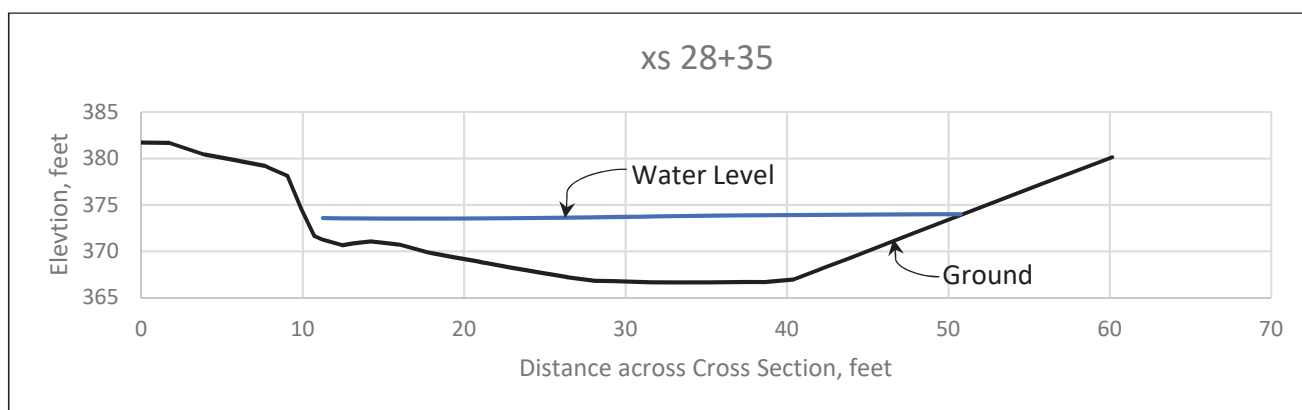
100-year water surface elevations predicted by the proposed-condition 2-D modeling at select cross sections.

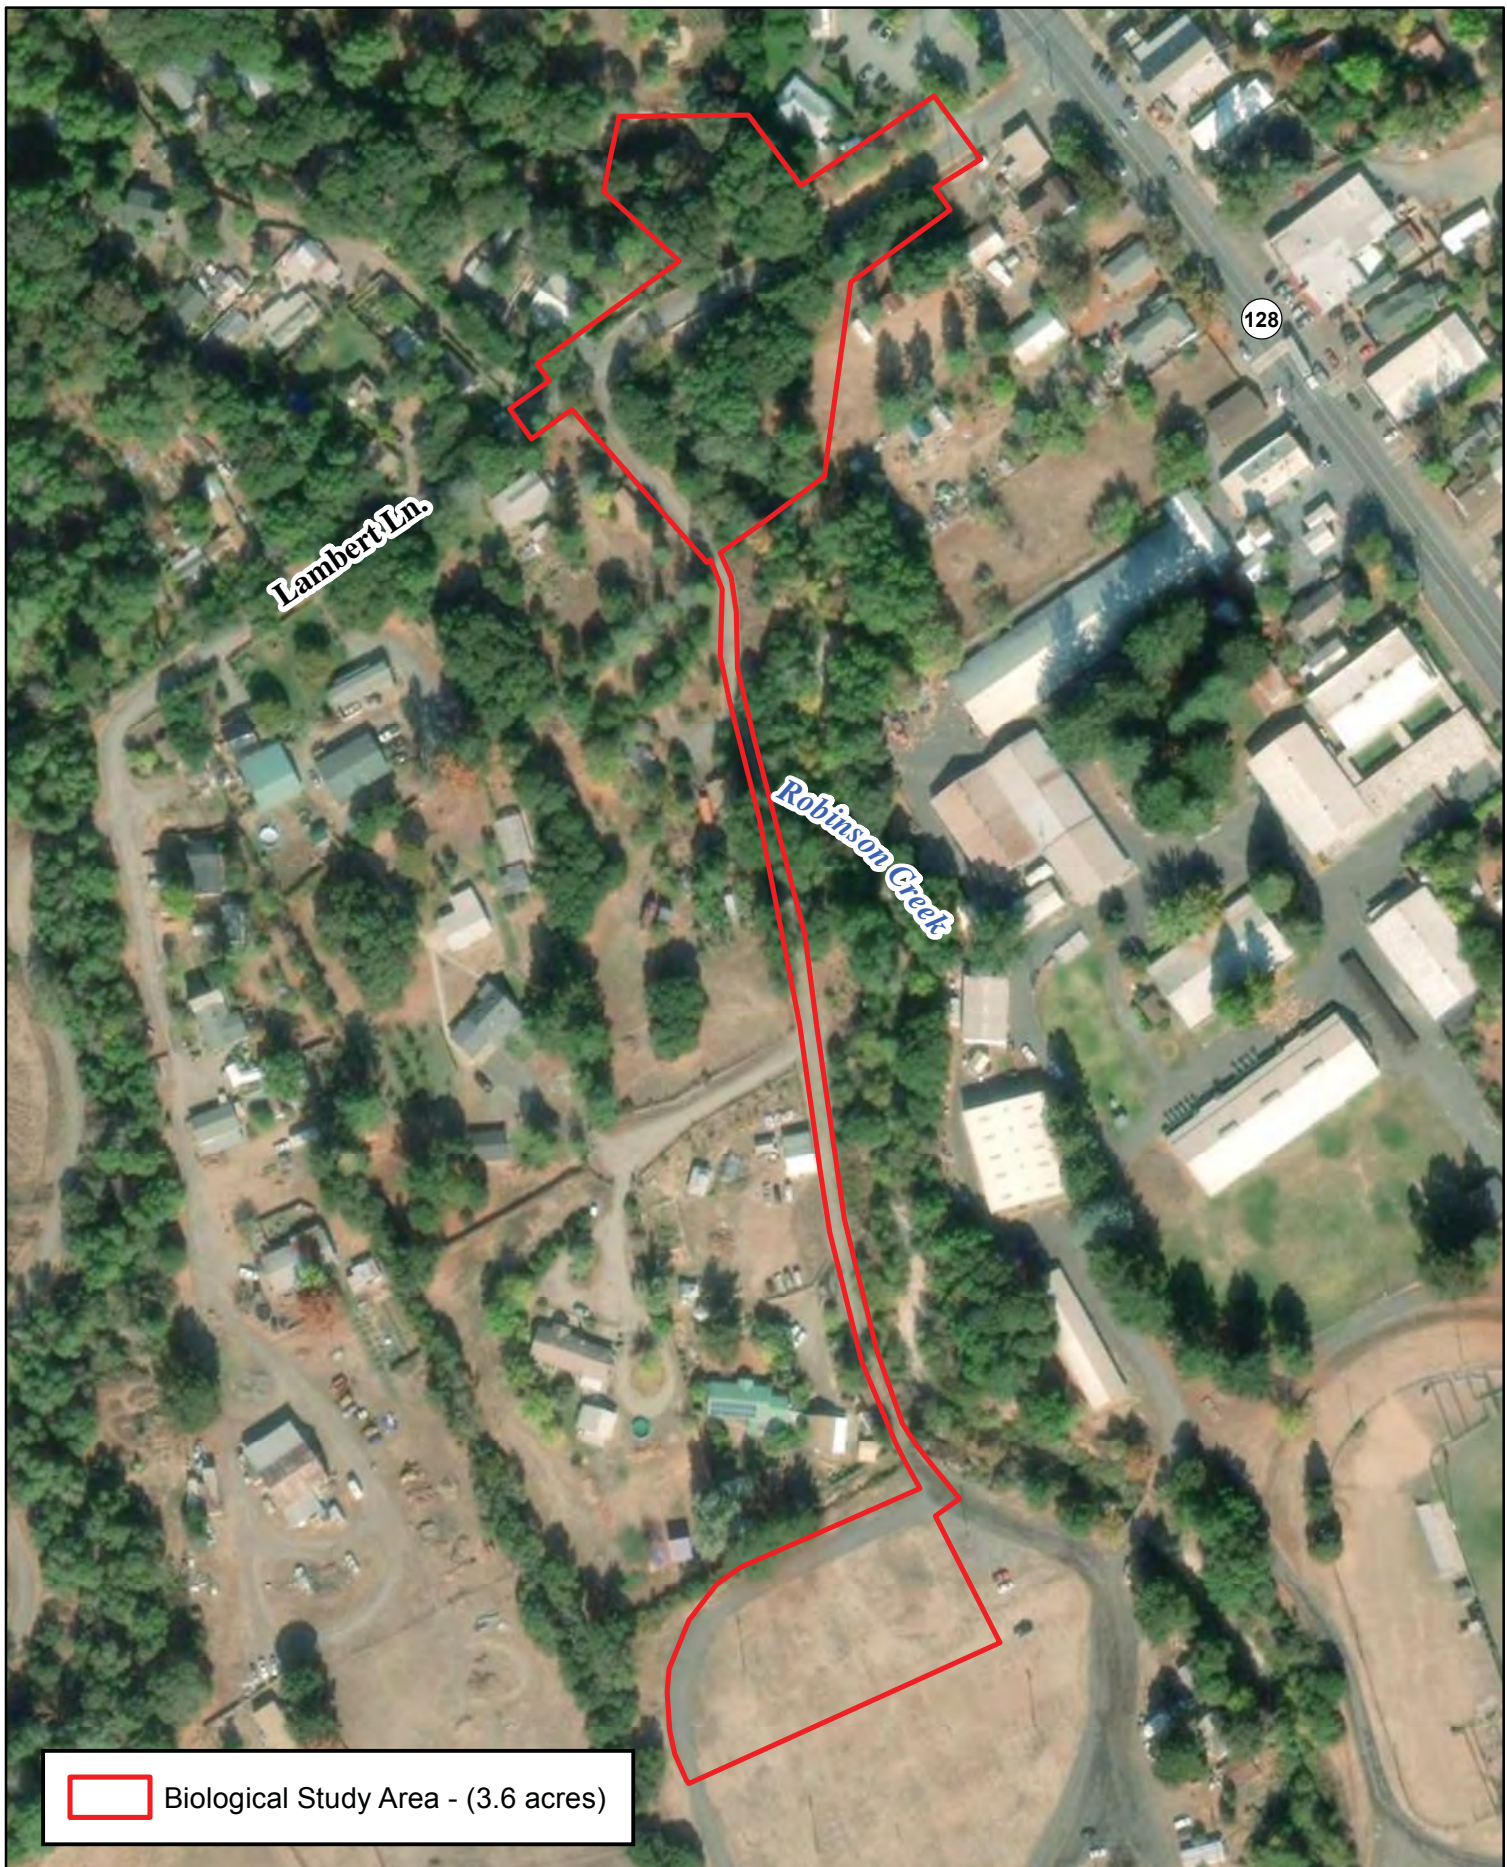
A long span steel plate girder bridge will be constructed within the existing bridge alignment and can be fabricated in shorter lengths to facilitate transport and then assembled on-site

(Figure 4). This bridge option will have a shorter construction time and will minimize impacts to the creek since it does not require falsework in the creek. Additionally, this long span bridge option provides the ability to improve the alignment of the creek to minimize future potential scour issues by increasing the channel opening and providing a softer and more gradual turn of the creek. Weathering steel will be utilized to minimize future maintenance efforts and costs. Significant changes to the vertical profile are not anticipated as the existing and replacement bridge option provide adequate hydraulic freeboard. The structure depth will be 4 feet 9 inches.

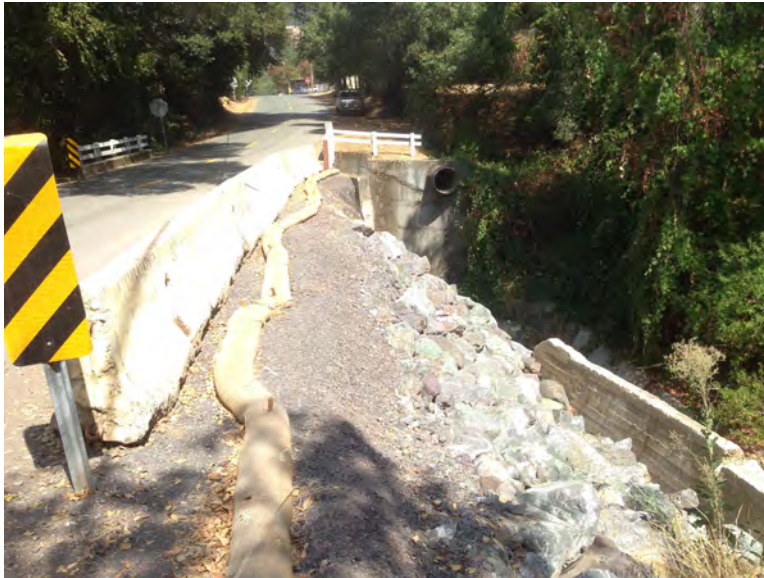
**Photo 1.** Project Site. Failed retaining wall, rock slope protection, shotgun storm drain, 8/26/15

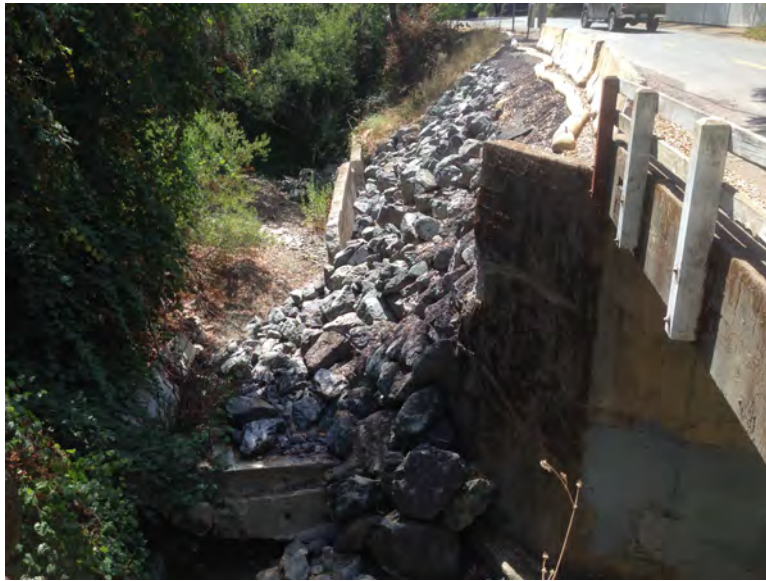
**Photo 3.** Failed retaining wall, painted guard rail, wing wall, grey paint covering graffiti, 8/26/15

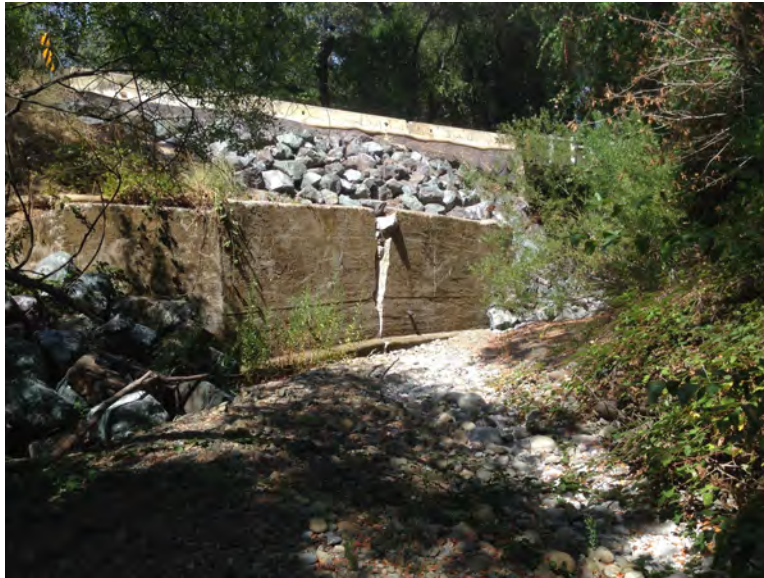
**Photo 5.** Cracked retaining wall upstream of bridge on west bank, 5/11/16
