**RESOLUTION OF THE MENDOCINO COUNTY BOARD OF SUPERVISORS ADOPTING AN INITIAL STUDY/MITIGATED NEGATIVE DECLARATION AND MITIGATION MONITORING REPORTING PROGRAM IN COMPLIANCE WITH CALIFORNIA ENVIRONMENTAL QUALITY ACT REQUIREMENTS FOR THE REPLACEMENT OF BRIDGE NUMBER 10C-0146, ON LAMBERT LANE, COUNTY ROAD 123A, MILEPOST 0.10, OVER ROBINSON CREEK (BOONVILLE AREA)**

## Robinson Creek Bridge Replacement on Lambert Lane

- A. Project Title: Robinson Creek Bridge Replacement on Lambert Lane, County Road 123A, Boonville. Bridge No. 10C0146. BRLO-5910(099)
- B. Project Sponsor/Lead Agency:  
County of Mendocino  
Department of Transportation  
340 Lake Mendocino Drive  
Ukiah, CA 95482, Willows, CA 95988

## **Robinson Creek Channel Design Report for the Lambert Lane Bridge Replacement Project**

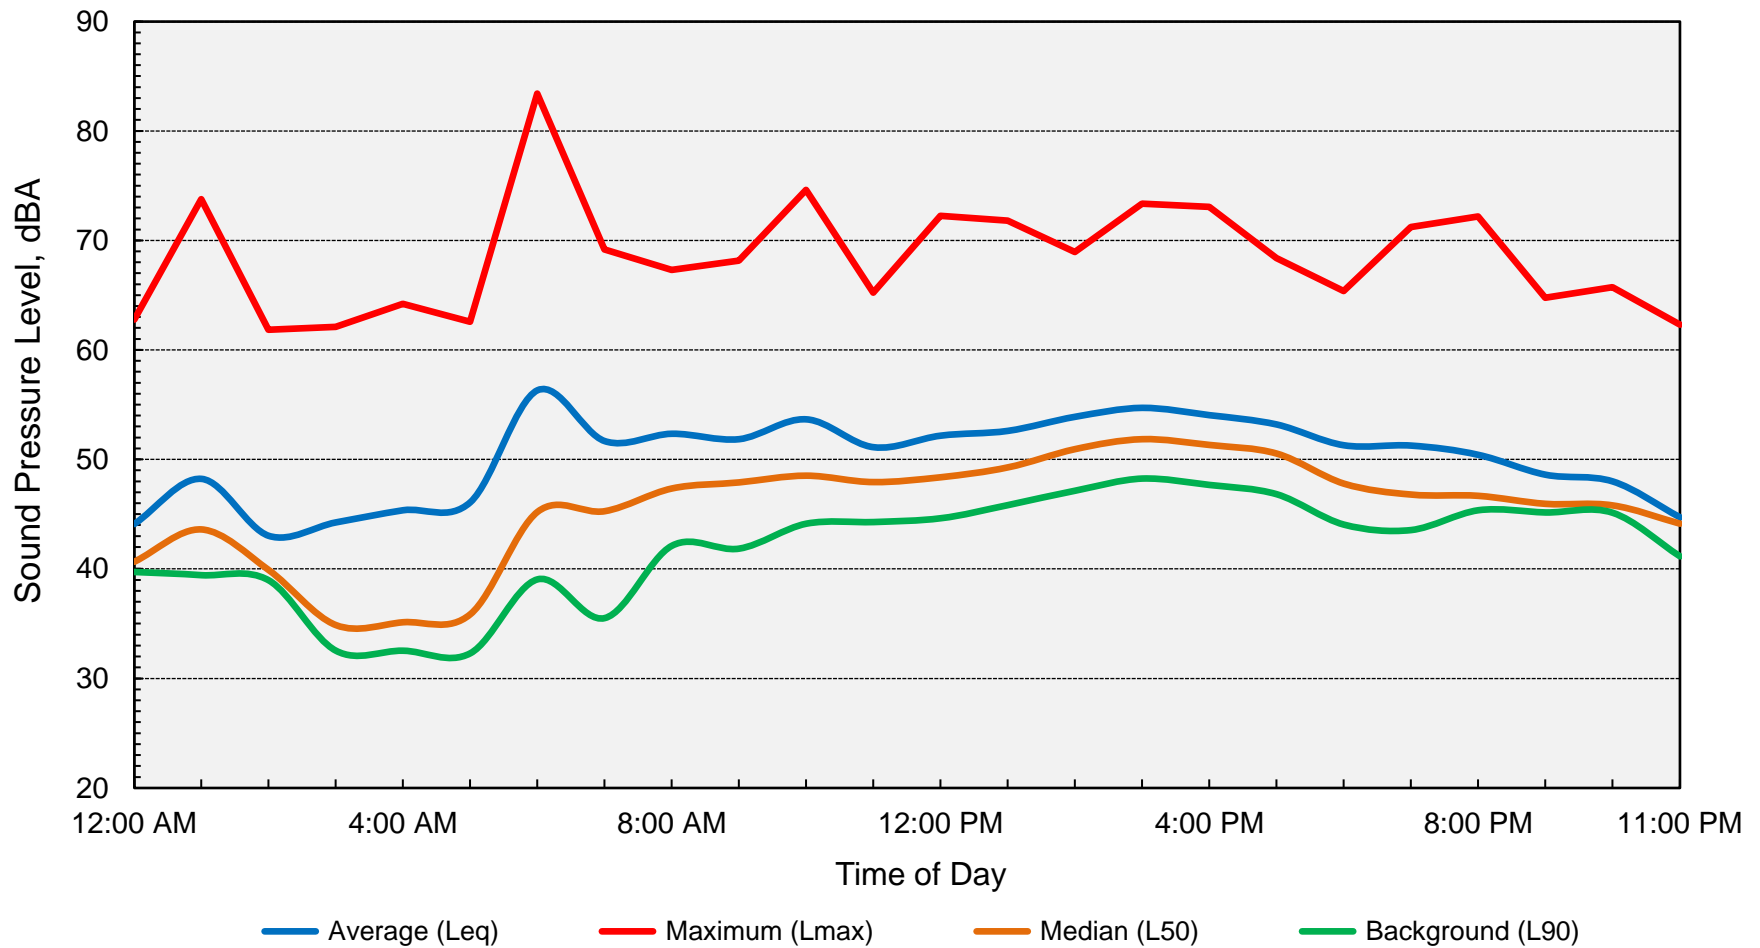
**Attachment D-1**  
**Ambient Noise Monitoring Results - Site LT-1**  
**Robinson Creek Bridge Replacement - Mendocino County**  
**Wednesday, September 16, 2020**

**Computed DNL = 56 dB**

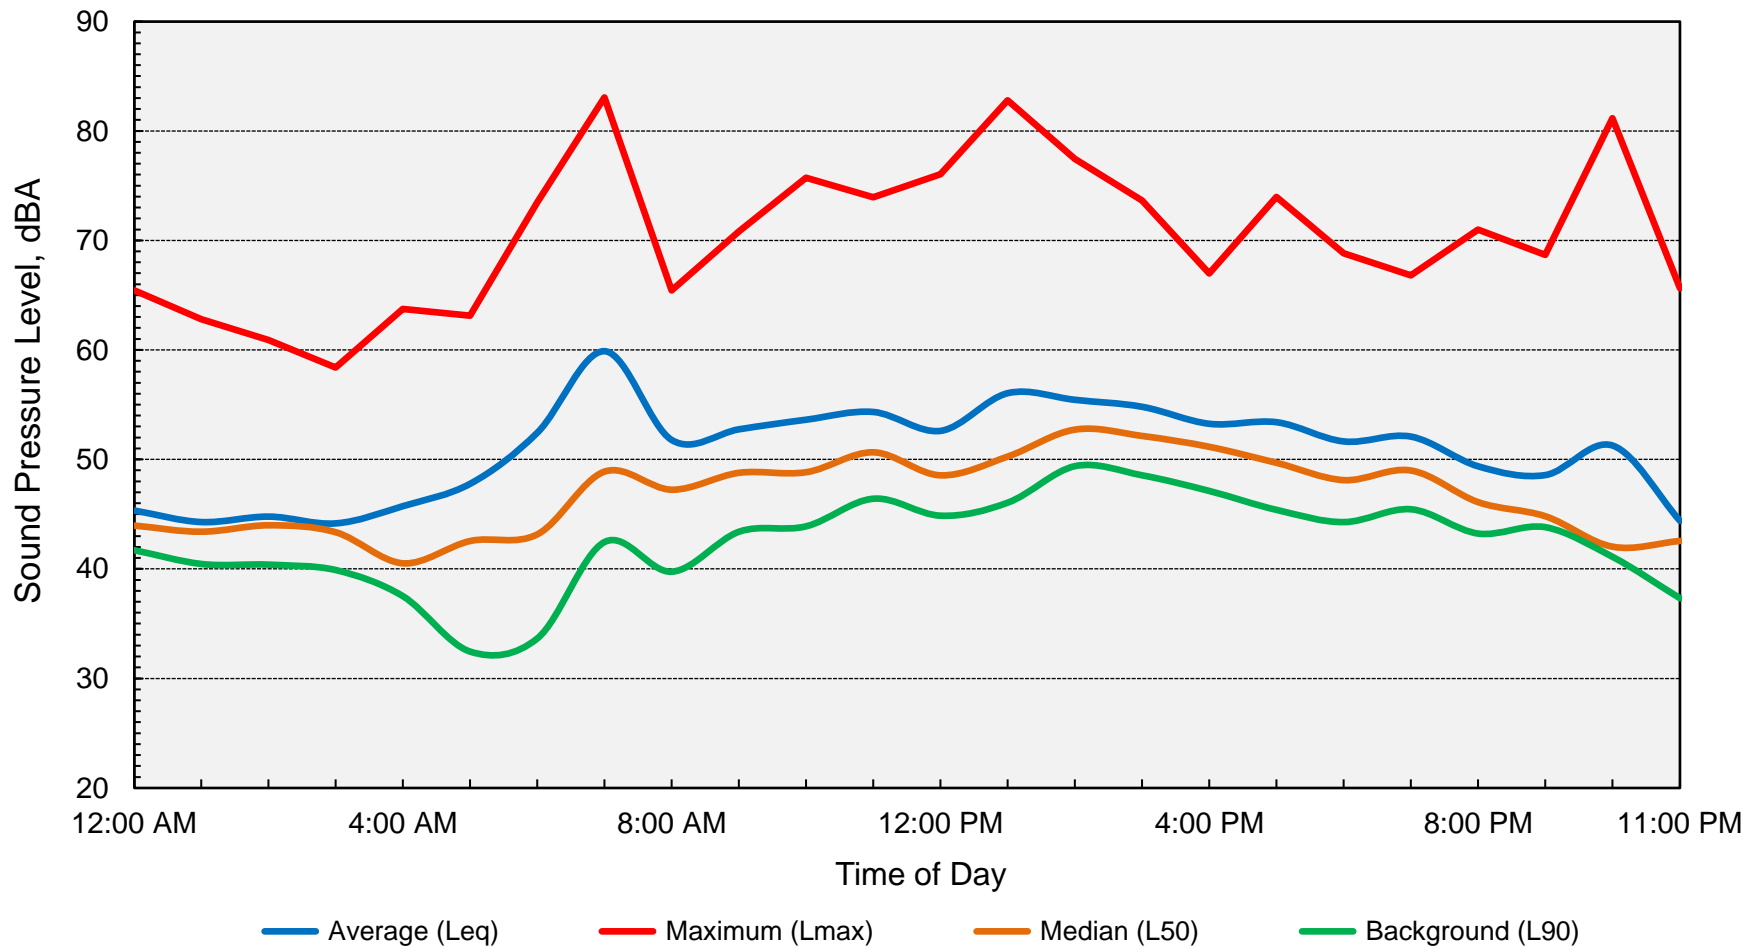
**Attachment D-2**  
**Ambient Noise Monitoring Results - Site LT-1**  
**Robinson Creek Bridge Replacement - Mendocino County**  
**Thursday, September 17, 2020**

**Computed DNL = 56 dB**
