EMERGENCY PERMIT APPLICATION FORM

**EM_2024-0003
This application for
SFR Foundation Repair/Stabilization
ONLY**

GEOTECHNICAL INVESTIGATION
BALDERSTON FOUNDATION IMPROVEMENTS
12700 NORTH HIGHWAY 1
MENDOCINO, CALIFORNIA

January 10, 2024

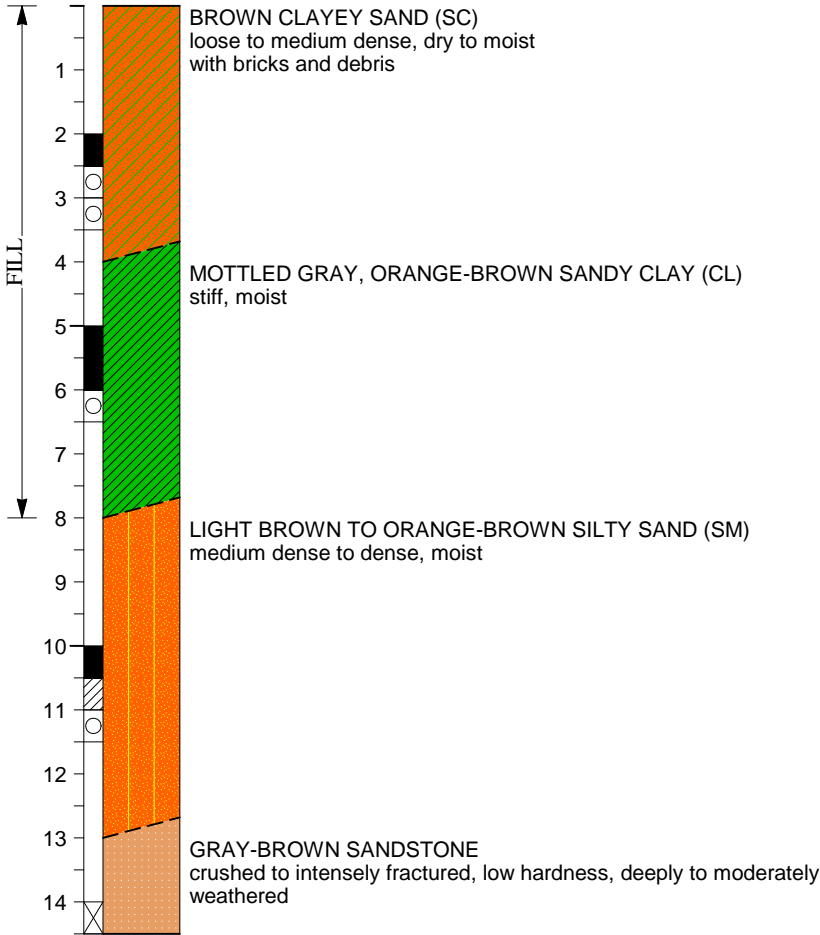
CA 16.6 108 44 **

- Notes:
1. No free water encountered
 2. No caving
 3. Practical drilling refusal at 14.5 feet

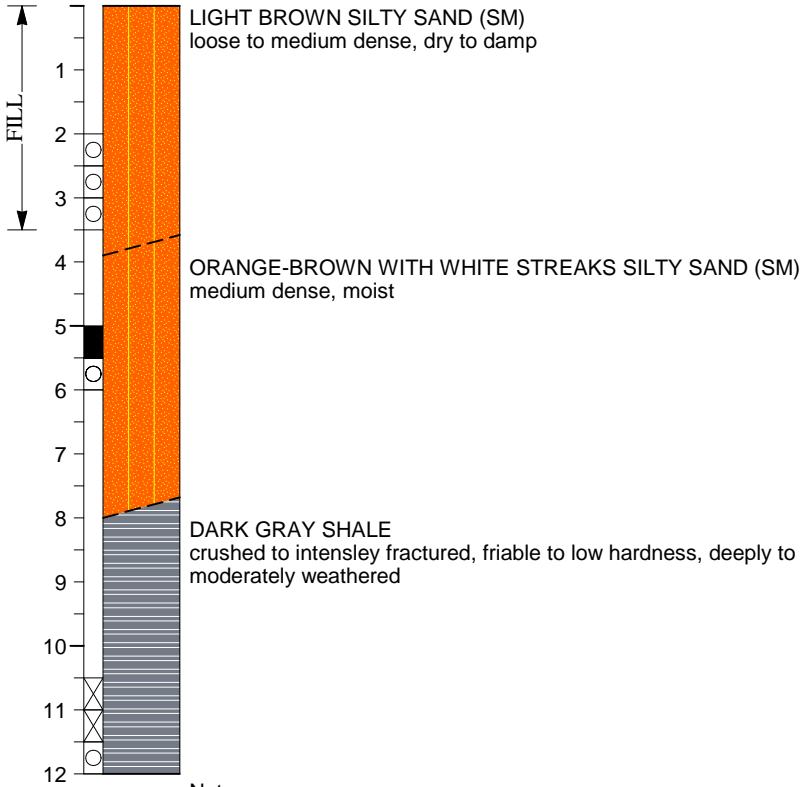
Sampler Type*	Moisture Content (%)	Dry Density (pcf)	Blows/foot
CA			15 **
CA	20.5	95	16 **
SPT			44

- Notes:
1. No free water encountered
 2. No caving
 3. Practical drilling refusal at 20.4 feet

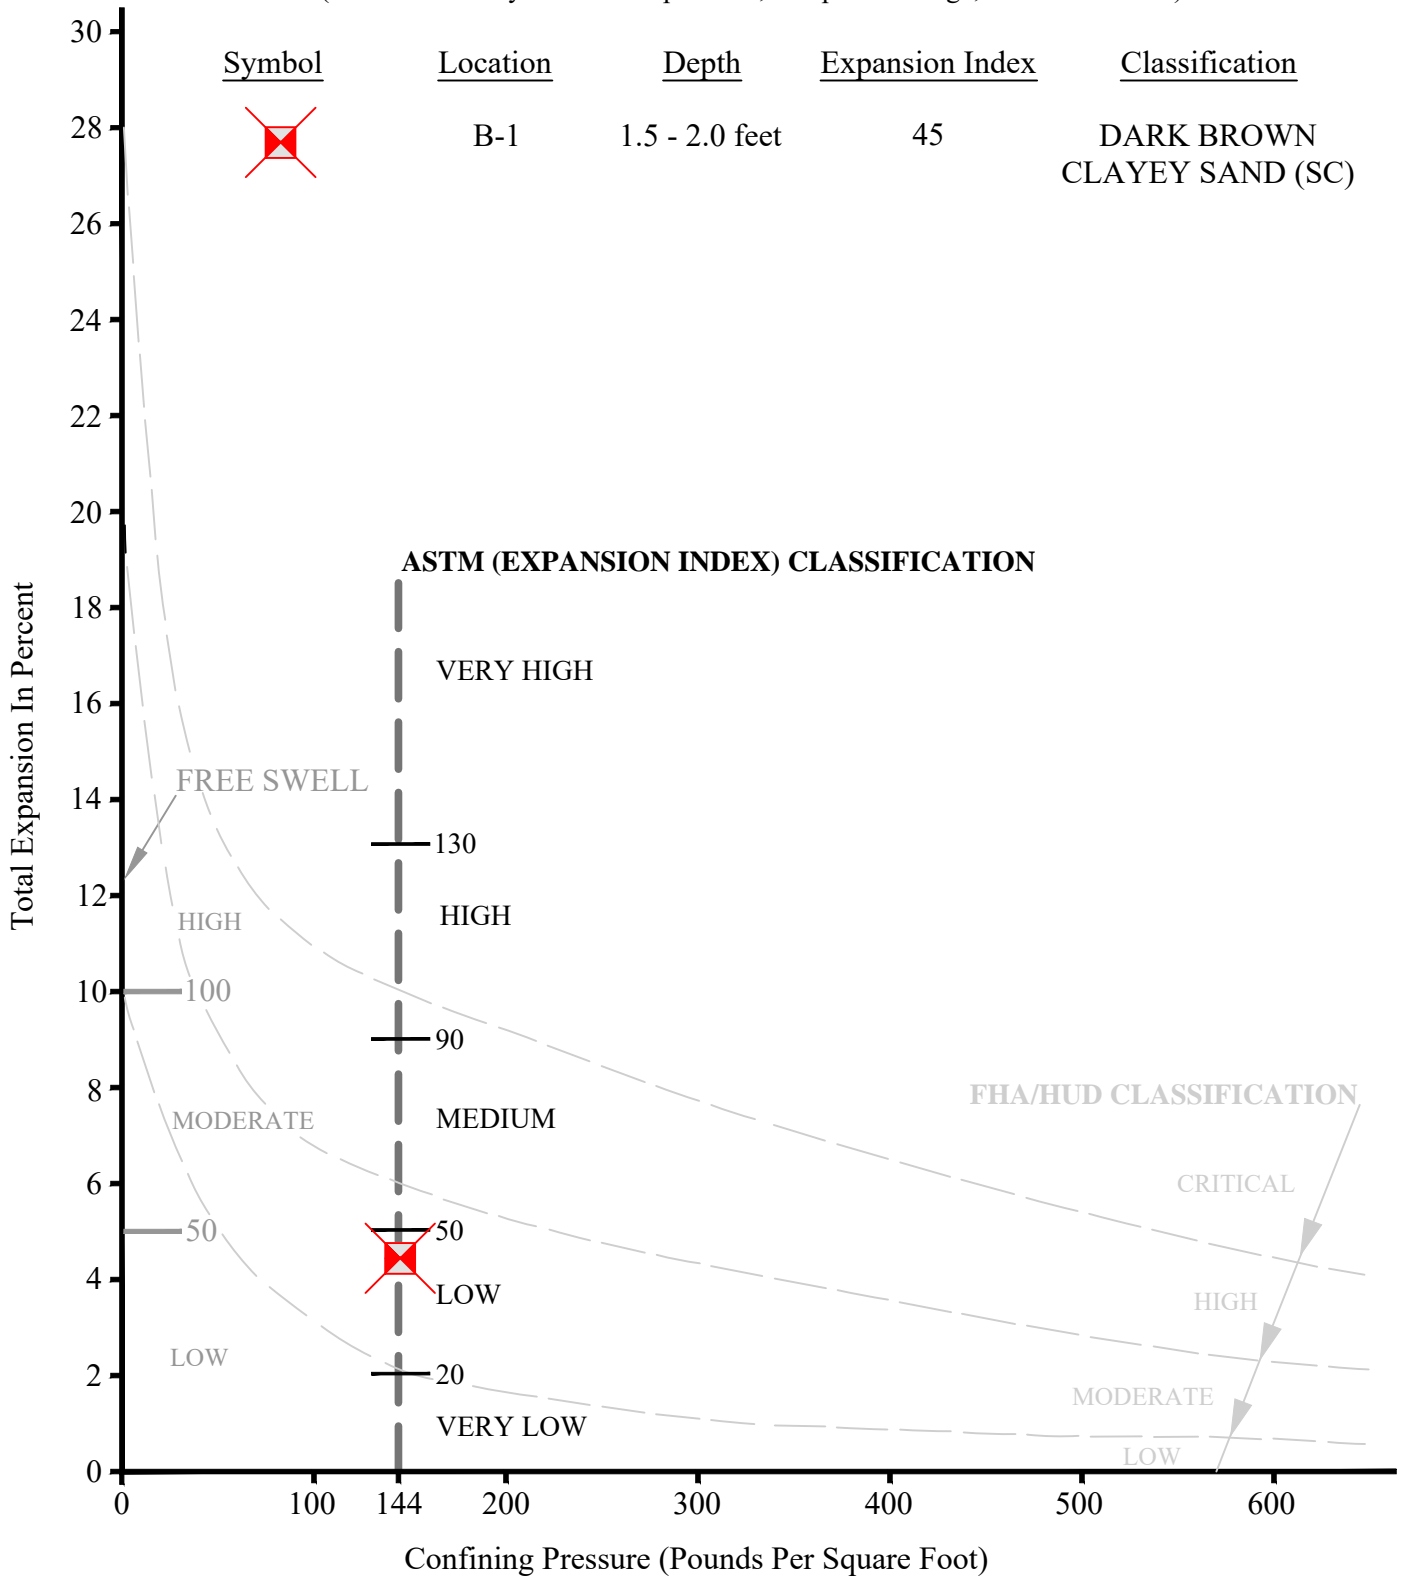
PLATE
9

B-1	1.5 - 2.0 feet	45	DARK BROWN CLAYEY SAND (SC)

EXPANSION INDEX TEST RESULTS
BALDERSTON FOUNDATION IMPROVEMENTS
12700 North Highway 1
Mendocino, California

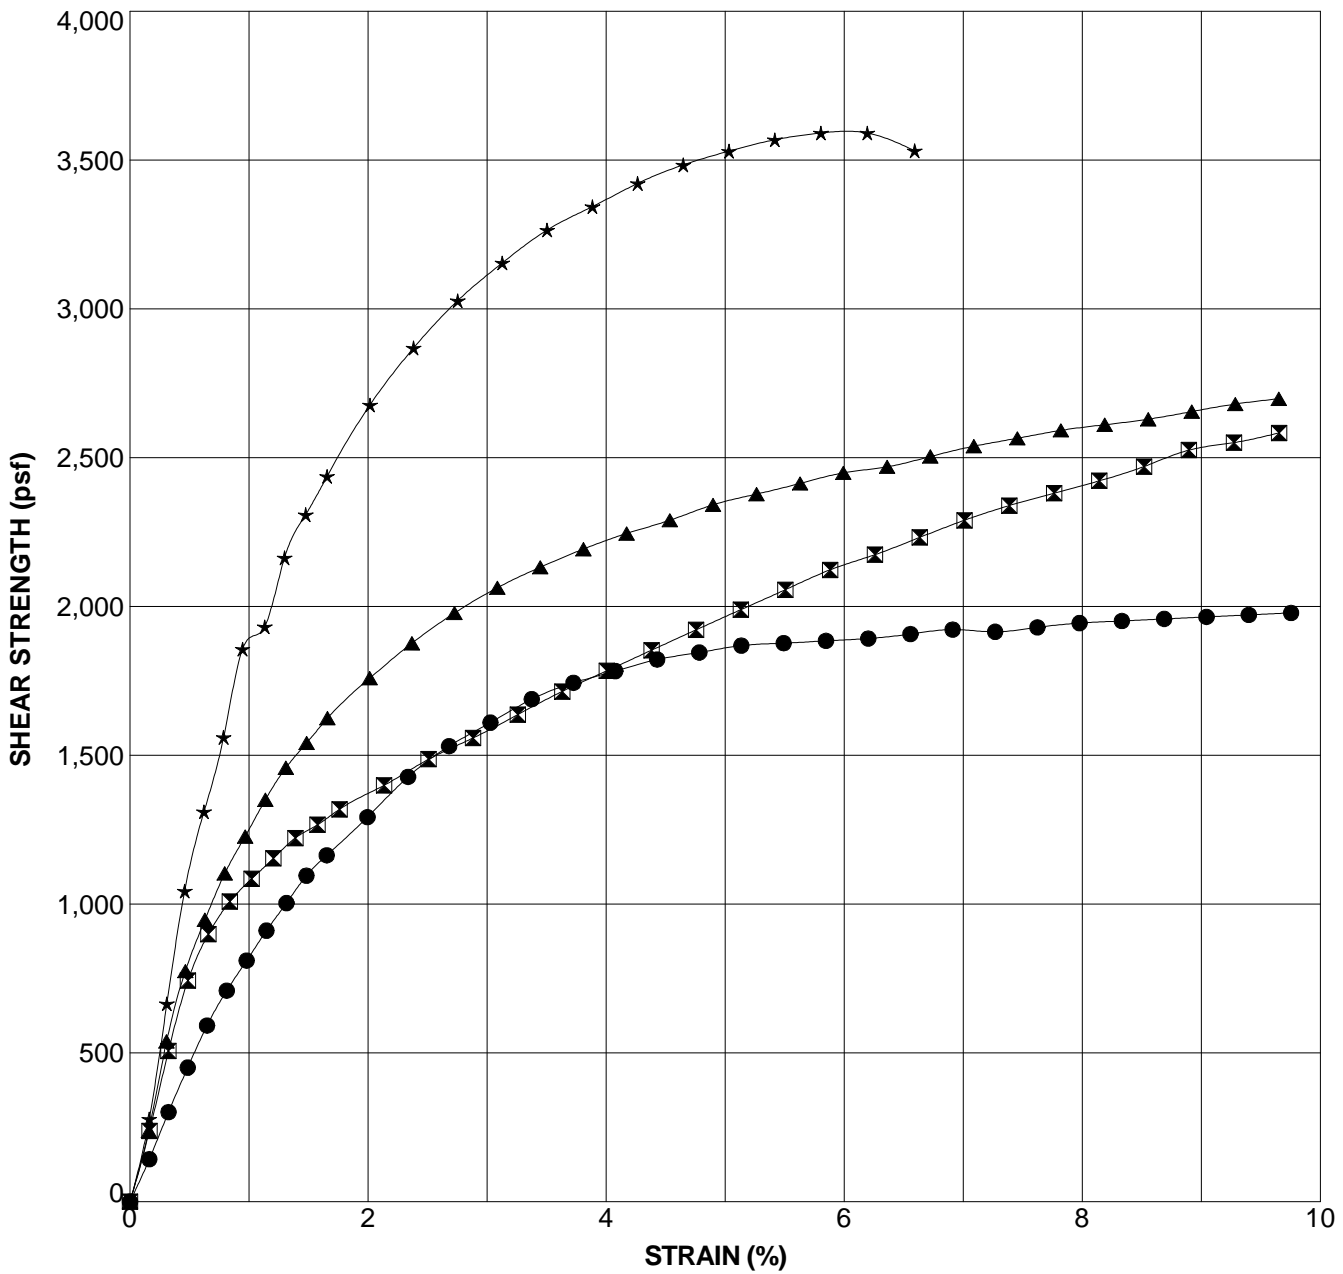
Sample Source	Classification	Confining Pressure (psf)	Ultimate Strength (psf)	Strain (%)	Dry Density (pcf)	Moisture Content (%)
● B-1 at 2 ft	DARK BROWN CLAYEY SAND (SC)	720	1978	9.8	80	27.6
☒ B-1 at 9 ft	MOTTLED GRAY-BROWN TO ORANGE CLAYEY SAND (SC)	1080	2583	9.7	99	23.1
▲ B-1 at 13 ft	MOTTLED GRAY-BROWN TO ORANGE CLAYEY SAND (SC)	1440	2698	9.7	107	20.9
★ B-2 at 6 ft	MOTTLED GRAY, ORANGE-BROWN SANDY CLAY (CL)	1008	3591	6.2	93	27.1
