RE: Main St. Mendo LLC Appeal # 2024-0009 of Mendocino Historical Review Board  
Decision  
Address: 45040 Main St., Mendocino, CA APN 119-238-10  
Hearing Date: Potentially April 8, 2025

# Duncan Engineering Inc.

May 18, 2023

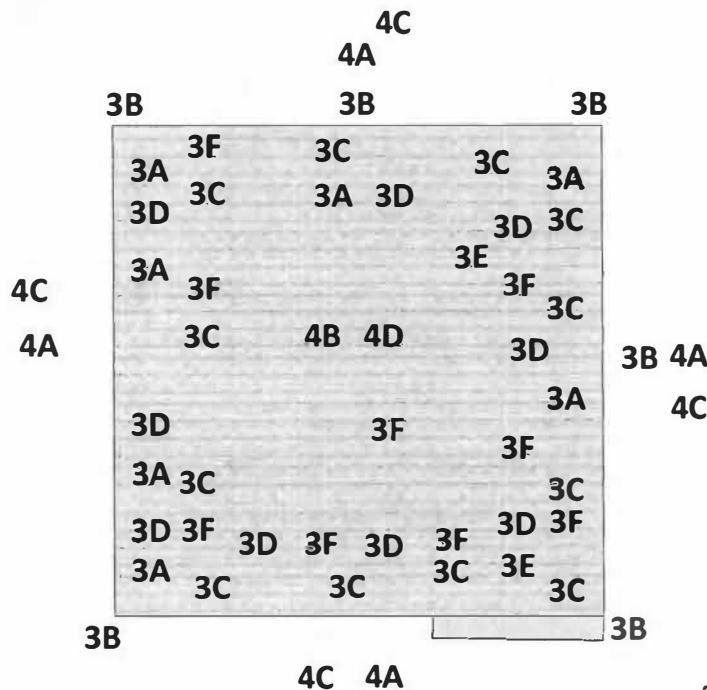
Select decking at first level deck was noted damaged by fungus and old drywood termites and wood boring beetles with the substructure or portions of substructure at this deck/porch mostly inaccessible due to height and/or being blocked by skirting.

Select large dimension support beams, diagonal supports and pads was noted damaged by fungus and wood boring beetles.

Second level plywood subfloor, tongue and groove decking and select railing was noted damaged by fungus and dampwood termites.

Third level plywood subfloor where marked on diagram was noted fungus damaged.

Appropriate trades to remove and replace damaged and infected timbers with new material. If further is wished remove decking at random and/or remove skirting to check the substructure/s for further conditions and issue a supplemental report if conditions are found with recommendation and price to complete any items.

Appropriate trades to remove and replace fungus damaged and badly wood boring beetle infested timbers with new material. Check for further conditions and issue a supplemental report if conditions are found.

Appropriate trades to remove and replace any damaged and infected timbers with new material. Check for further conditions and issue a supplemental report if conditions are found. If damage is in roof areas roofing contractor to check and certify.
