Acceptance of Informational Report Regarding the Issuance of Emergency Coastal Development Permit EM\_2023-0003 (McLellan) to Relocate the Single-Family Residence, Located at 34301 Pacific Reefs Road, Albion, APN: 123-340-19

In early March 2023, approximately twenty-two (22) feet of the ocean bluff collapsed extending to the foundation of the existing single-family residence. On July 14, 2023, the current landowners submitted an emergency request application for the relocation of the existing single-family residence to Planning and Building Services. The application requests to relocate or re-construct the single-family residence to a new foundation within a stable building site on the subject parcel further away from the existing failed bluff edge, no less than sixty-six (66) feet east of the bluff top edge. Because of the structure's proximity to the blufftop, Planning Staff has determined the work is considered development and requires the issuance of a Coastal Development Permit

**NATURE OF EMERGENCY:** Approximately twenty-two (22) feet of the ocean bluff collapsed in early March 2023, extending to the foundation of the existing single-family residence.

**CAUSE OF EMERGENCY

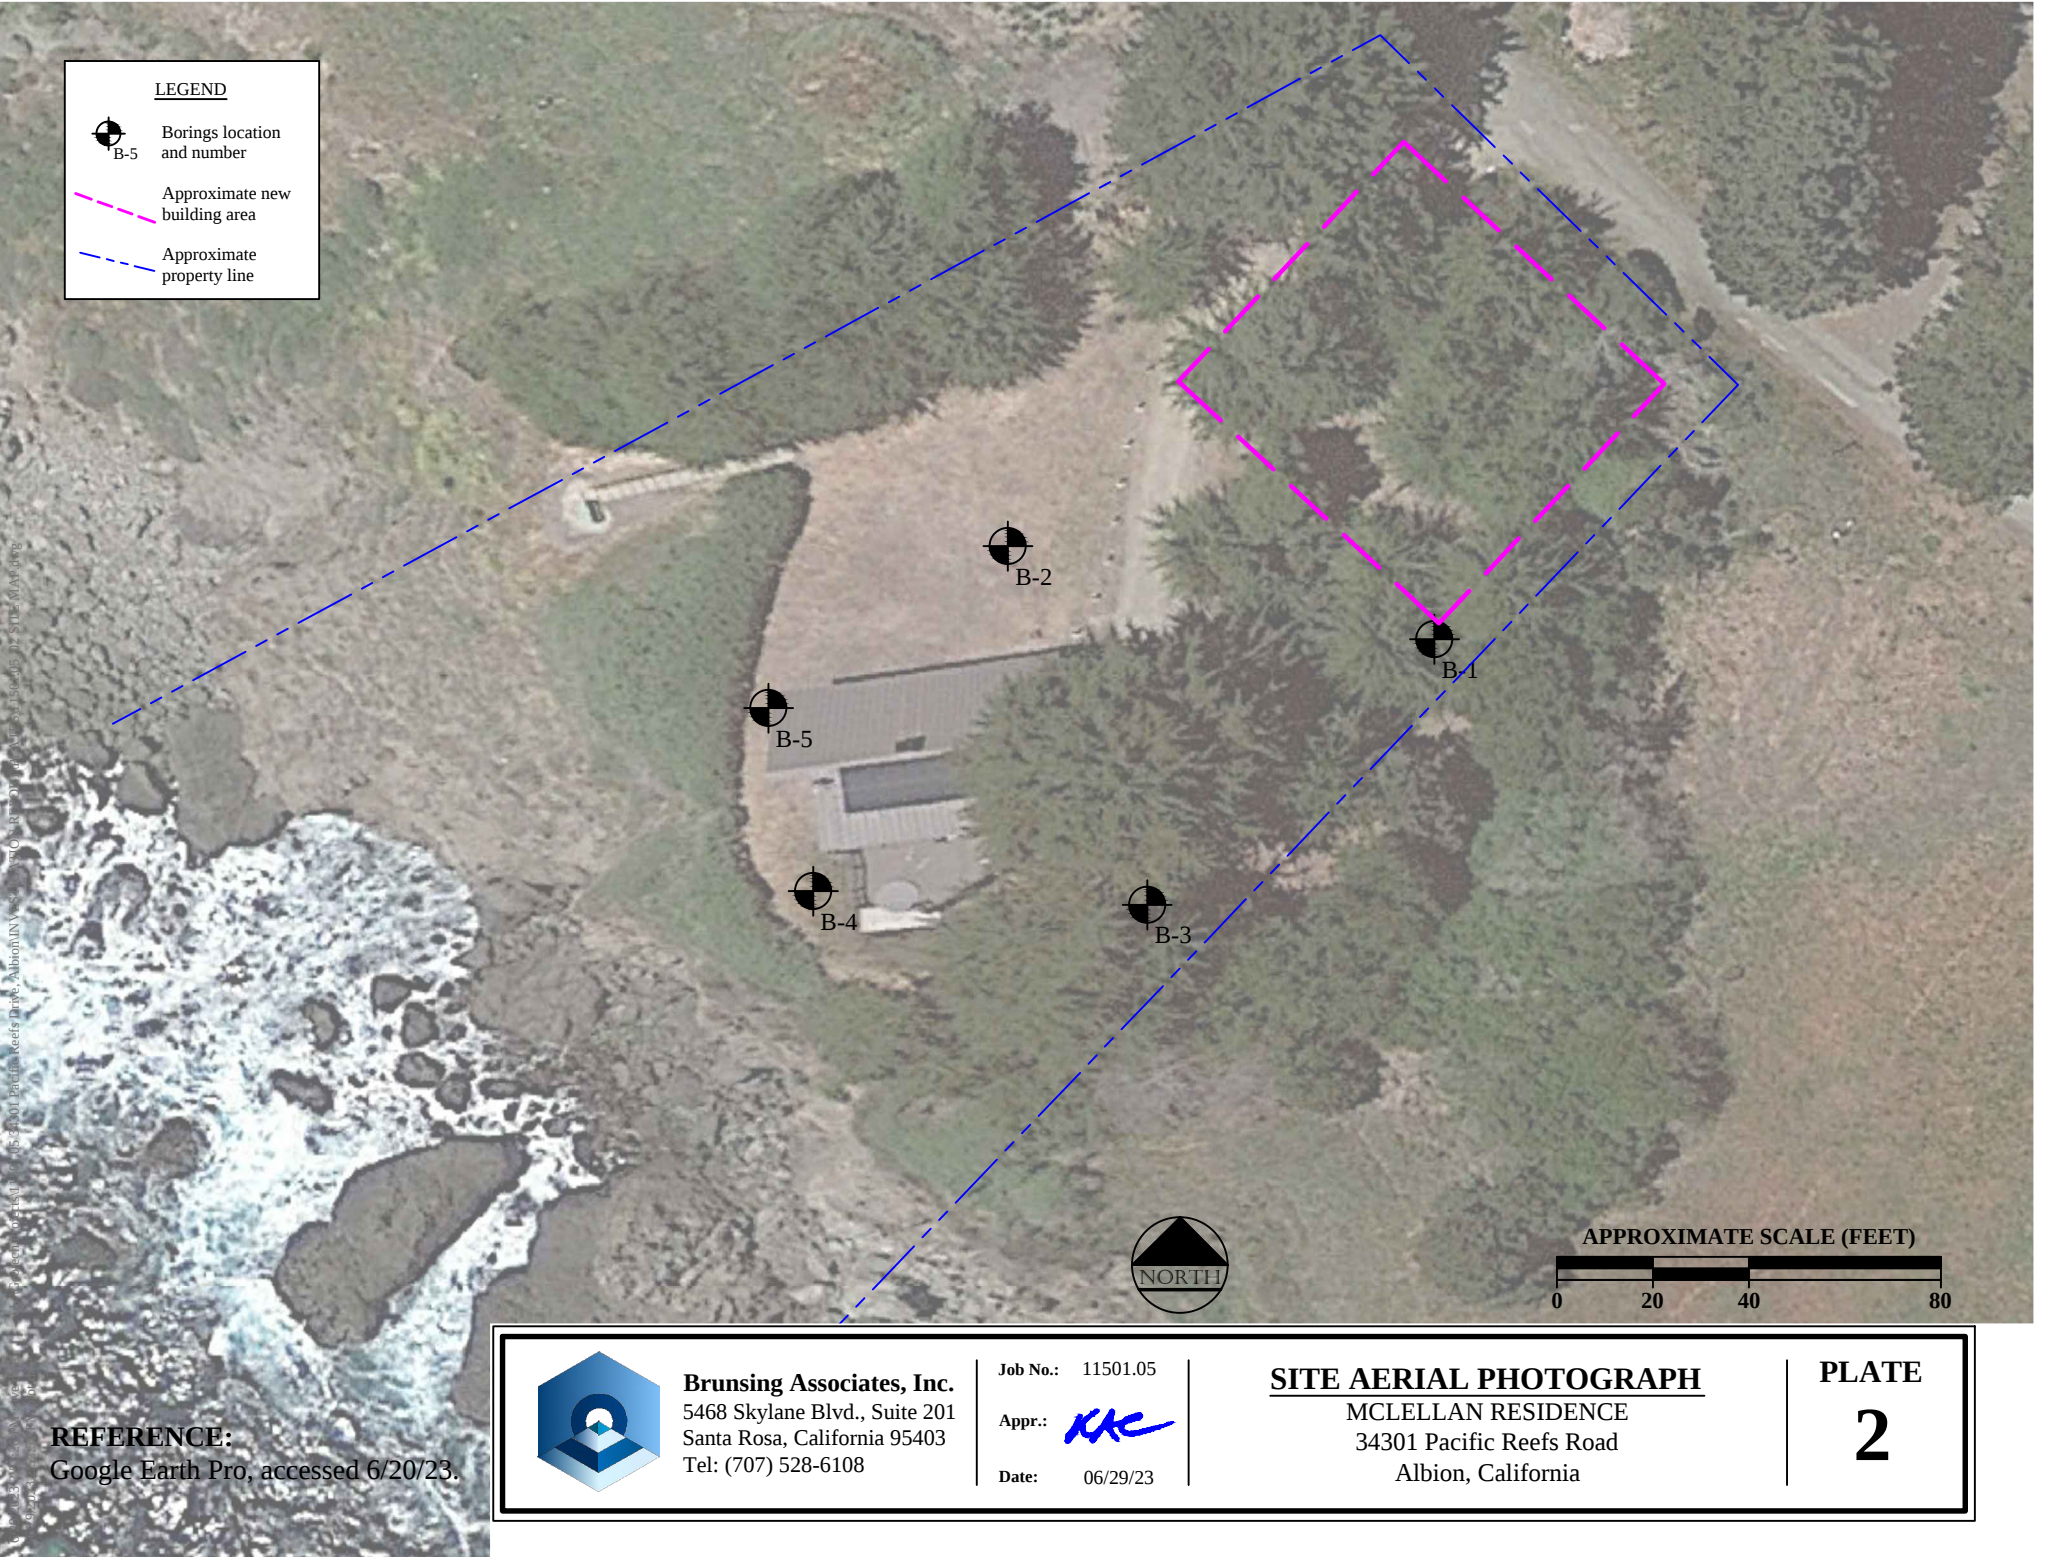
The ocean bluff next to the residence collapsed in early March 2023. The bluff landslide headscarp extended to the residence foundations. Since a landslide “repair” is extremely difficult to nearly impossible to be permitted by coastal agency standards or performed economically, the house needs to be abandoned or moved back, away from the landslide, as recommended below. The intent of this investigation is to evaluate the site geologic conditions in order to determine the feasibility of moving the house away from the bluff landslide to a new, stable building site on the property. The proposed, new building site is shown on the Site Aerial Photograph, Plate 2.

We conclude that the house can be moved back or re-constructed onto a new foundation within a stable building site at the property. This should be done as soon as possible since further damage or loss of the house is imminent.
