EMERGENCY PERMIT APPLICATION FORM

February 14, 2024

10945.05

GEOTECHNICAL INVESTIGATION

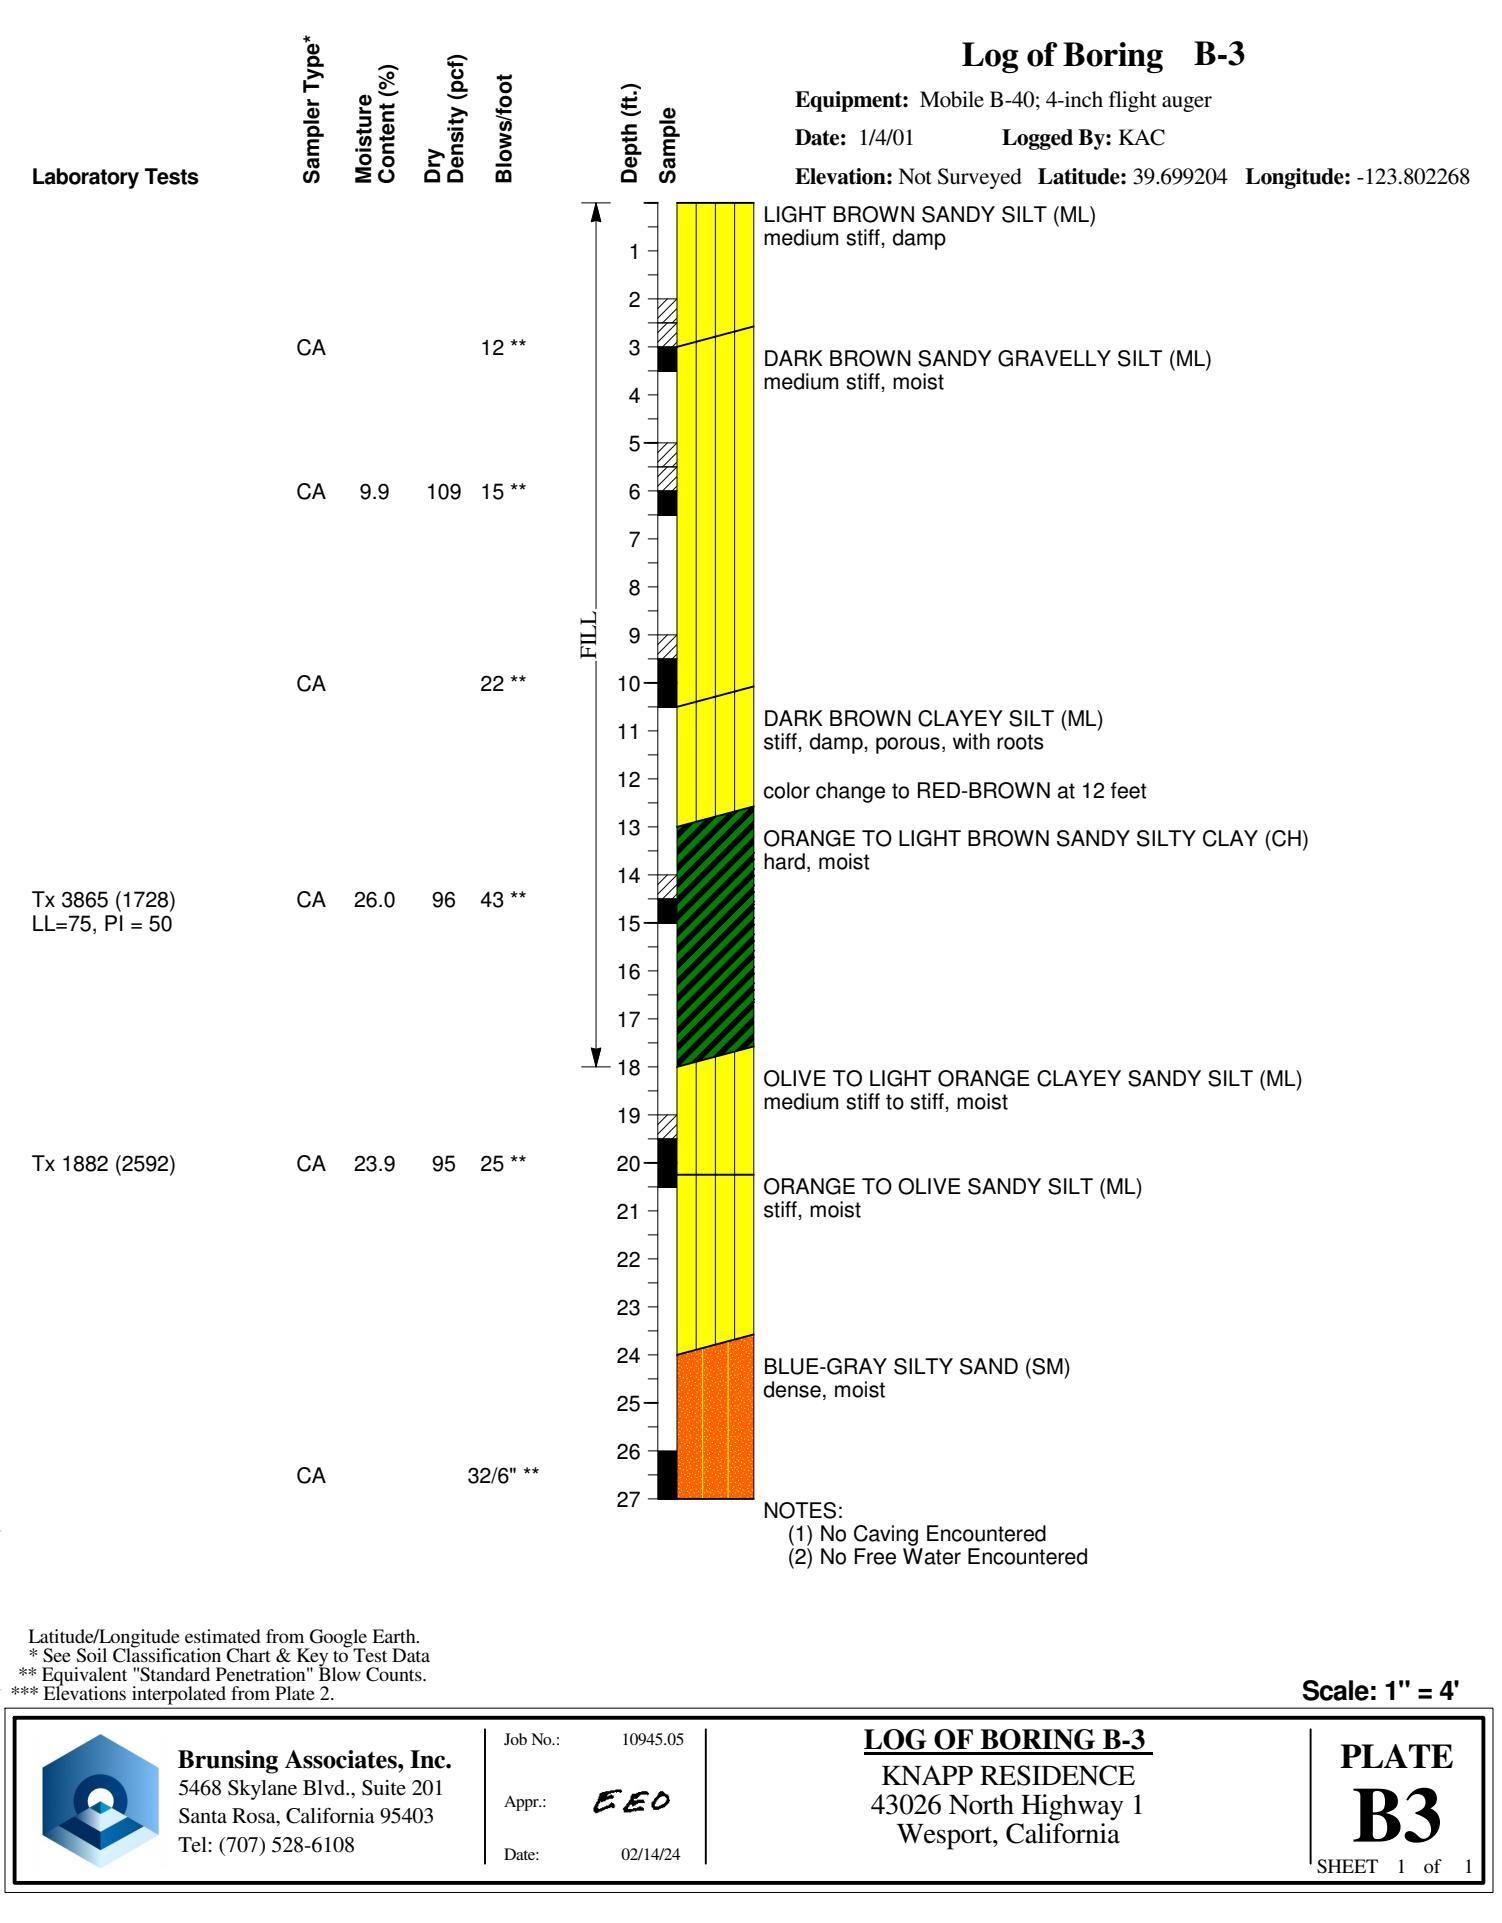
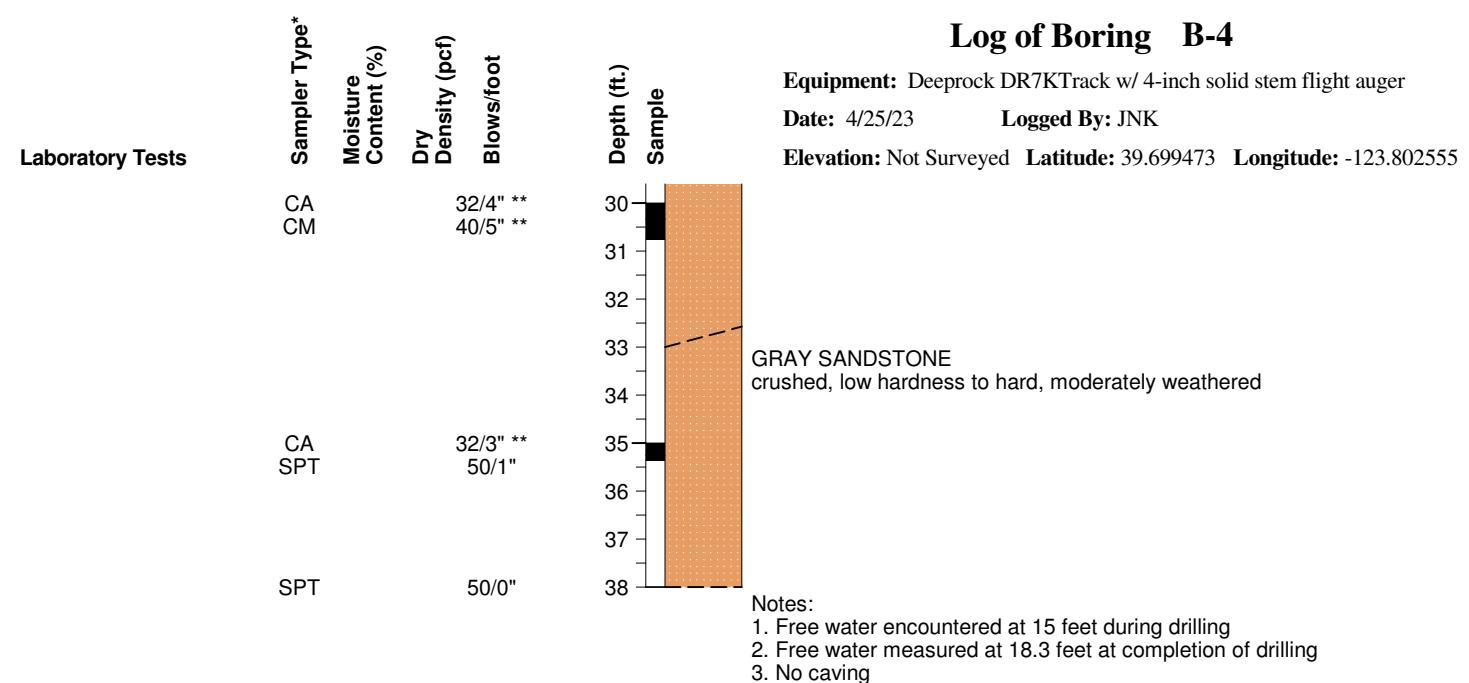
ype*	(%	cf)	÷		Log of Boring B-4	
	ler T	ure int (%	ty (p	s/foo	(ft.) le	Equipment: Deeprock DR7KTrack w/ 4-inch solid st	em flight auger
	amp	oisti onte	ry ensi	lows	epth amp	Date: 4/25/23 Logged By: JNK	
Laboratory Tests	ũ	ΣŰ		Ш	ٽ ۾ 	Elevation: Not Surveyed Latitude: 39.699473 Lor	igitude: -123.802555
					$1 = \frac{1}{\sqrt{1 + \frac{1}{1 + \frac{1}{1 + \frac{1}}}}}}}}}}}}}}}}}}}}}}}}}}}}}}}}}}}}$	TOPSOIL/GARDEN	
					2 -	BROWN SANDY SILT (ML) medium stiff to soft, moist few gravels	
Tx 1533 (432)		14.9	108			Ŭ.	
55% Passing #200	CA			7 **	4 -		
	см			o **	5-		
	Civi			2	6 -		
					7 -		
					8 -	BROWN SILTY SAND (SM) with gravel	
					9 -	loose, moist few gravels	
Tx 554 (1152)		18.8	106		10-		
27% Passing #200 67% Passing #4	CA			2 **	- 11 -		
					12		
	СМ			3 **	- - 12 -	Very loose, wet to saturated	
						bedrock fragments	
						LIGHT ORANGE-BROWN SANDY CLAY (CL)	
					⊻ 15-		
	CA			8 **	16		
	~				17 -

СМ			12 **		ORANGE-BROWN SANDY CLAY (CL)	
Tx 2113 (2160) 65% Passing #200	CA	28.2	94	10 **	19 -	stiff, saturated	
95% Passing #4					20-	ORANGE-BROWN SILTY SAND (SM)	
	СМ			8 **		ORANGE-BROWN CLAYEY SAND (SC)

-		
					22	BLUE-GRAY SILTY SAND (SM)	
					23 -	moist some mottled orange at 25 feet	
					24 -		
					25-		
1x 2476 (3024) 24% Passing #200	CA	14.1	118	12 **	- 26 -		
96% Passing #4					- 27 -		
	СМ			21 **	28		
					20 -	GRAY SANDSTONE crushed, friable to low hardness, deeply weathered	
T-14-1-17 - 1-1 - 1-1 - 1-1	C	.1. 5			29 -	, <u> </u>

4. Practical drilling refusal at 38 feet

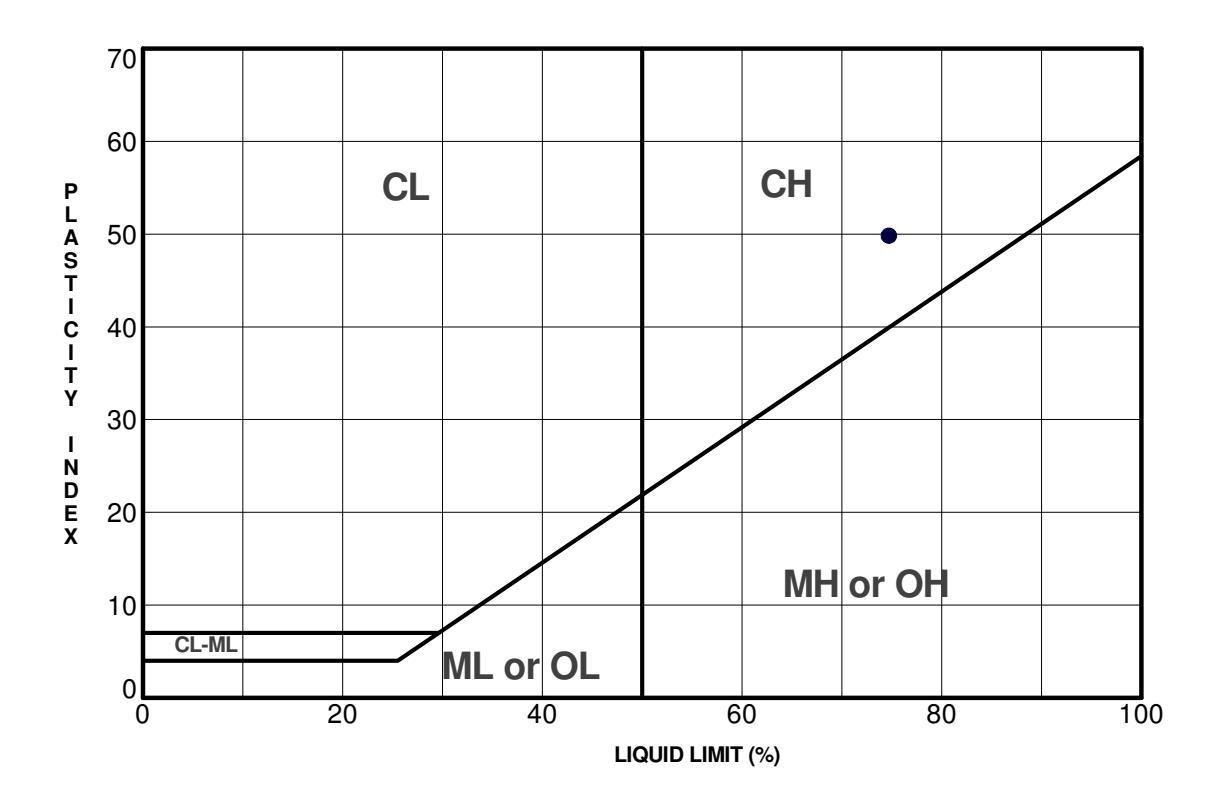
plate C1

SYMBOL	CLASSIFICATION AND SOURCE	LIQUID LIMIT (%)	PLASTIC LIMIT (%)	PLASTICITY INDEX	% PASSING No. 200 SIEVE
•	ORANGE TO LIGHT BROWN SANDY SILTY CLAY (CH) B-3 @ 14.5 feet	75	25	50

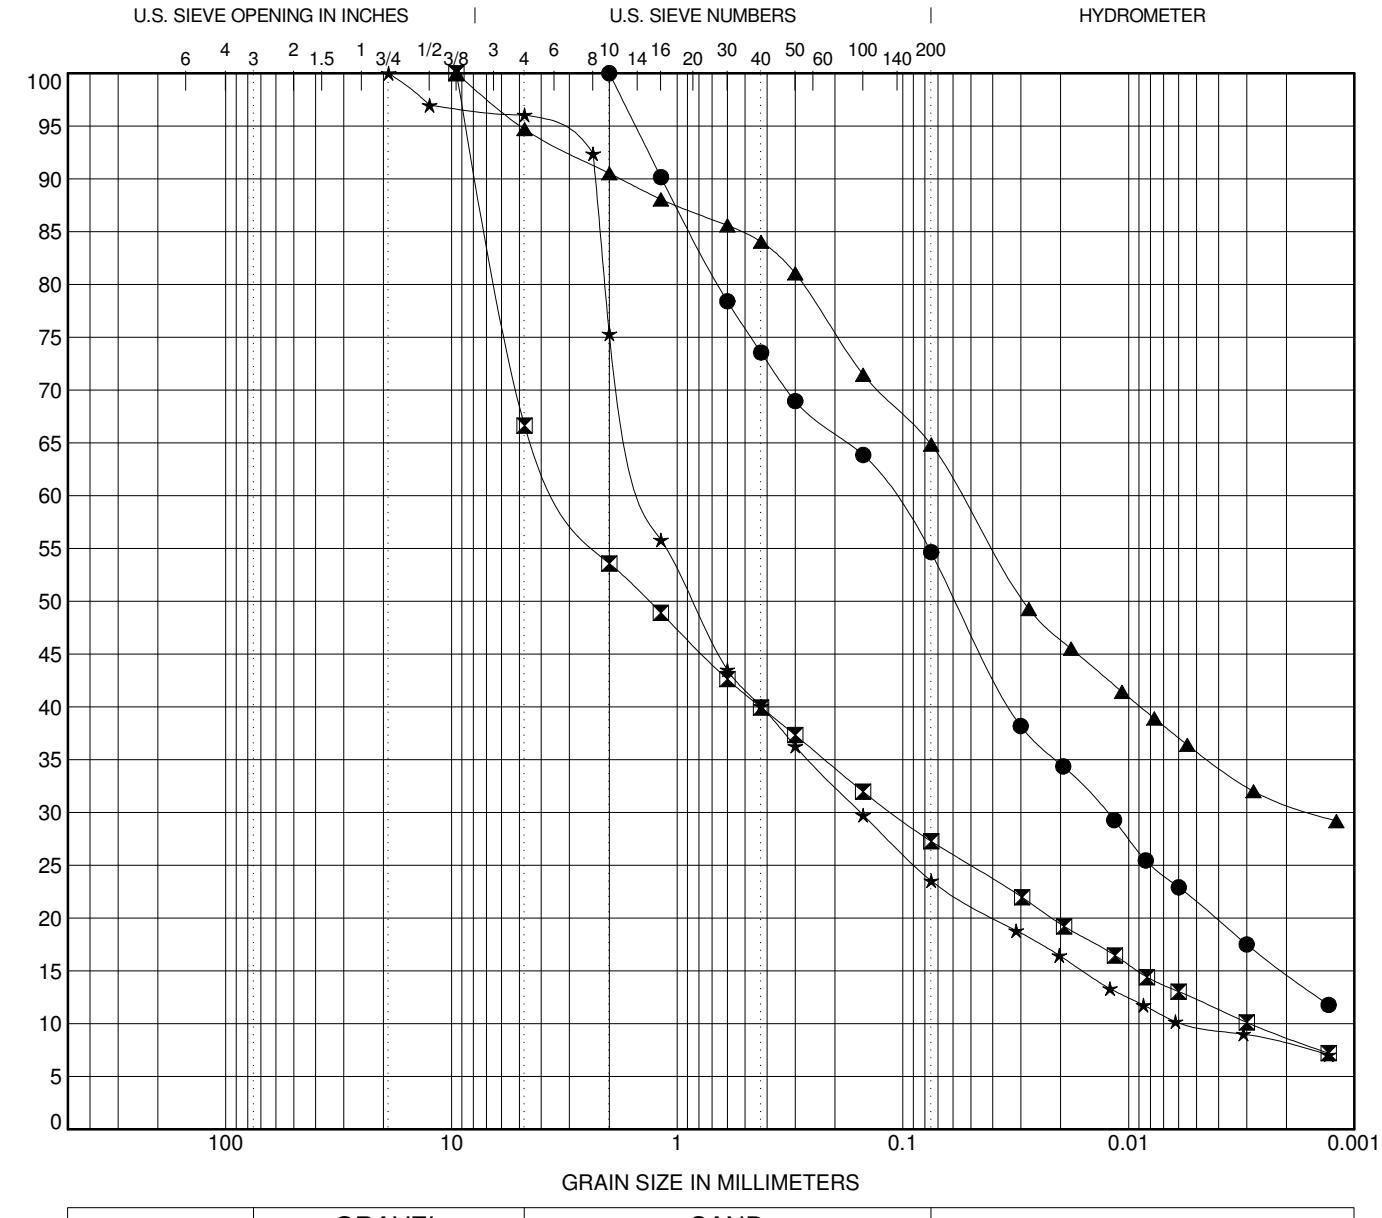
PLATE **C2**

onunoauon		0.0	accontrolation						00	04
•	B-4	3.5 ft		BROWN	SANDY SILT	(ML)						
	B-4	10.0 ft	BR	OWN SILTY	SAND (SM)	with gravel					1.42	1055.83
	B-4	18.5 ft	OF	RANGE-BRO								
*	B-4	25.5 ft		BLUE-GRA	Y SILTY SAN	ID (SM)					3.24	238.30
5	Specimen Ic	lentification	D100	D60	D30	D10	%Grave	9	%Sand	%Sil	t 9	6Clay
•	B-4	3.5 ft	2	0.112	0.012				45.4	33.2	2	21.5
	B-4	10.0 ft	9.5	3.06	0.112	0.003	33.4		39.4	15.0)	12.3
	B-4	18.5 ft	9.5	0.055	0.002		5.3		29.9	29.1		35.8
*	B-4	25.5 ft	19	1.322	0.154	0.006	3.9		72.5	13.7	,	9.8

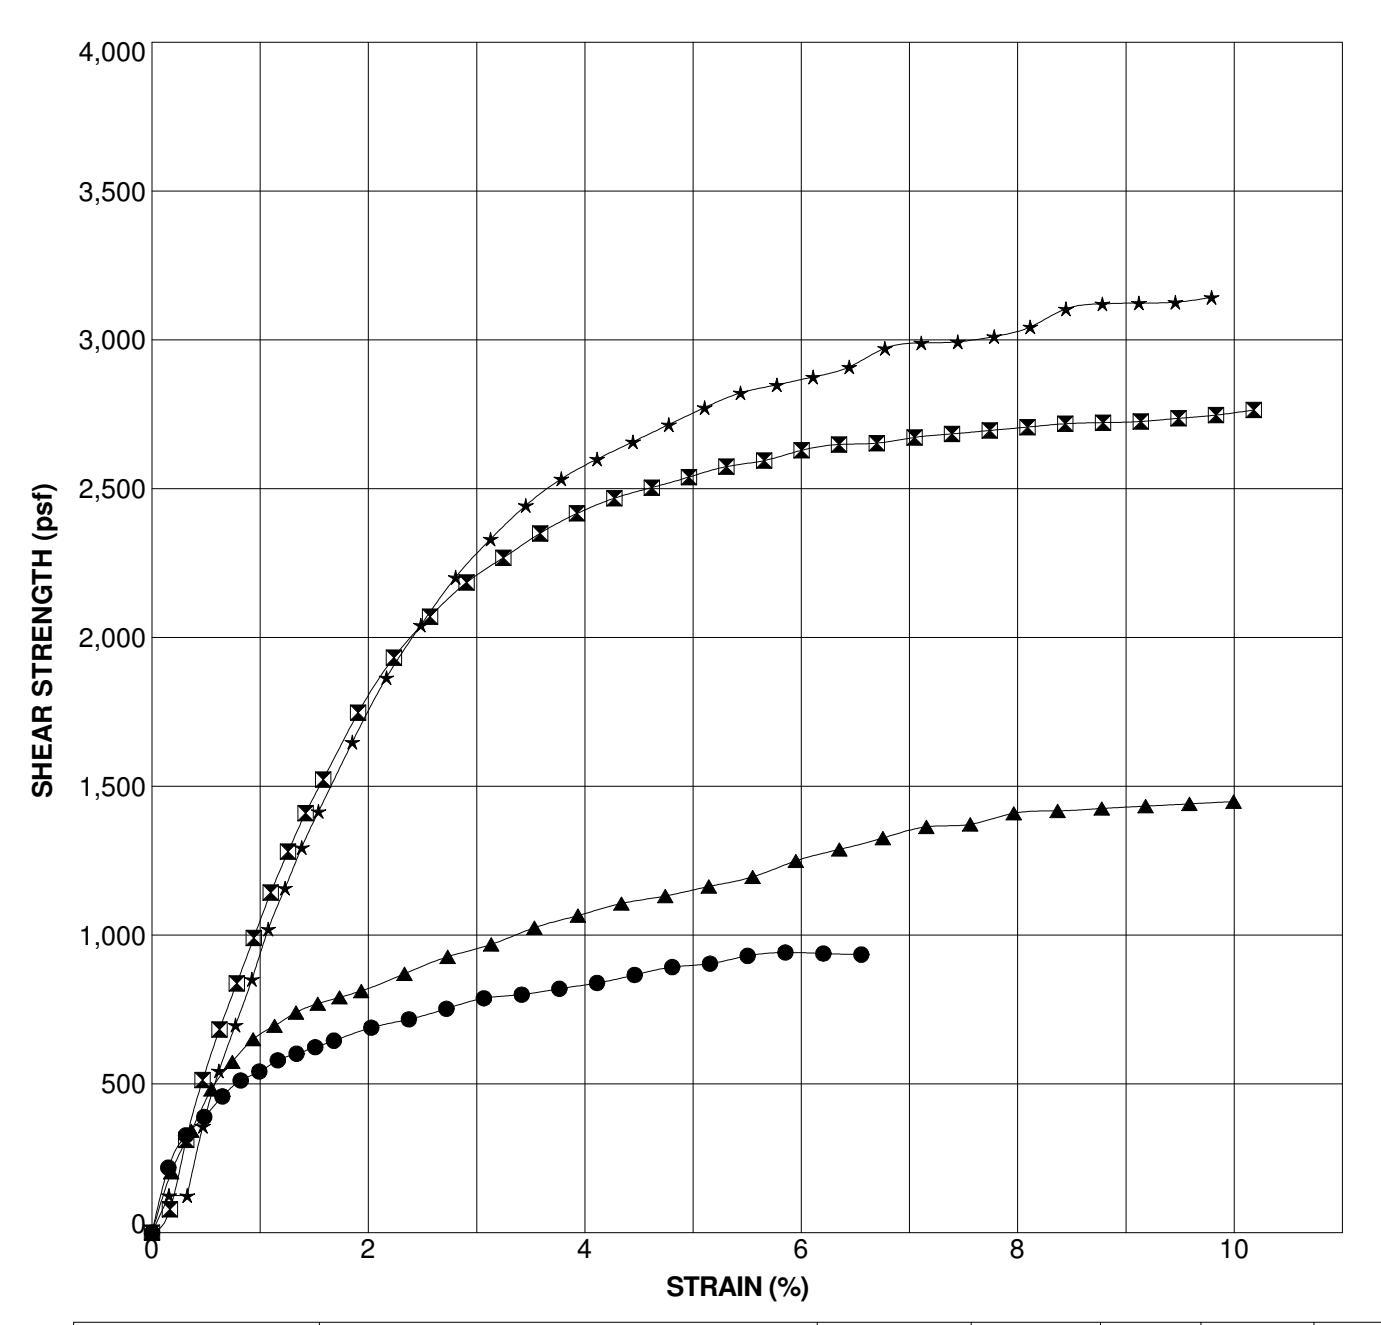
Sample Source	Classification	Confining Pressure (psf)	Ultimate Strength (psf)	Strain (%)	Dry Density (pcf)	Moisture Content (%)
● B-1 at 6 ft	BROWN SANDY SILT (ML)	720	941	5.9	102	15.1
I B-1 at 10 ft	DARK BROWN CLAYEY SILT (ML)	1296	2765	10.2	91	25.6
▲ B-2 at 4.5 ft	LIGHT-BROWN SANDY SILT (ML)	576	1448	10.0	111	10.9
★ B-2 at 15 ft	DARK BROWN CLAYEY SILT (ML)	1872	3143	9.8	101	21.0

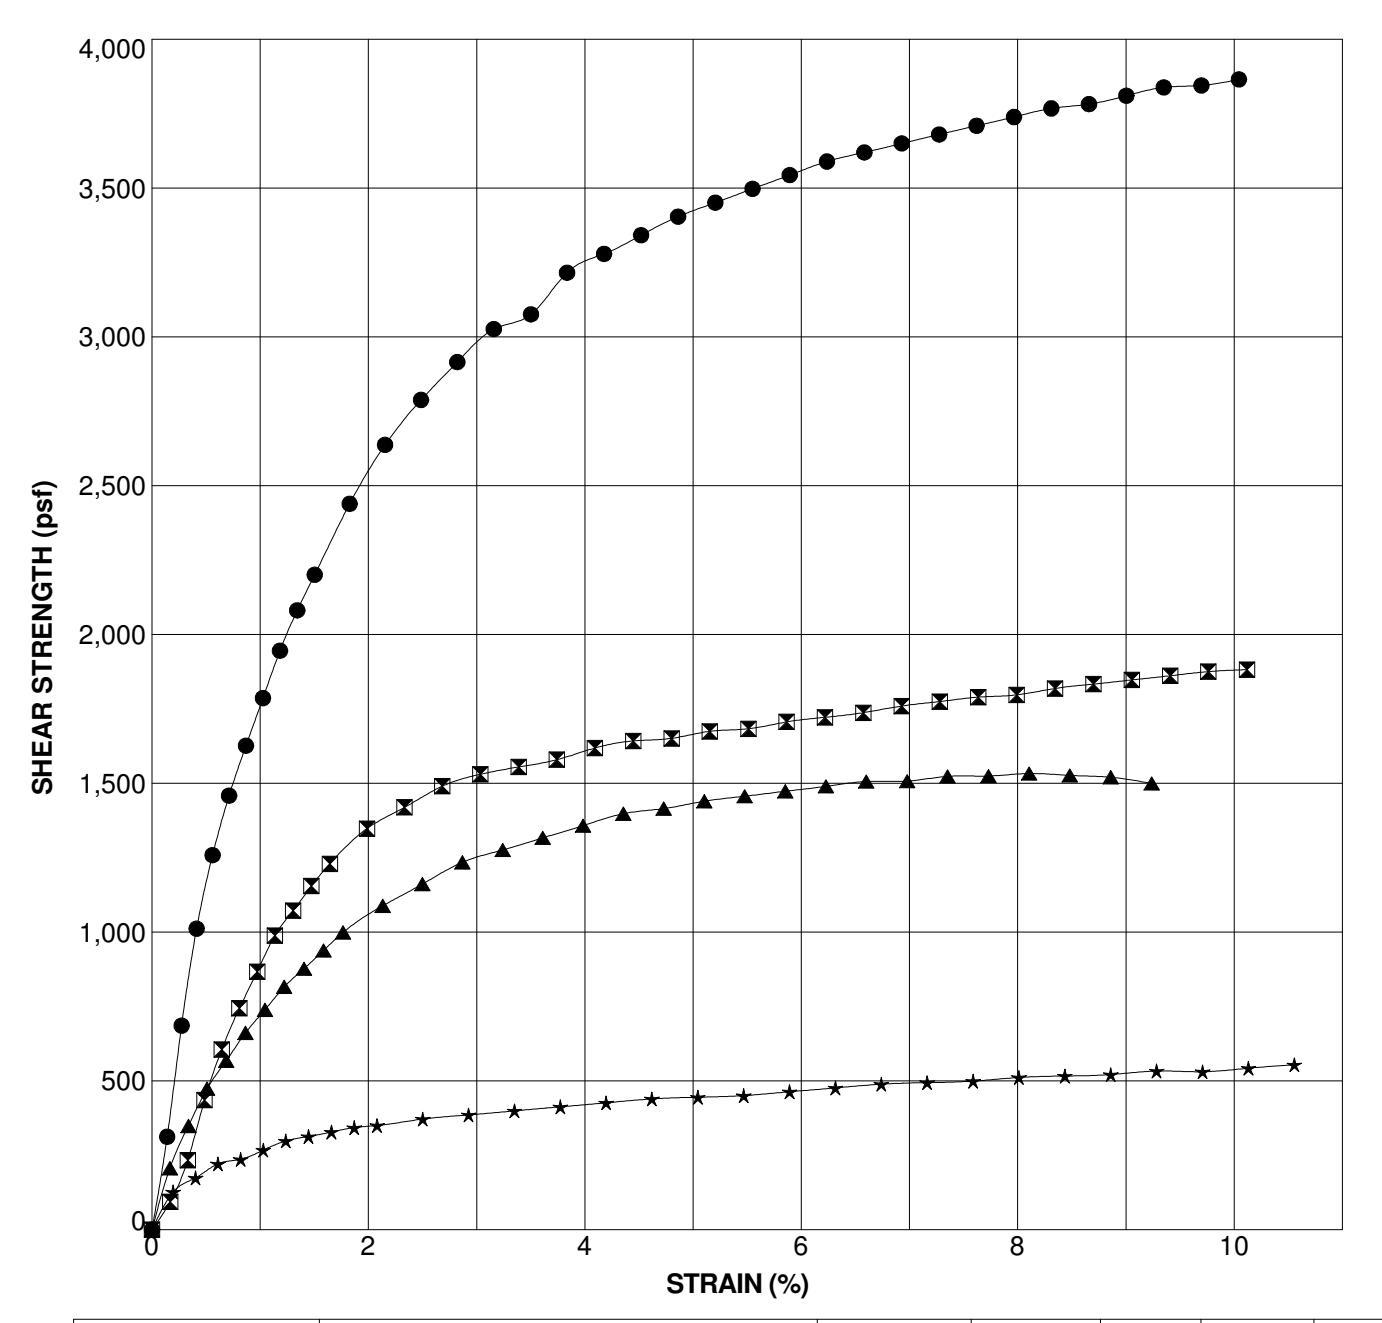
Sample Source	Classification	Confining Pressure (psf)	Ultimate Strength (psf)	Strain (%)	Dry Density (pcf)	Moisture Content (%)
• B-3 at 14.5 ft	ORANGE TO LIGHT BROWN SANDY SILTY CLAY (CH)	1728	3865	10.0	96	26.0
I B-3 at 20 ft	OLIVE TO LIGHT ORANGE CLAYEY SANDY SILT (ML)	2592	1882	10.1	95	23.9
▲ B-4 at 3.5 ft	BROWN SANDY SILT (ML)	432	1533	8.1	108	14.9
★ B-4 at 10 ft	BROWN SILTY SAND (SM) with gravel	1152	554	10.6	106	18.8

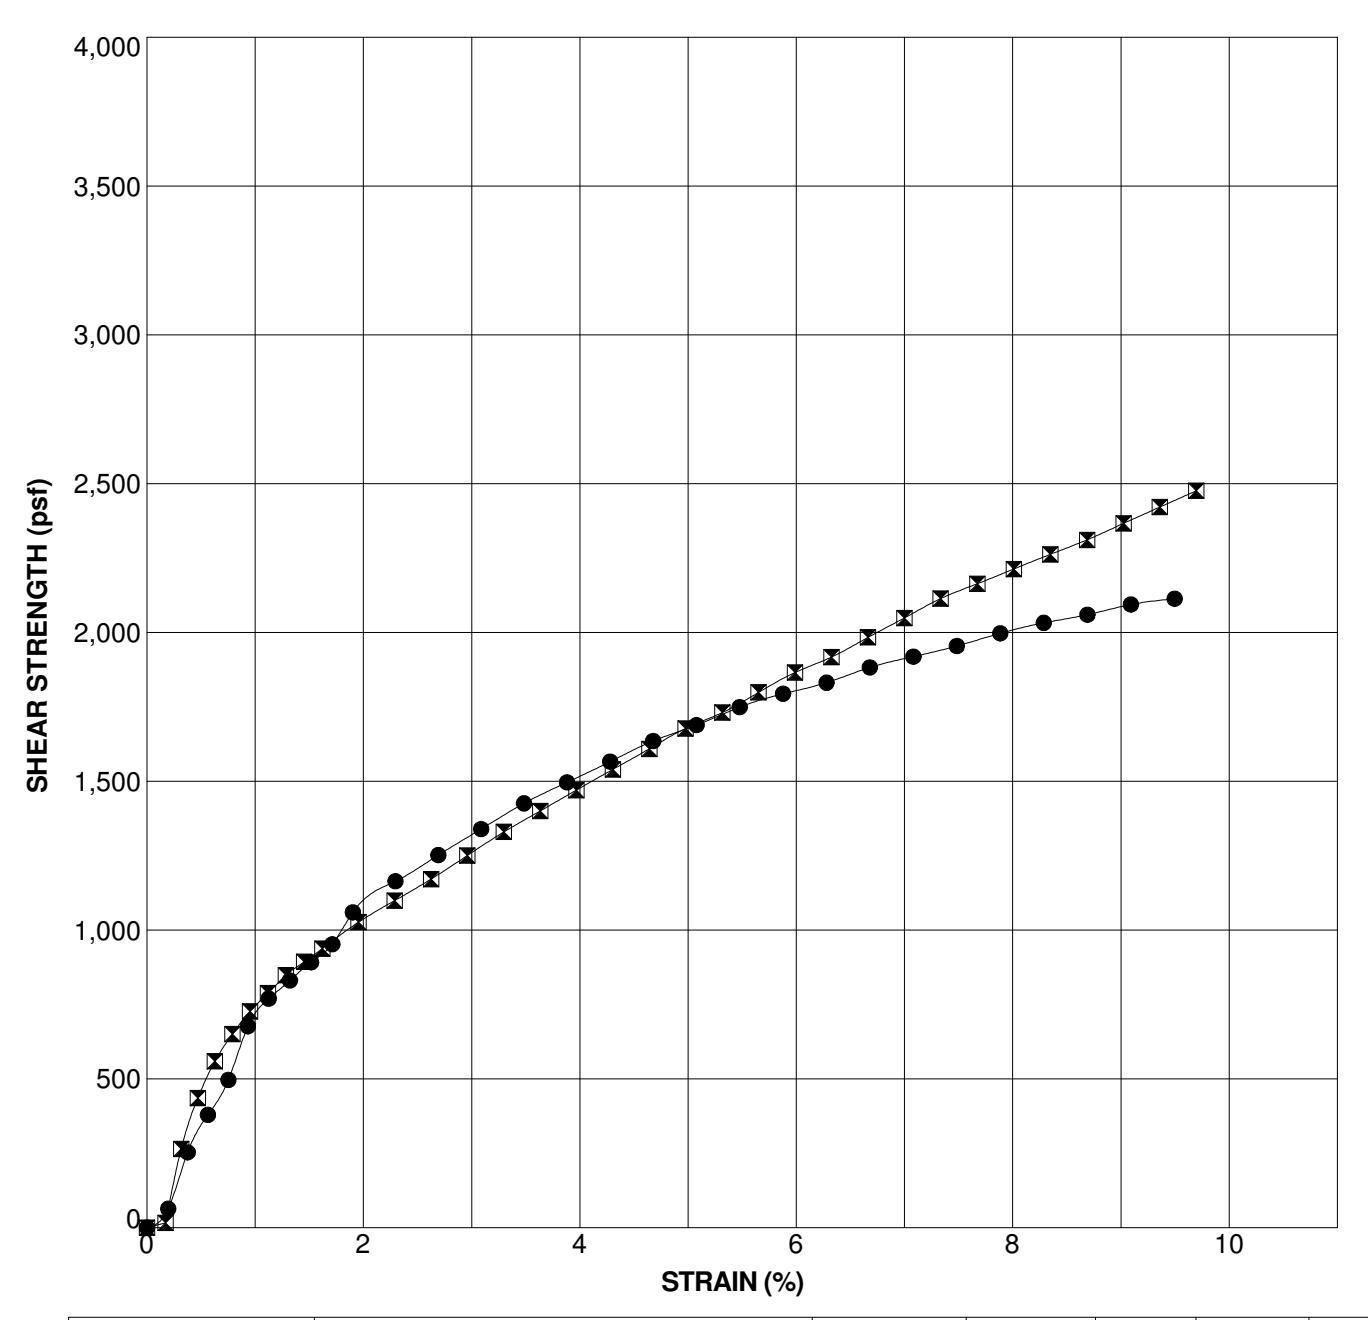
Sample Source	Classification	Confining Pressure (psf)	Ultimate Strength (psf)	Strain (%)	Dry Density (pcf)	Moisture Content (%)
● B-4 at 18.5 ft	ORANGE-BROWN SANDY CLAY (CL)	2160	2113	9.5	94	28.2
■ B-4 at 25.5 ft	BLUE-GRAY SILTY SAND (SM)	3024	2476	9.7	118	14.1

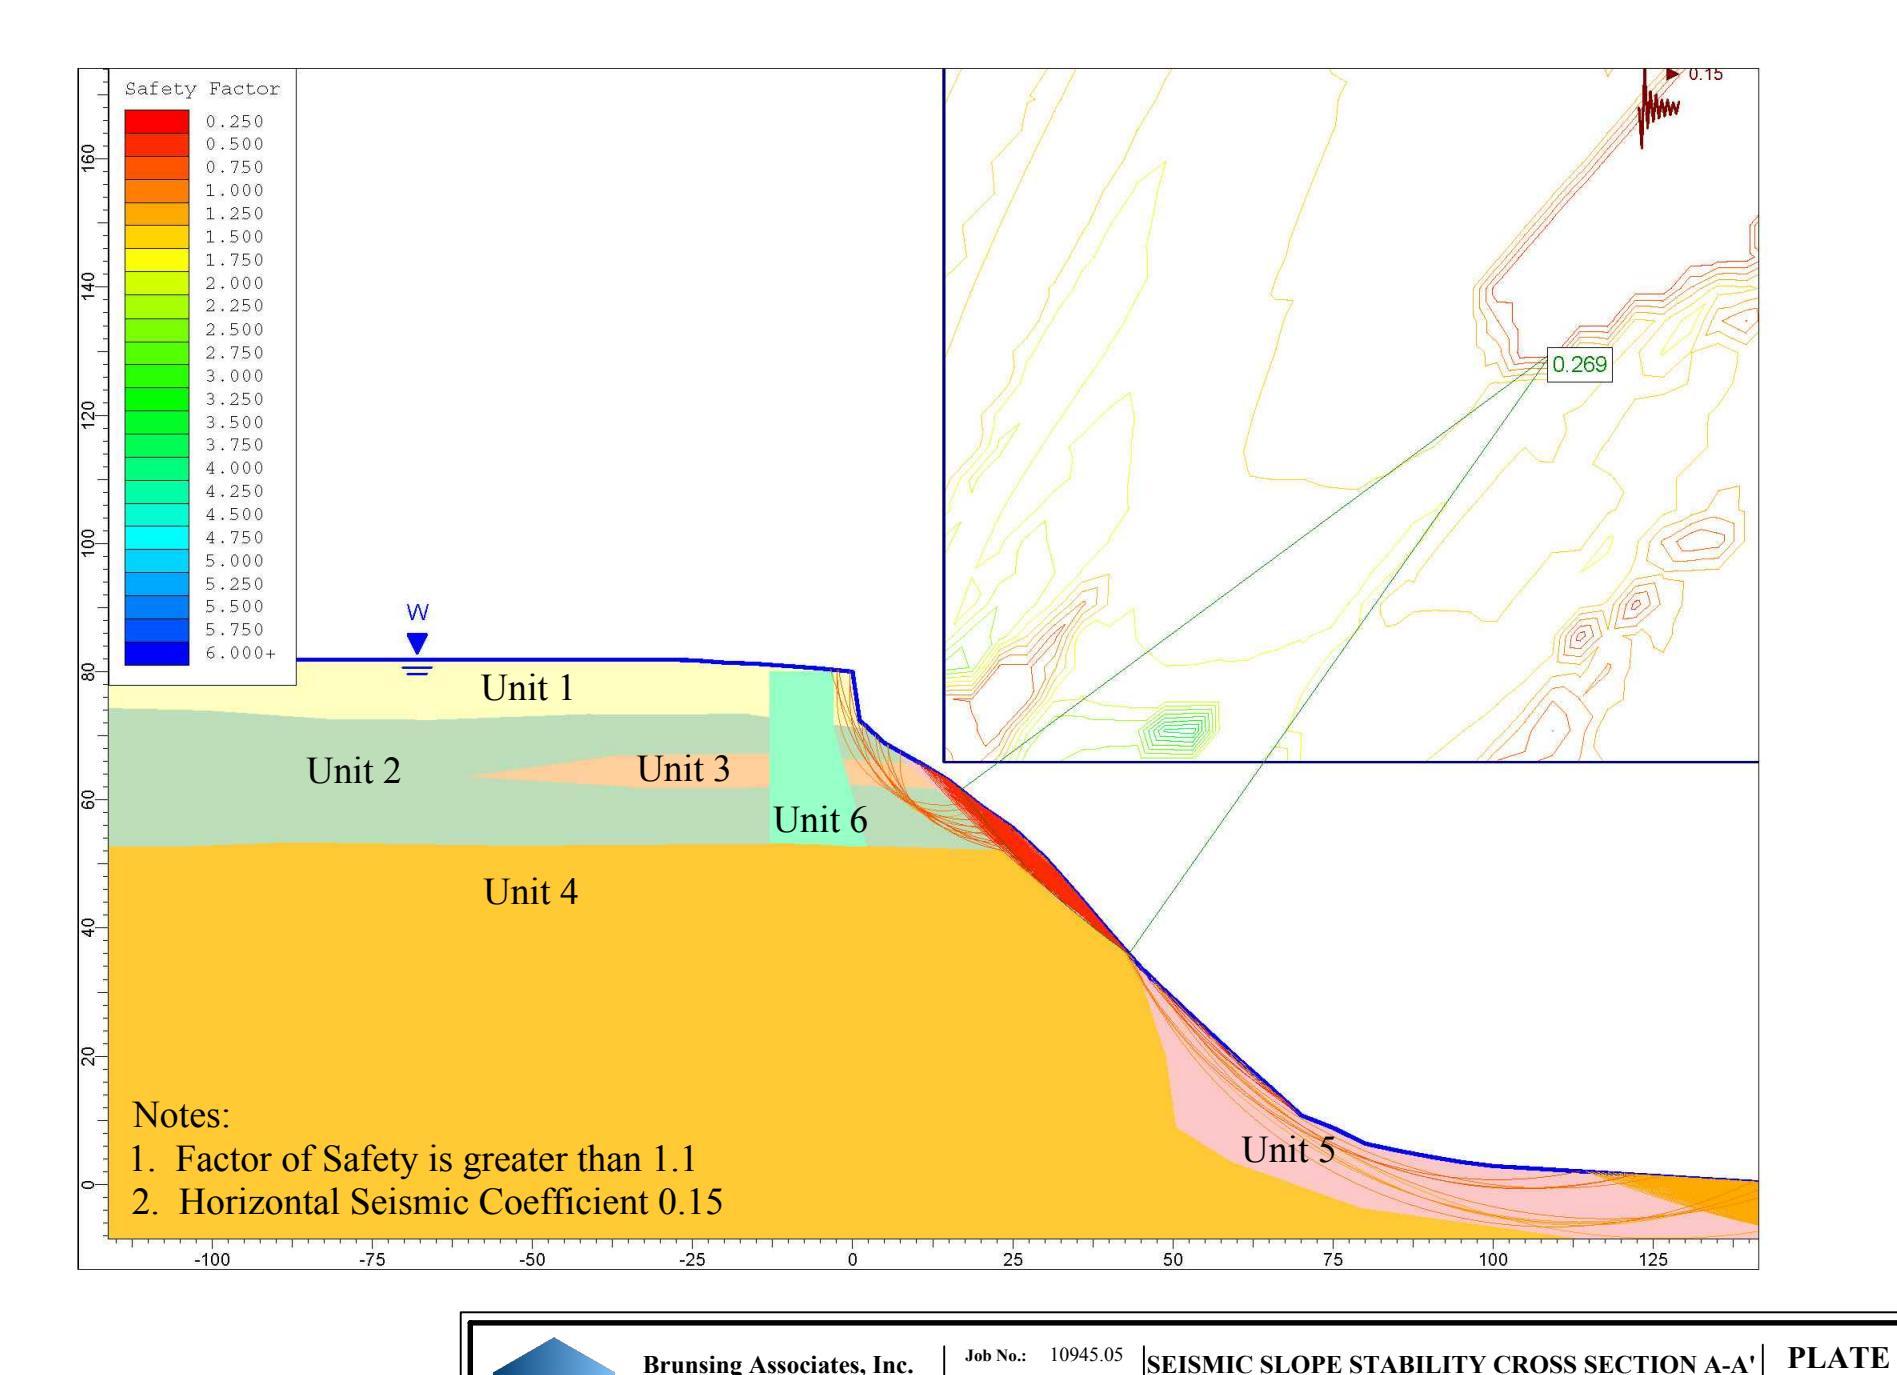
E2

TIC SLOPE STABILITY CROSS SECTION A-A' KNAPP RESIDENCE 43026 Highway 1 Westport, California
